Motion Amplification Study, KTG Memphis, TN

1: Executive Summary

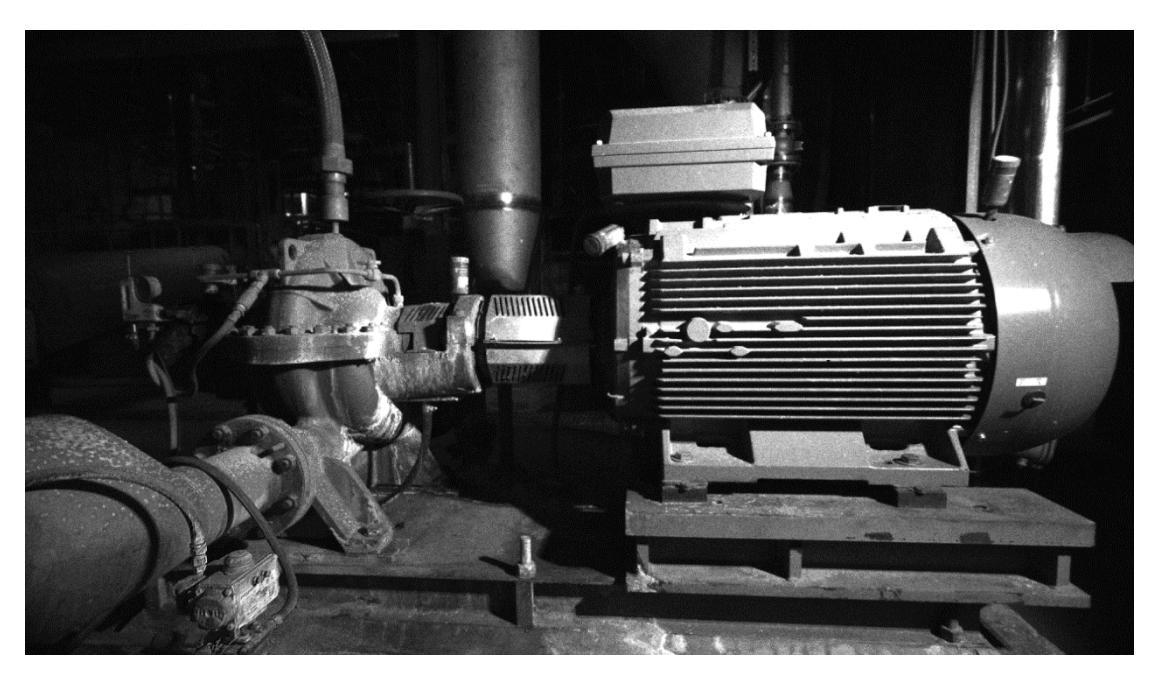
Figure 1: Motion Amplification, Motor/Pump side view

Motion amplification of the motor and pump showed very little to no movement of the motor; however, MA video did show some movement of the pump. The inboard end of the pump appeared to have the most movement. Vibration data showed the unit to have an overall vibration of .1 inches per second peak or less with data indicating most of the vibration to be at the pump inboard vertical. Data showed a 1 x rpm vibration throughout the pump with pump inboard horizontal showing some 2 x rpm vibration as well

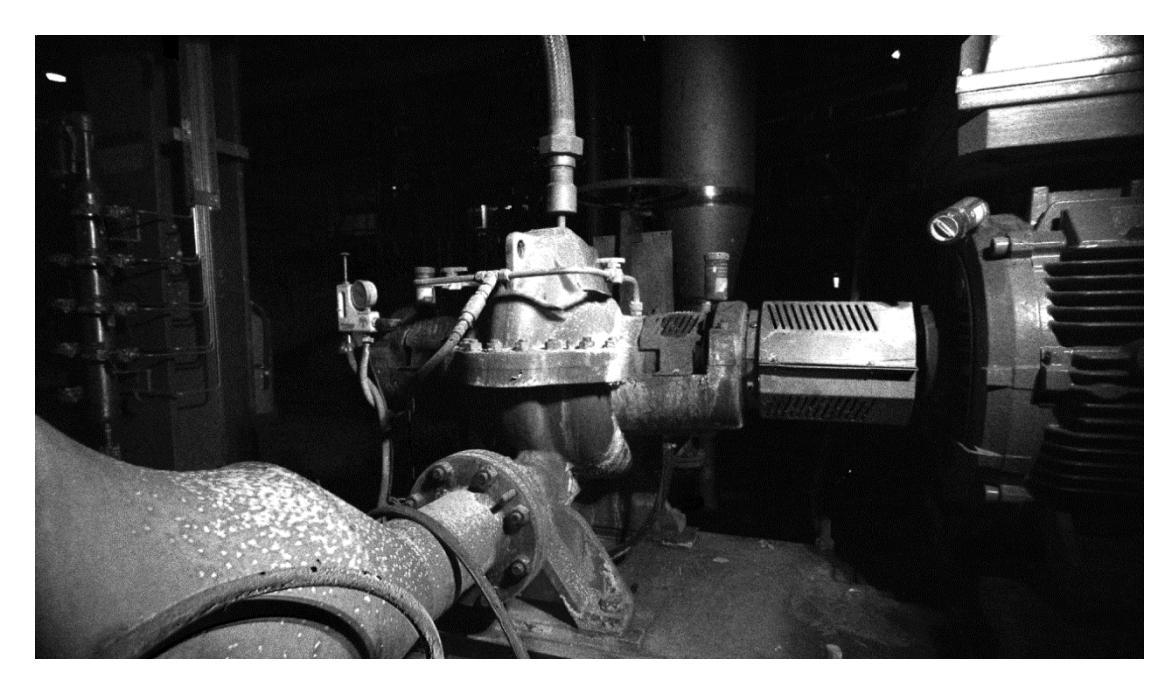
Figure 2: Motion Amplification, Pump Inboard Side View

Motion Amplification video of the pump shows a torsional type of movement which leads us to believe that the pump has an issue with the pump coupling hub or possible bent or bowed pump shaft. Because the motion appears to be at the bearing housings, it may also be possible that there could be loose fasteners at the bearing housings. We do understand that this unit is controlled by a Variable Frequency Drive and may operate at different speeds from time to time. Because of the forcing frequencies from the pump, it is possible that this pump may operate near a resonant frequency; however, during our testing, the motor/pump did not appear to be operating near a resonant or critical speed.

In conclusion, overall vibration was rather low during our test. Pump rpm was around 1350 which is approximately 75 percent of full speed. Motion amplification showed some torsional type of movement in the pump and may be due to the possible issues previously discussed in this report. It is recommended to investigate and inspect for these types of issues as time allows. Because the amplitudes of vibration were rather low during our testing, this issue has a low severity at this time.

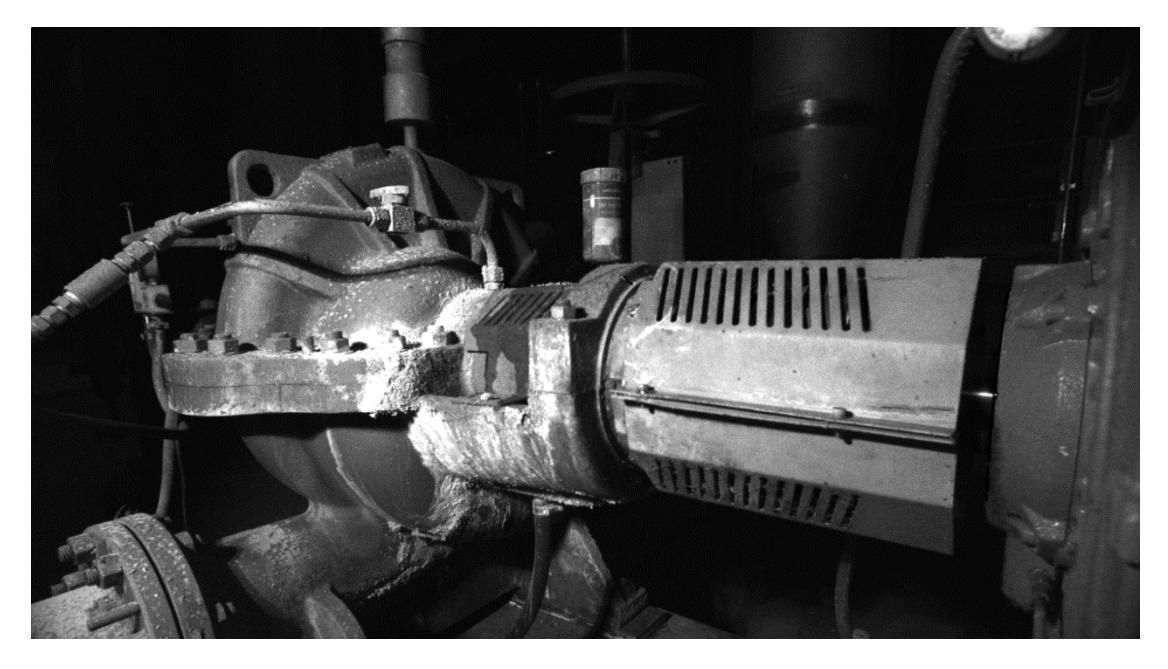
Figure 3: Motion Amplification, Pump Inboard

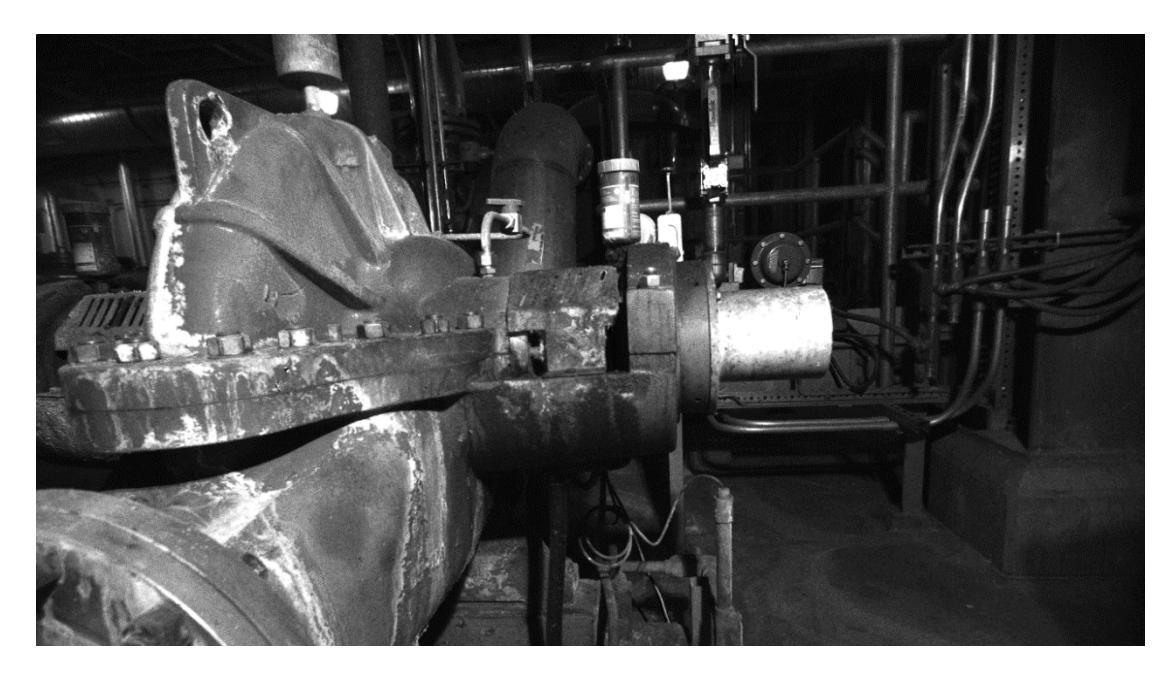
Figure 4: Pump Outboard End (Side View)

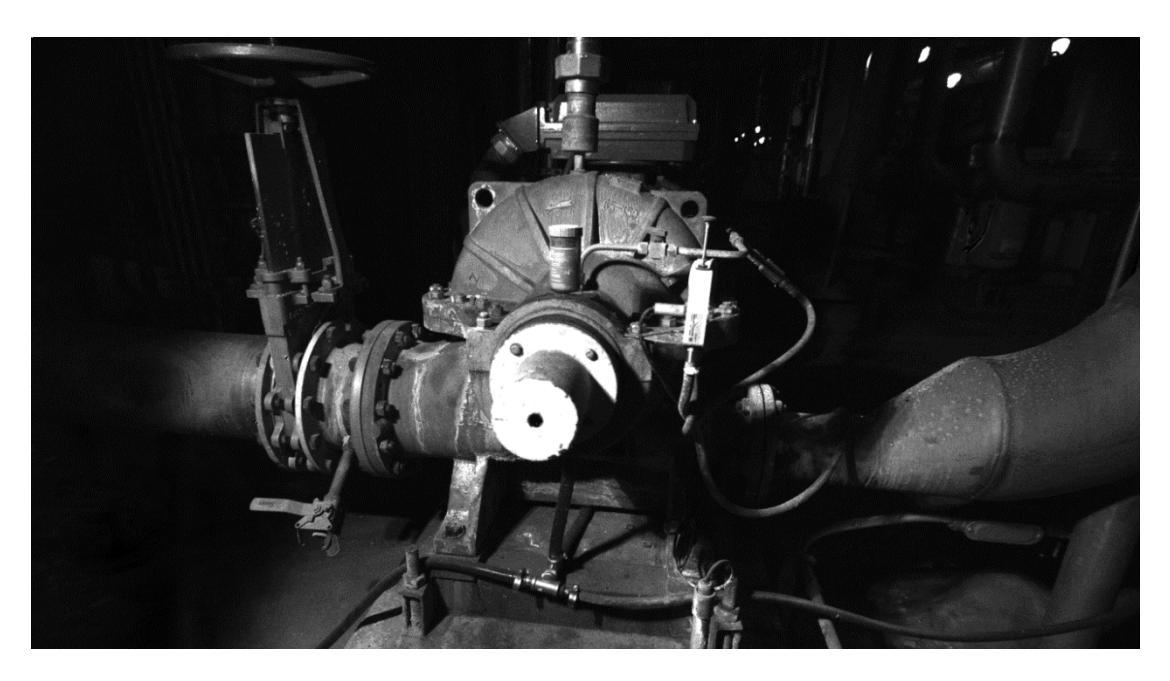
Figure 5: Pump Outboard End (End View)

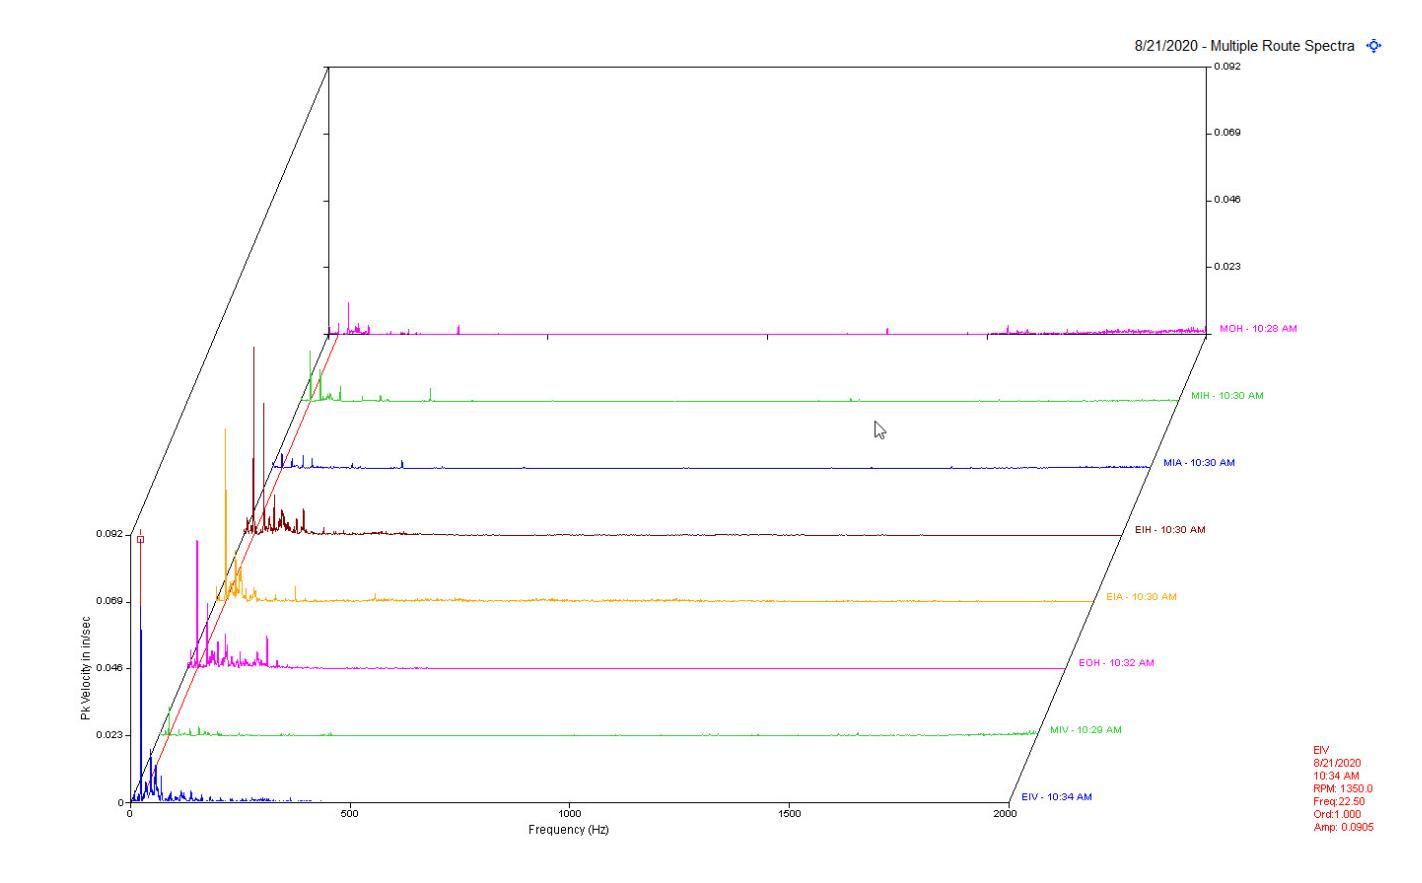
Abbreviated Last Measurement Summary

122 14 1				
M16 - Headbox		Dilution Fan Pump		(21-Aug-20	
		OVERA	LL LEVEL	1 - 20 KHz	
MOH		.027	In/Sec	.847 G-s	
MIH		.025	In/Sec	.713 G-s	
MIA		.013	In/Sec	.942 G-s	
EIH		.094	In/Sec	.153 G-s	
EIA		.080	In/Sec	.238 G-s	
EOH		.067	In/Sec	.108 G-s	
MIV		.017	In/Sec	1.012 G-s	
EIV		.108	In/Sec	.145 G-s	
	of Wibesti
