November 24, 2021

Scott Scaccia KTG Memphis, TN

The following is a summary of findings from the vibration analysis on the Low Vacuum Pump, Low Vacuum Pump Spare, and Hi Vacuum Pump #4. Below you will data plots along with a brief description of the data provided.

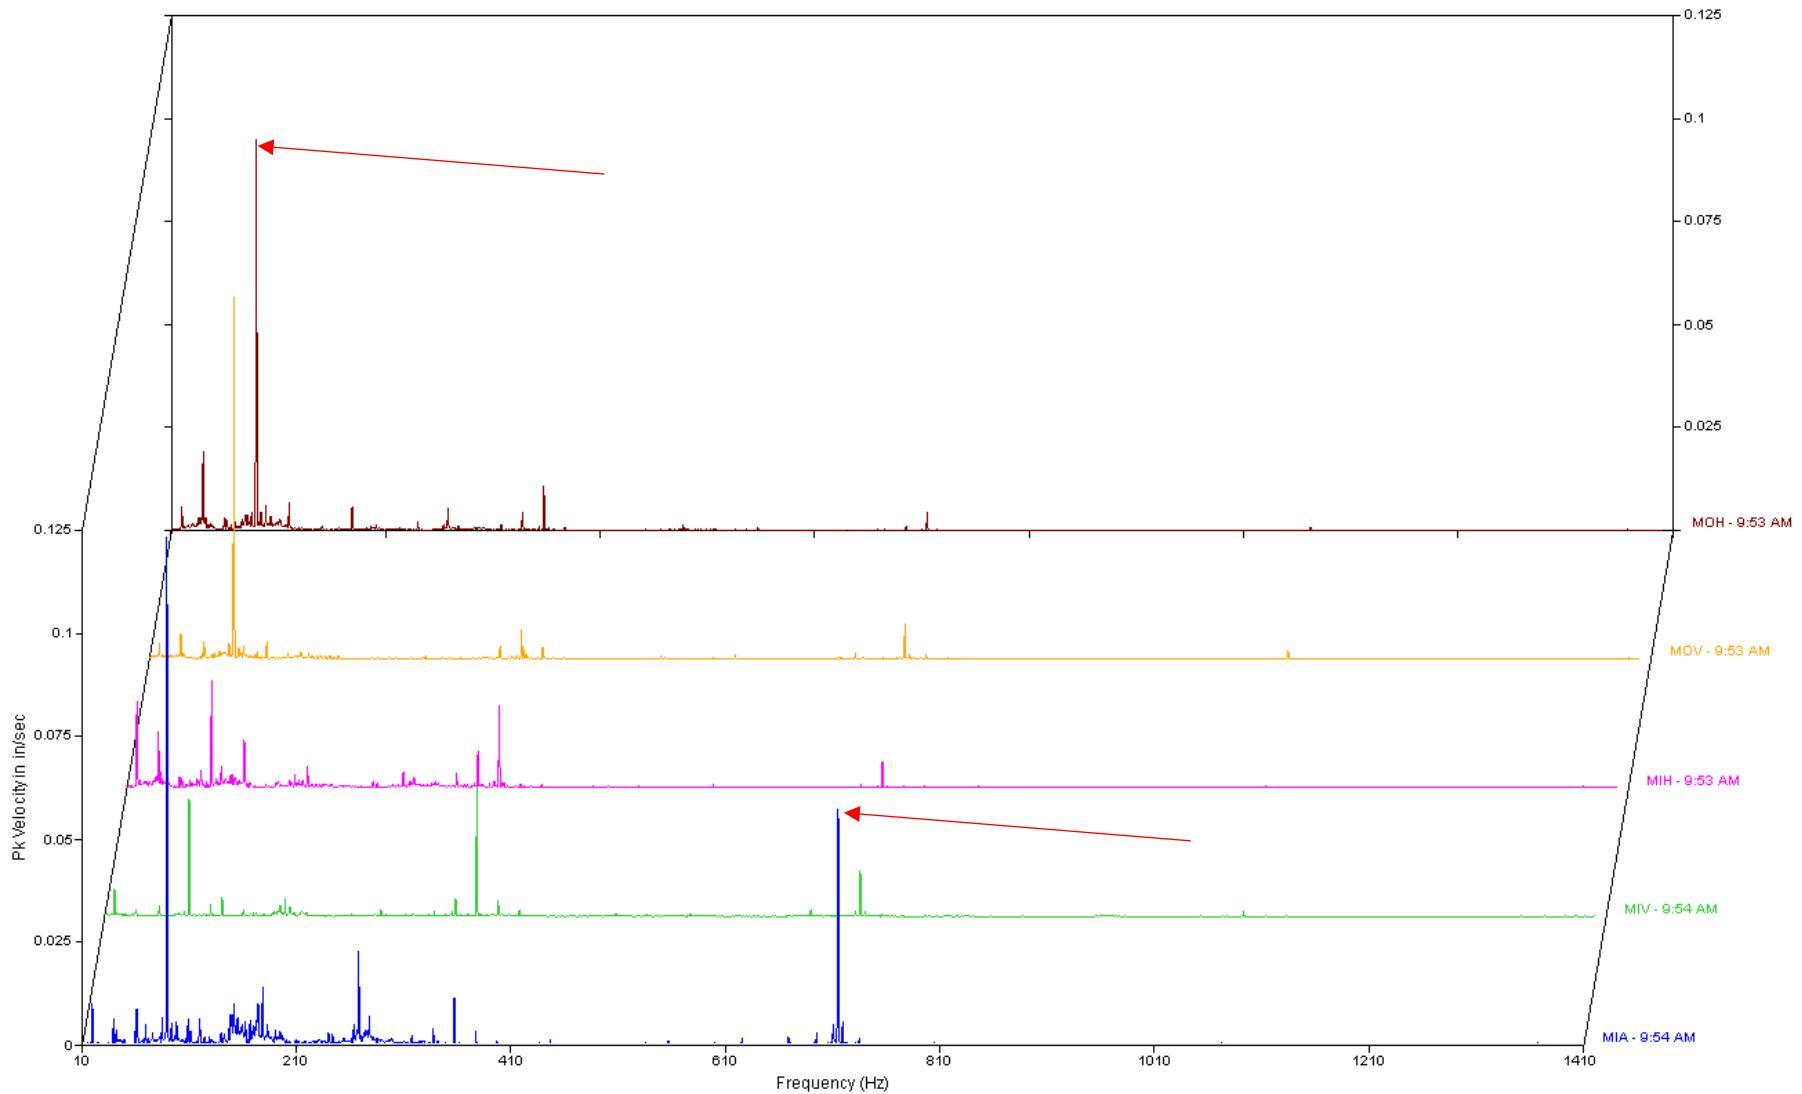
Low Vacuum Pump MOTOR

The plot above is drive motor. The first large peak is pump vane pass frequency. The second large peak seen in MIA is 2 x gear mesh frequency. No issues really to note here. All amplitudes appear to be low in the motor.

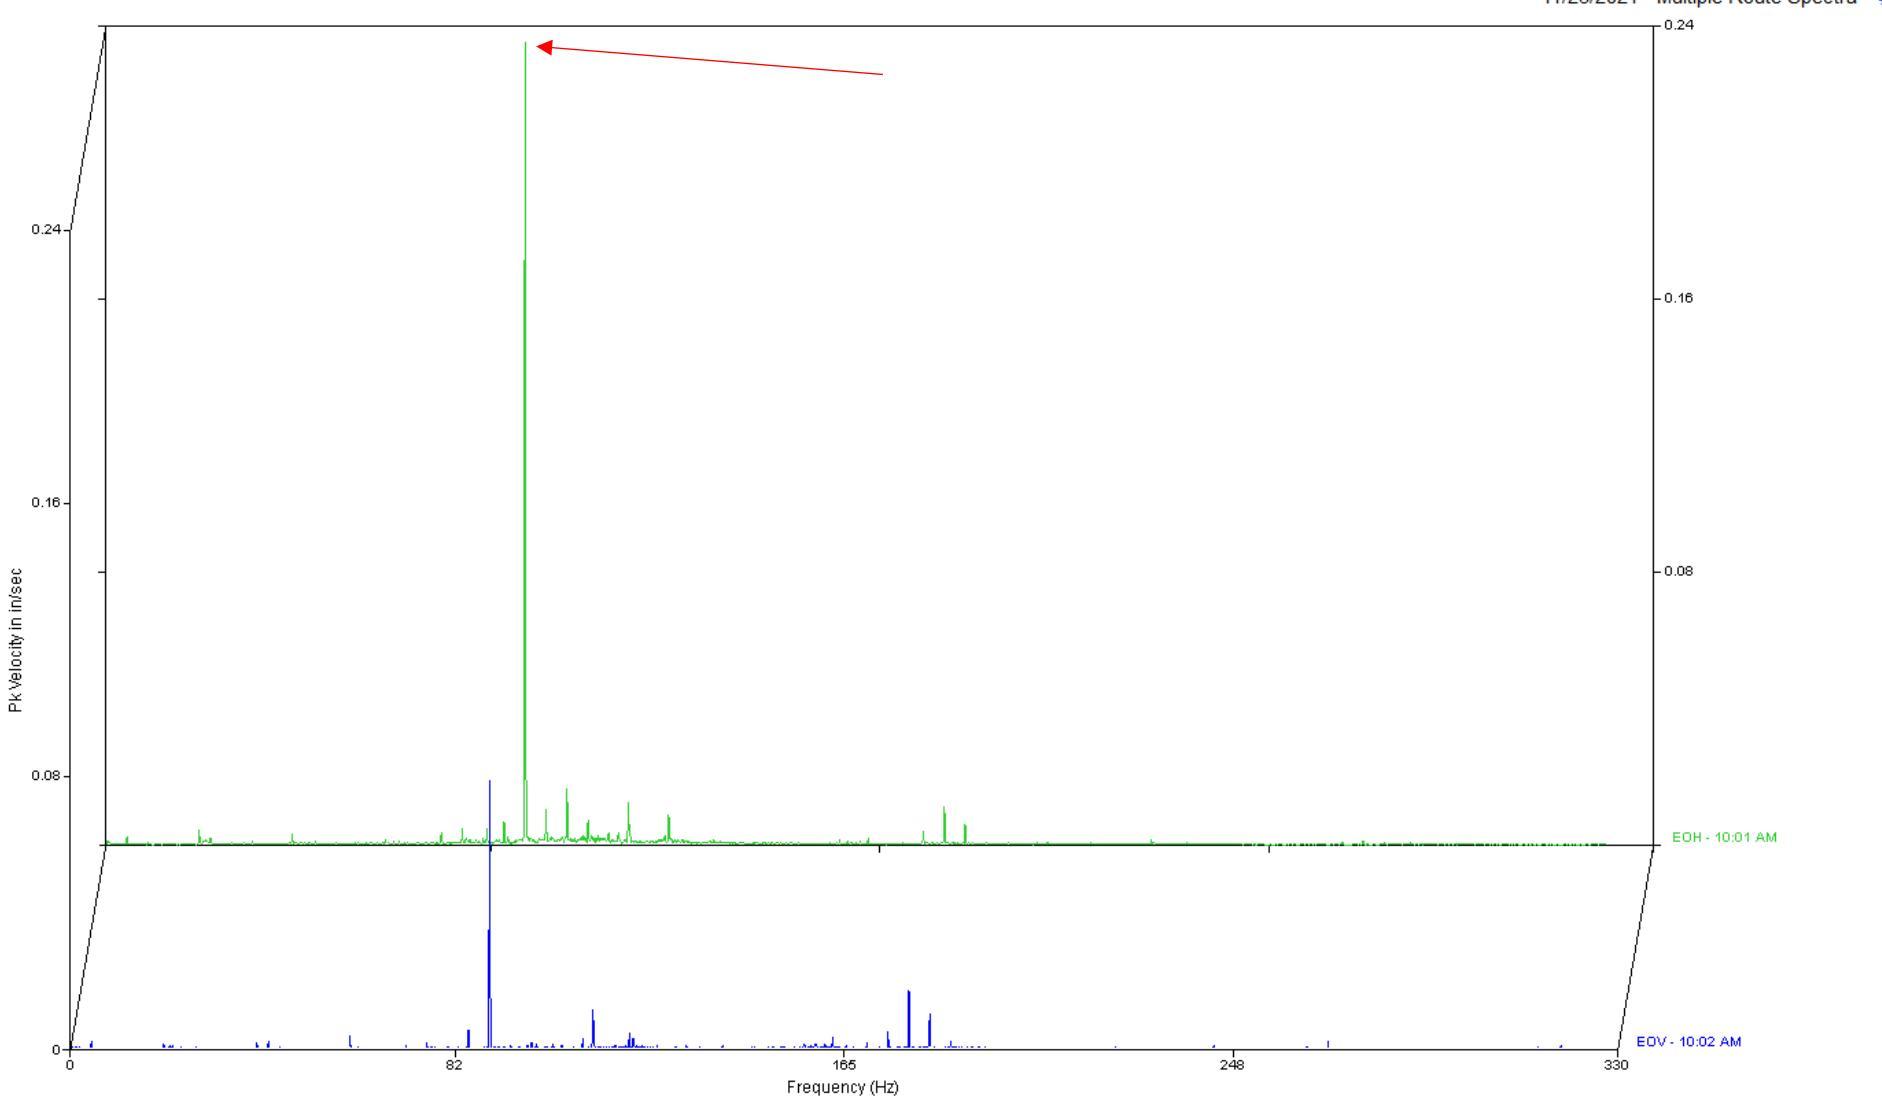
Low Vacuum Pump GEARBOX INPUT DE

The data plot above is the Drive end of the gearbox input shaft. The dominant vibration seen in EIH (inboard horizontal) is the pump vane pass frequency. Other peaks in the spectra are gear mesh frequency and harmonics of GMF.

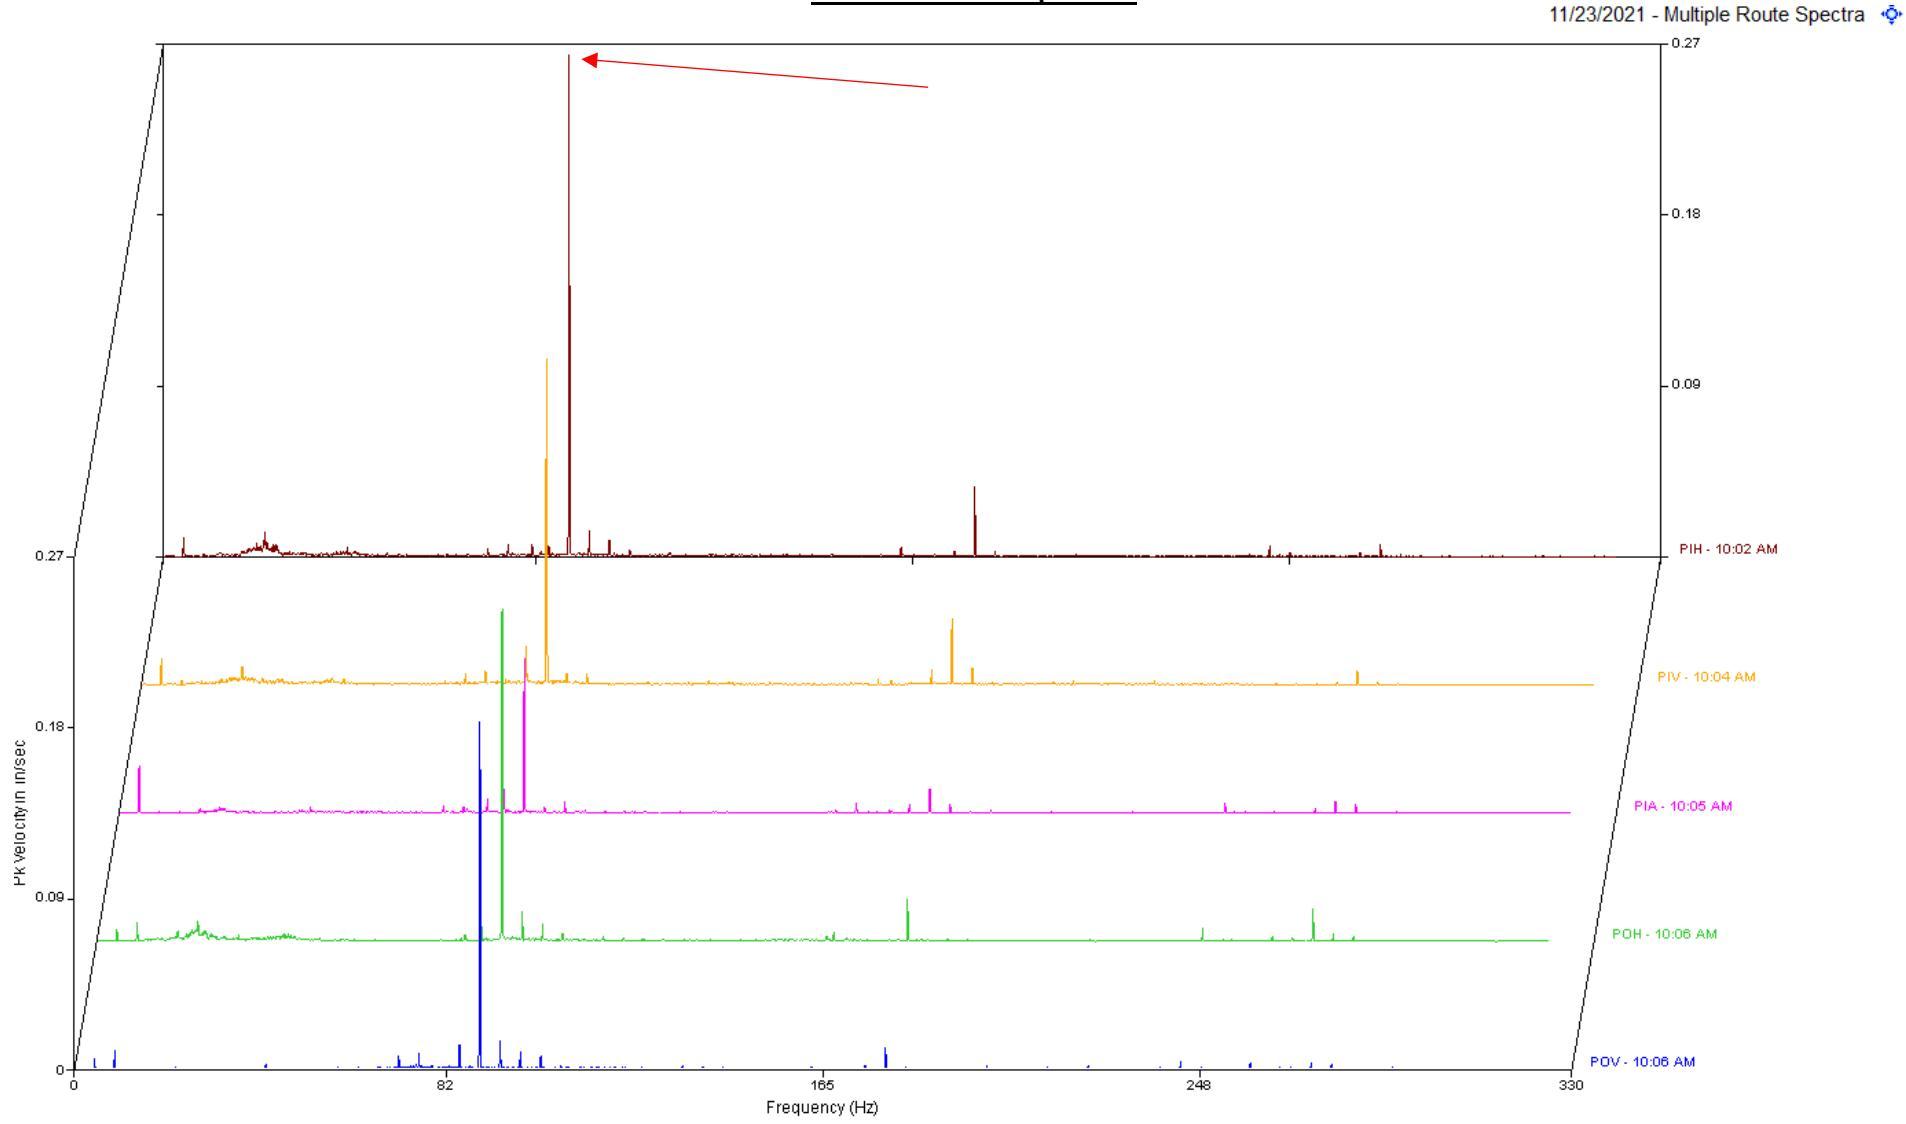
Low Vacuum Pump PUMP

Data plot above is of the pump. Large peak is the pump vane pass. There are some small sidebands of pump rpm around this peak. This vane pass amplitude is slightly high for a newly rebuilt pump. The vane pass vibration may be process related if pump is getting too much water flow. Also the pump could have tighter clearances. It is difficult to say with no trendable vibration history of this pump.

There does appear to be some vane pass vibration in the low vacuum pump that is being transferred into the gearbox and motor. This pump is higher in amplitude than the spare pump next to the pump in question and also much higher than the #4 Hi Vac Pump. During a visual inspection of the low vacuum pump, the pump was noticed to have a possible soft foot condition on the front left foot (facing drive end of pump). This may be causing some pump casing distortion and possible piping strain of the pump. There may also be process flow issues such as excessive water flow that could influence the vane pass vibration. Pump clearance may also affect vane pass. There isn't a lot of sidebands around vane pass which would indicate excessive impeller clearances or wear of the impeller.

We recommend checking the low vacuum pump for soft foot by loosening the pump feet and shimming where necessary. We also recommend re-aligning the gearbox to the pump and then the motor to gearbox after shimming any soft foot.

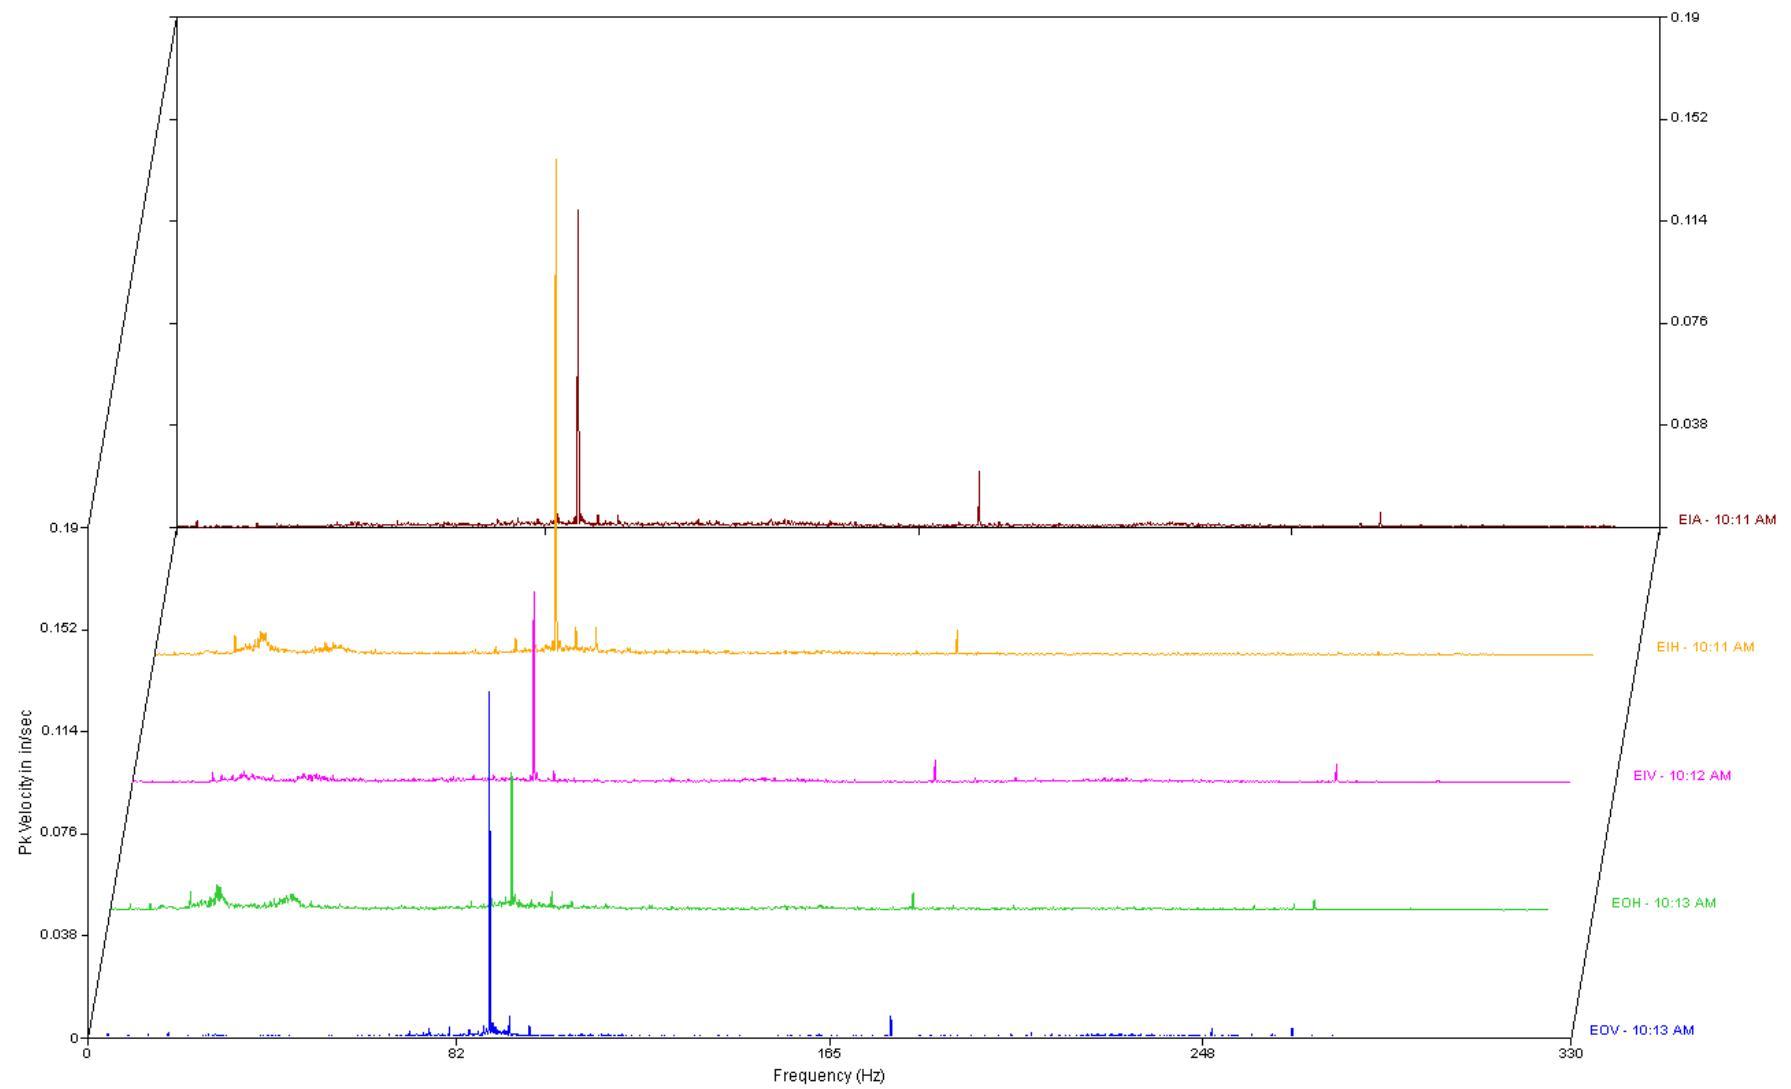
Low Vacuum Pump Spare PUMP

This is from the spare pump next to the low vacuum pump. This pump also has a vane pass vibration but amplitudes are slightly lower.

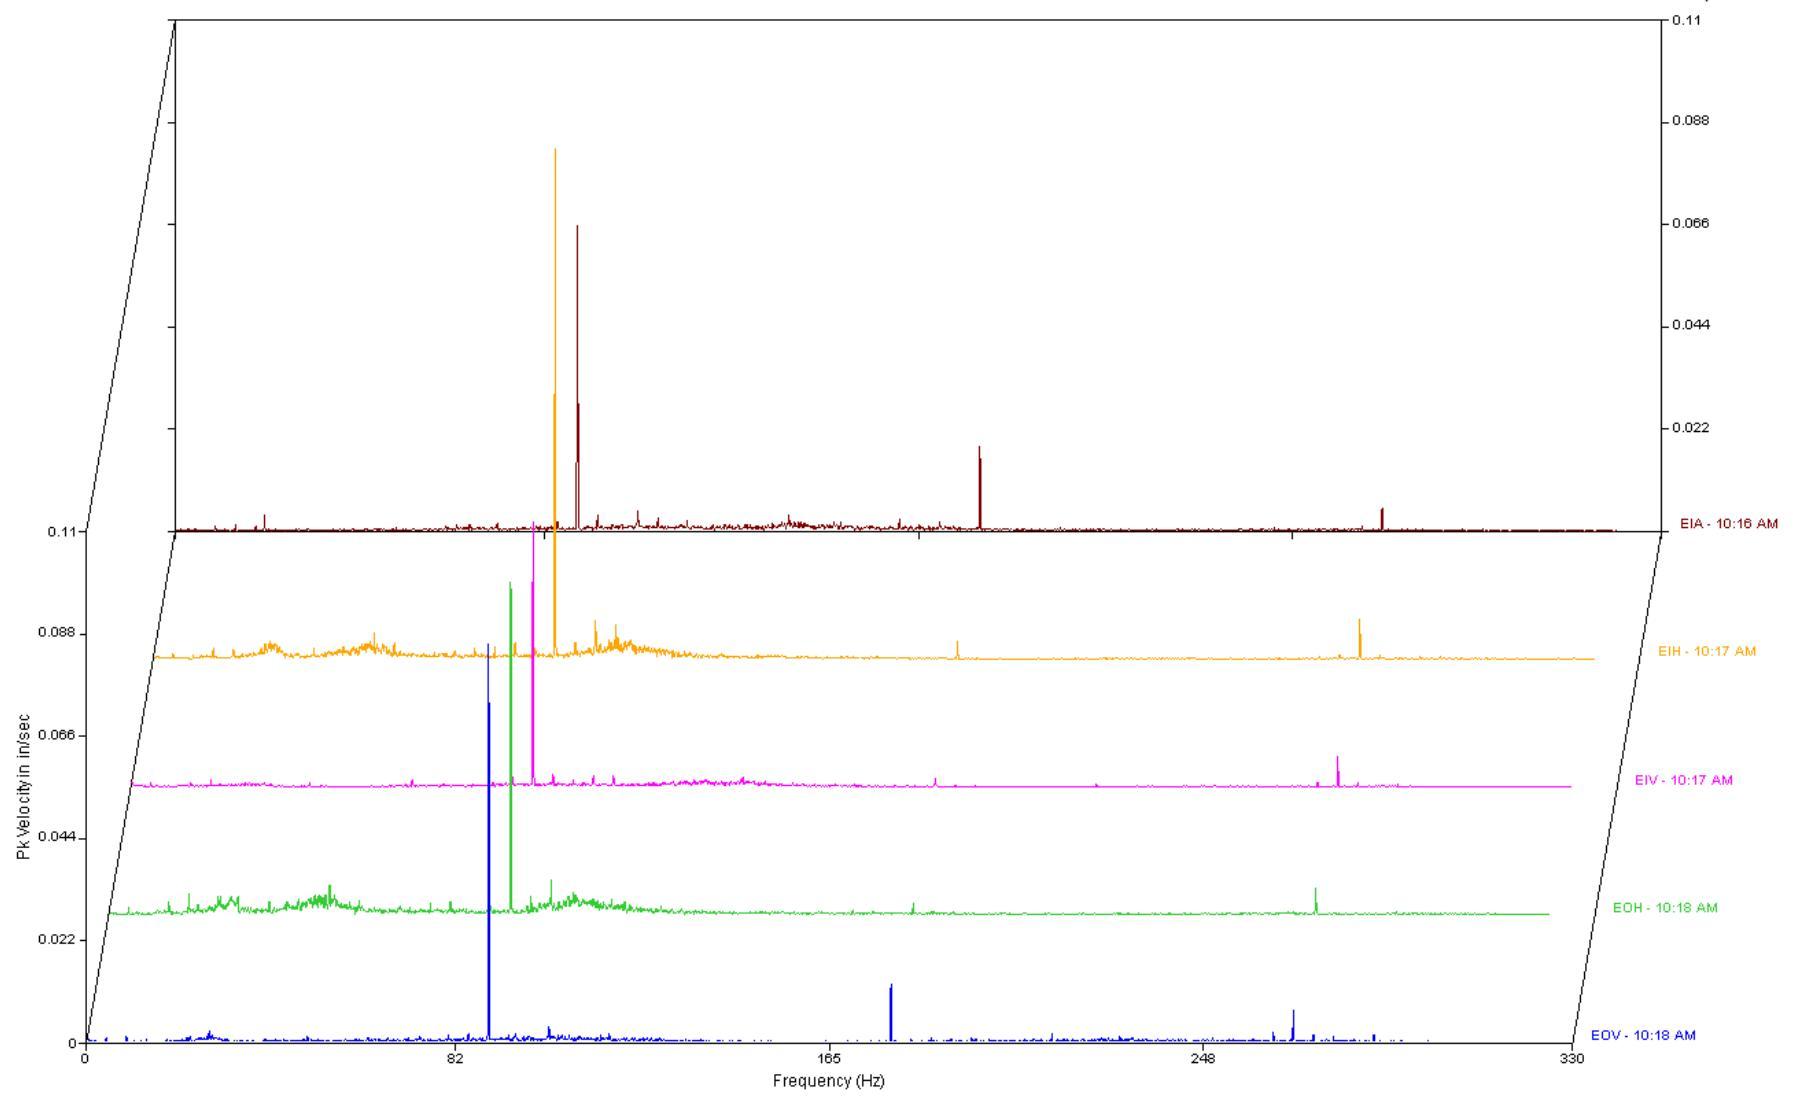
Hi Vacuum Pump #4

Vane pass vibration is also present in the #4 vacuum pump (pump at the other end). Amplitudes are much lower on the pump.
