Main Air Blower Motion Amplification Study, Lucite Fite Road Memphis, TN

1: Executive Summary

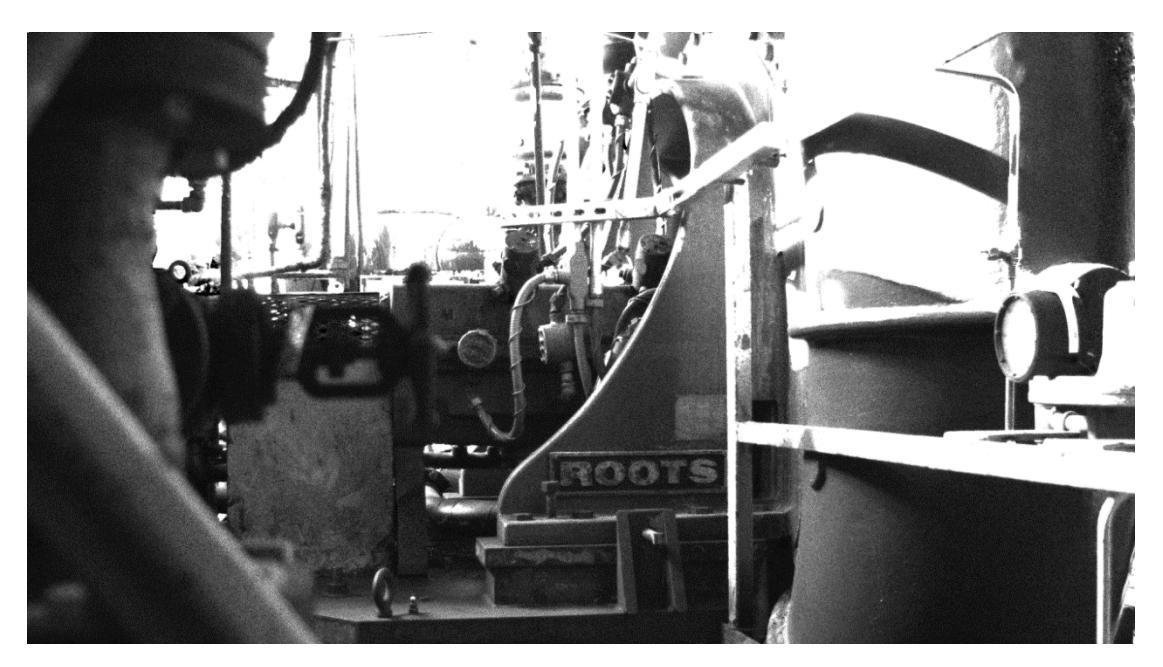
Figure 1: Motion Amplification, Side View Blower Bearing Assembly/Baseplate

Motion amplification video of the Main Air Blower did not show any excessive movement at 1 x rpm of the blower. Overall casing vibration varied from .04 to .08 ips-pk or less than 1 mil pk-pk. Onboard proximity probes are installed on this unit and were showing .7 mil and 1.7 mil pk-pk. We performed a quick analysis while on site and relative vibration was much lower. The proximity probes will read higher amplitudes as they measure absolute displacement of the blower shaft; however, casing vibration was .4 mil pk-pk or less. We recommend inspecting the shaft ensuring there are not scratches, knicks, or dings on the shaft. Also ensure probes gap voltage is set properly.

If no issues are found with probes and vibration persists, then blower wheel may have imbalance and or excessive bearing clearances.

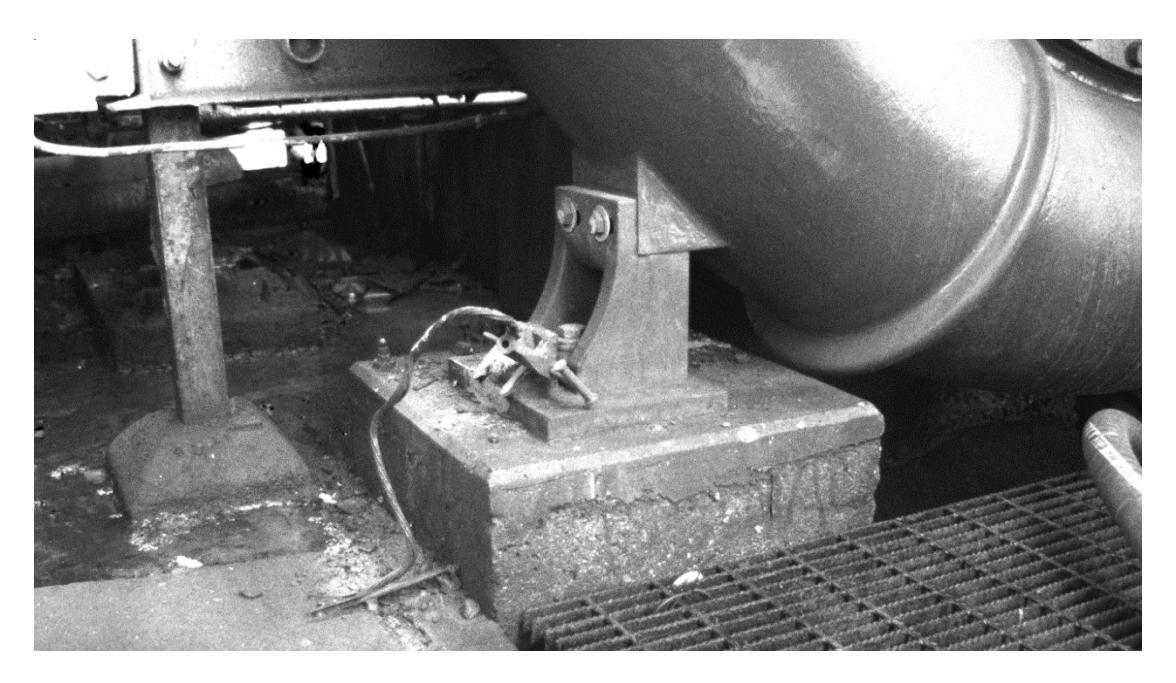
Figure 2: Motion Amplification, Volute Left Foot

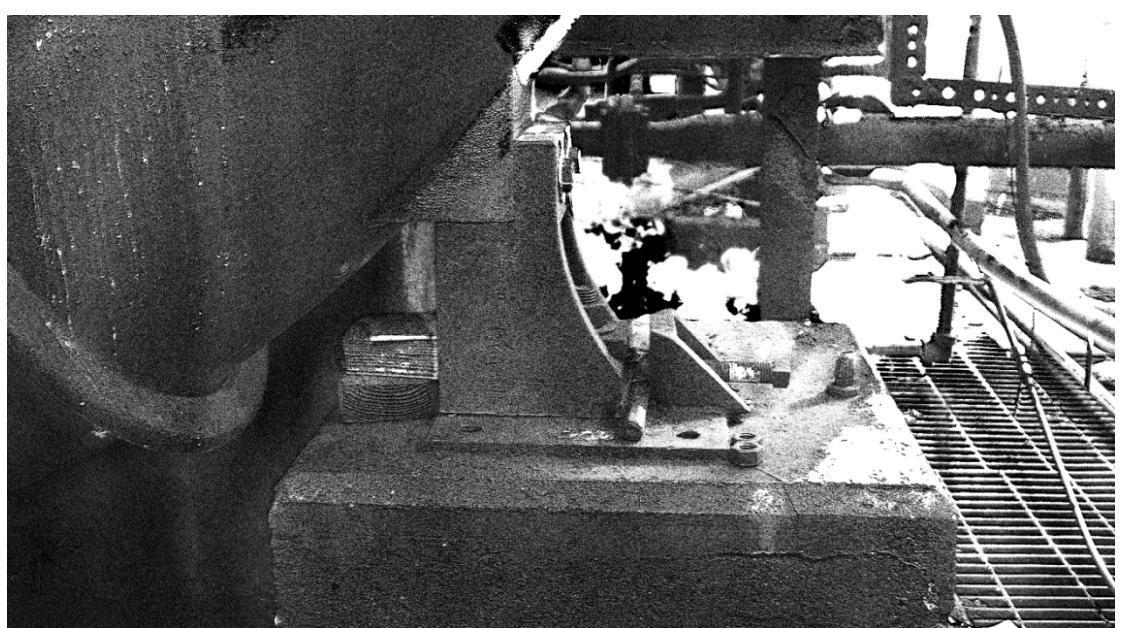
Figure 3: Motion Amplification, Volute Right Foot
