Client	TMK IPSCO	Survey Date	10-17-19
Location	Blytheville, AR	Report Date	10-21-19
Machine	Heat Treat North Quench Pump	QMS No.	140915
Component	Pump	Analyst	DWS

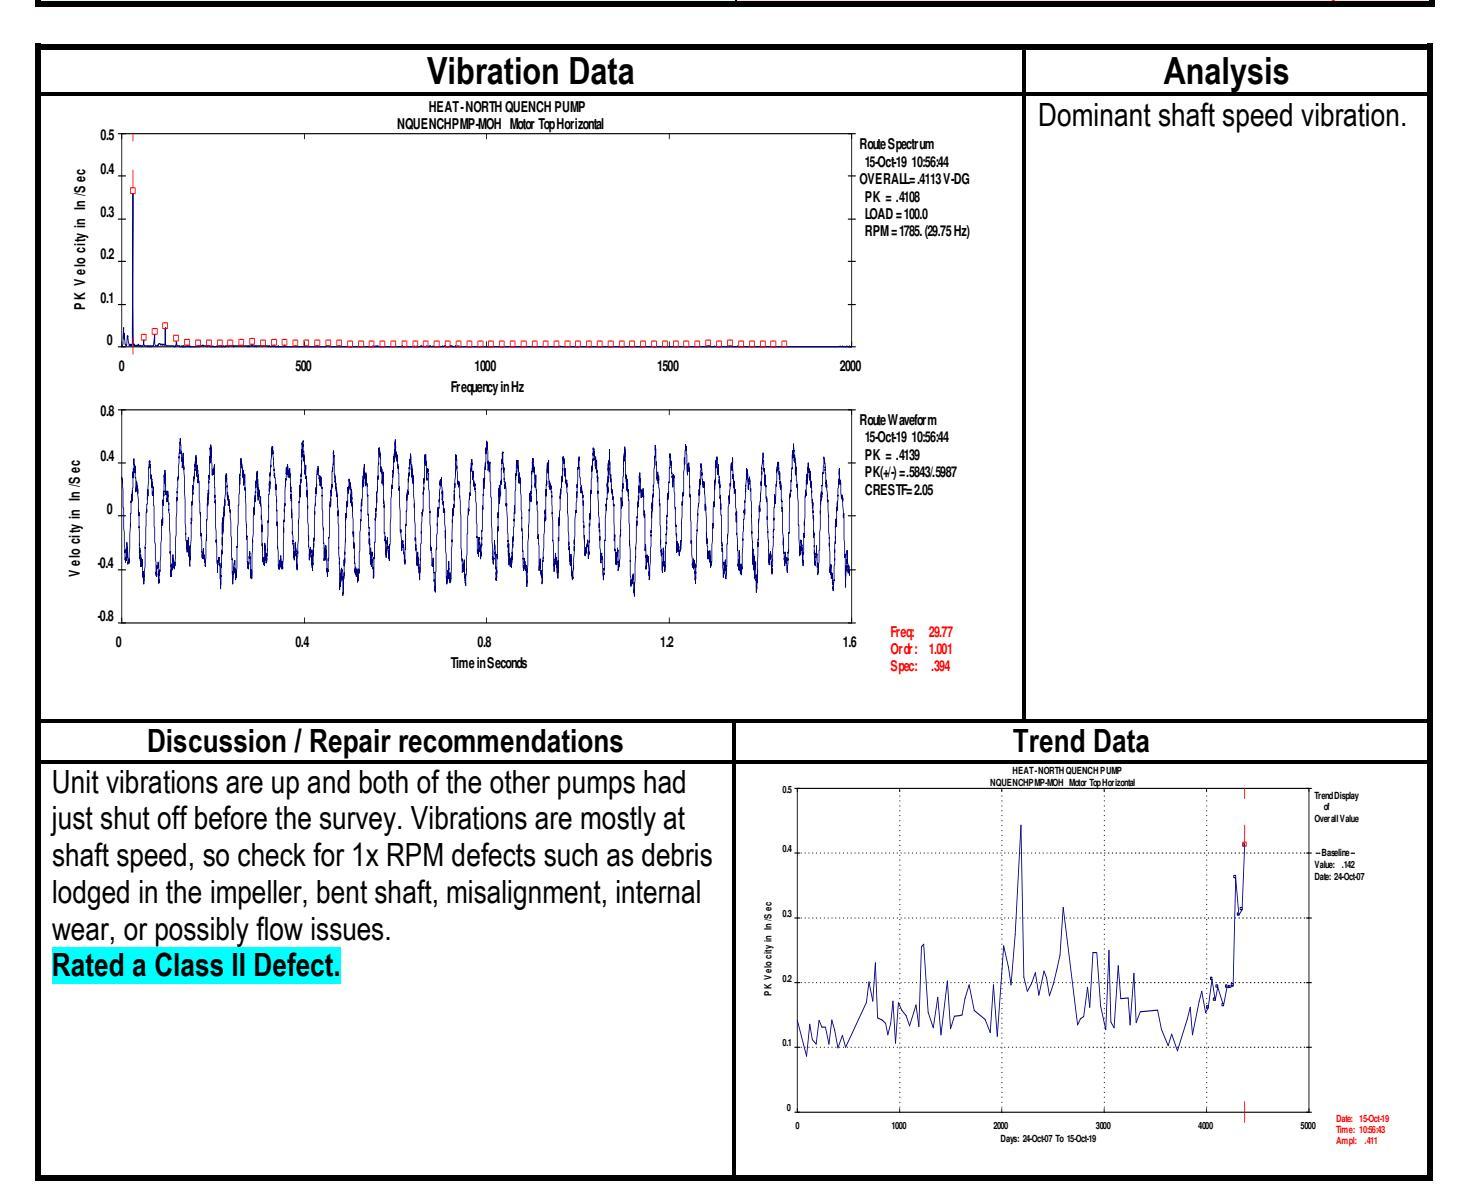
Defect Rating for this machine	Class II			
Defect Rating System				
<u>Class I:</u> Defect is present, but effect on reliability is not clear; no immediate action is required. Continue normal monitoring.	<u>Class III:</u> Defect (s) present that may cause failure in short term (less than 2 mos.). Should be addressed as soon as practical, with a high maintenance priority. Increase monitoring frequency.			
<u>Class II:</u> Defect (s) present that may cause problem in long term (2-6 mos.). Repair during normal maintenance scheduling. Continue to monitor.	<u>Class IV:</u> Defect (s) present that makes continued reliability unpredictable, and possibility of secondary damage is high. <i>Repairs should be made</i> ASAP. An unscheduled shutdown should be considered for repairs.

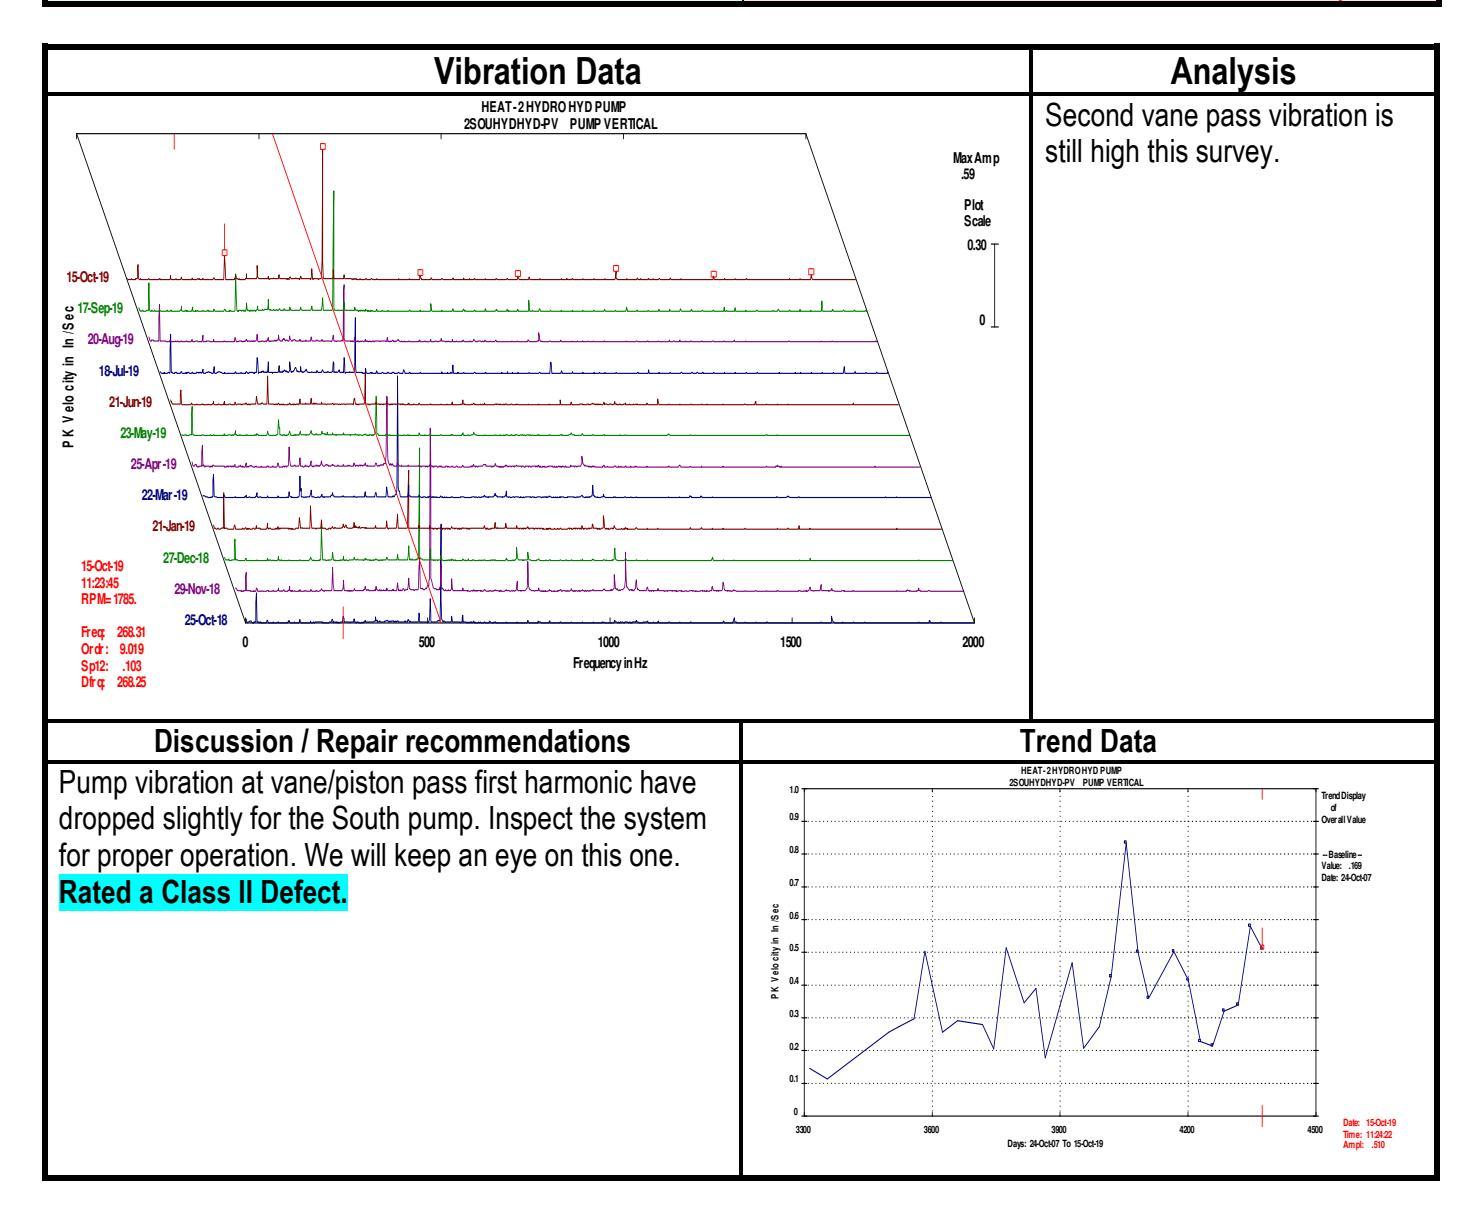
Client	TMK IPSCO	Survey Date	10-17-19
Location	Blytheville, AR	Report Date	10-21-19
Machine	Heat Treat #2 Hydro Hydraulic Pump (large South Unit)	QMS No.	140915
Component	Pump	Analyst	DWS

Defect Rating for this machine	Class II			
Defect Rating System				
<u>Class I:</u> Defect is present, but effect on reliability is not clear; no immediate action is required. Continue normal monitoring.	<u>Class III:</u> Defect (s) present that may cause failure in short term (less than 2 mos.). Should be addressed as soon as practical, with a high maintenance priority. Increase monitoring frequency.			
<u>Class II:</u> Defect (s) present that may cause problem in long term (2-6 mos.). Repair during normal maintenance scheduling. Continue to monitor.	<u>Class IV:</u> Defect (s) present that makes continued reliability unpredictable, and possibility of secondary damage is high. <i>Repairs should be made</i> ASAP. An unscheduled shutdown should be considered for repairs.
