December 3, 2020

Subject: December Dust Collector vibration service

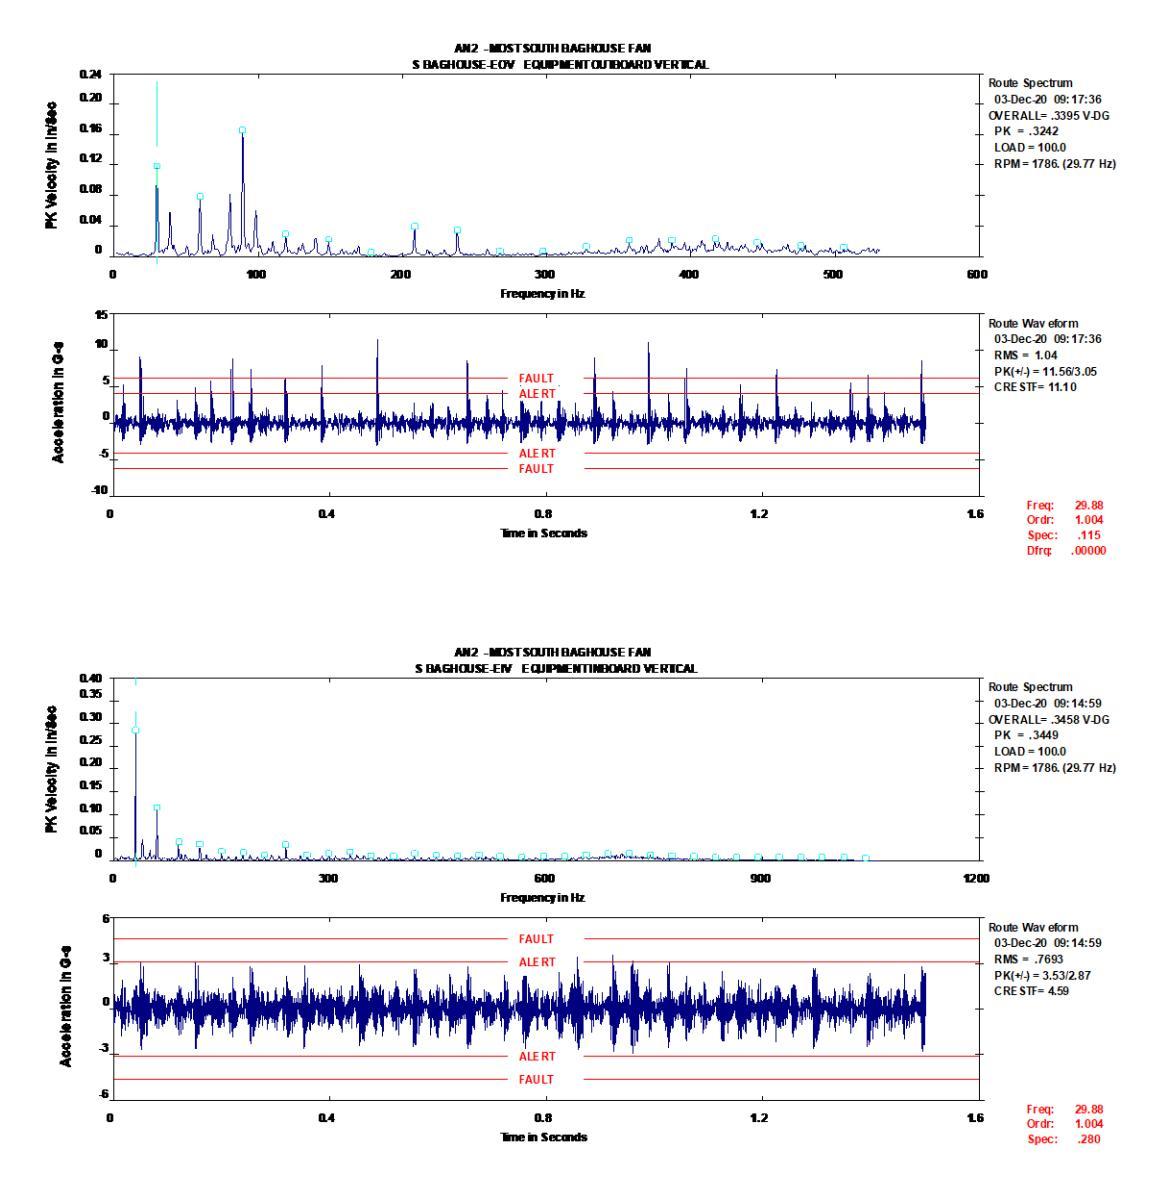
South Dust Collector Fan

The south fan bearings seem to be in distress. Multiple 1/3 order harmonics vibrations plus random impacting and a 1x RPM vibration over 0.3"/second in the horizontals. Fractional harmonics are not good. We believe high vibrations over time have degraded them. Bearing replacement would be prudent due to the duty cycle of these units. **Rated a Class II Defect.**

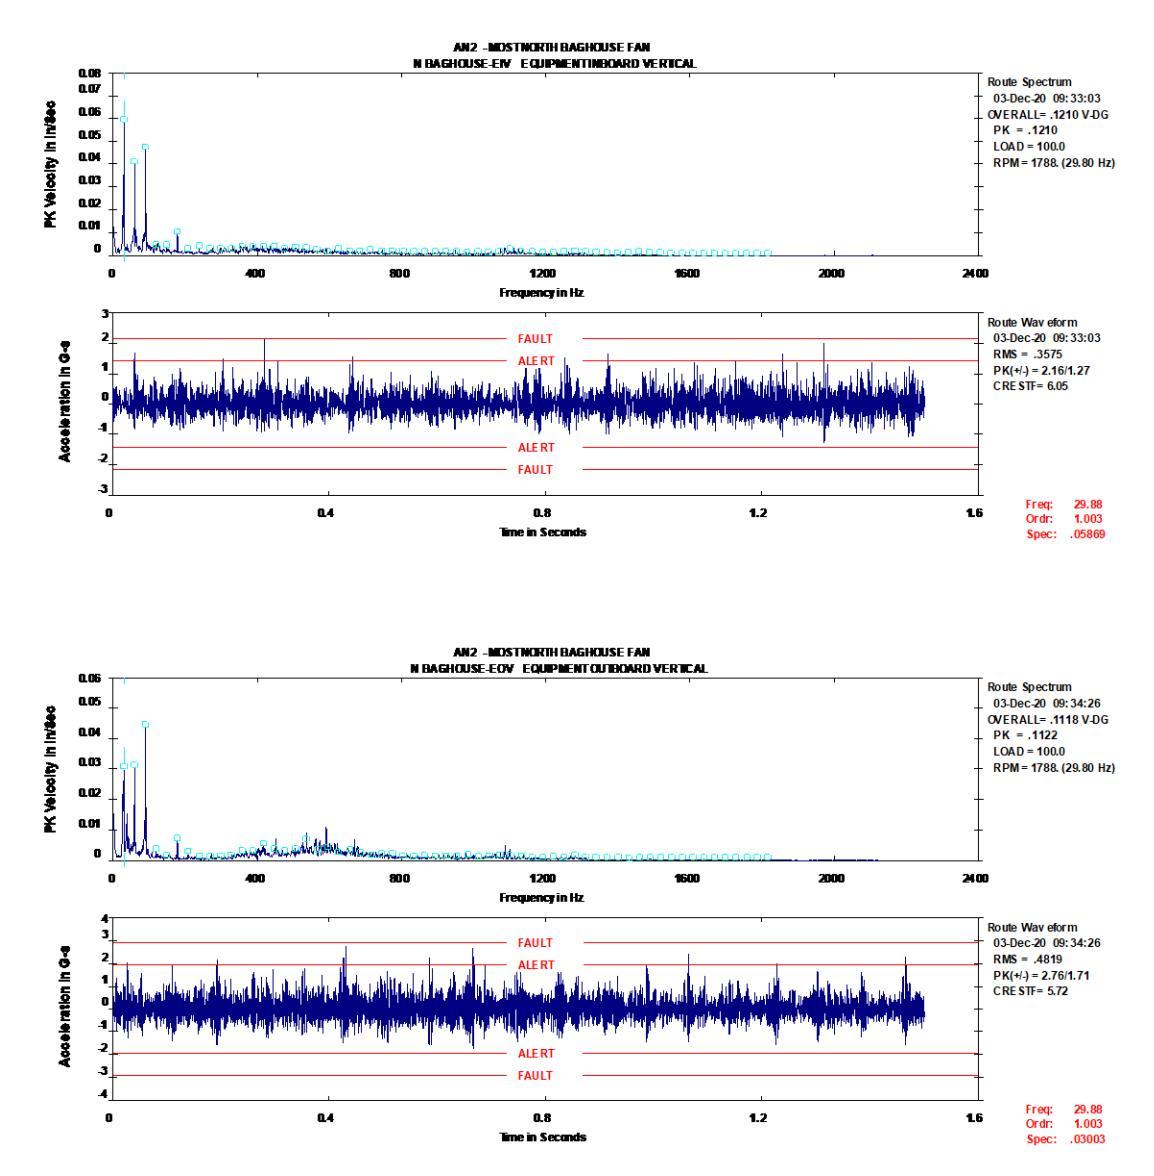
North Dust Collector Fan

The North fan looks to have some bearing wear and a few normal shaft speed harmonics. Inspect the bearings, purge the grease and re-lubricate s specified by manufacturer. Inspect the coupling, re-lube and have the alignment checked. Rated a Class I Defect
