March 7, 2022

Joshua Palmer ATS Southwire-Starkville, MS

The following is a brief summary of the field balancing that was performed on SH-2 and SH-3 Taping Head Spindles at the Starkville facility. SH-2 was checked on 3/3/22 and was operating at around 1200 rpm. This unit appears to operate at around 500 rpm on average. During our reference run, data showed vibrations to be within tolerance for 1200 rpm. Overall amplitude at 1 x rpm was .06 ips-pk. 1 x rpm peak in displacement, which is typically what unit of measure is used for field balancing, showed an amplitude of 1.08 mil pk-pk. These amplitudes are acceptable for 1200 rpm. See spectral data below.

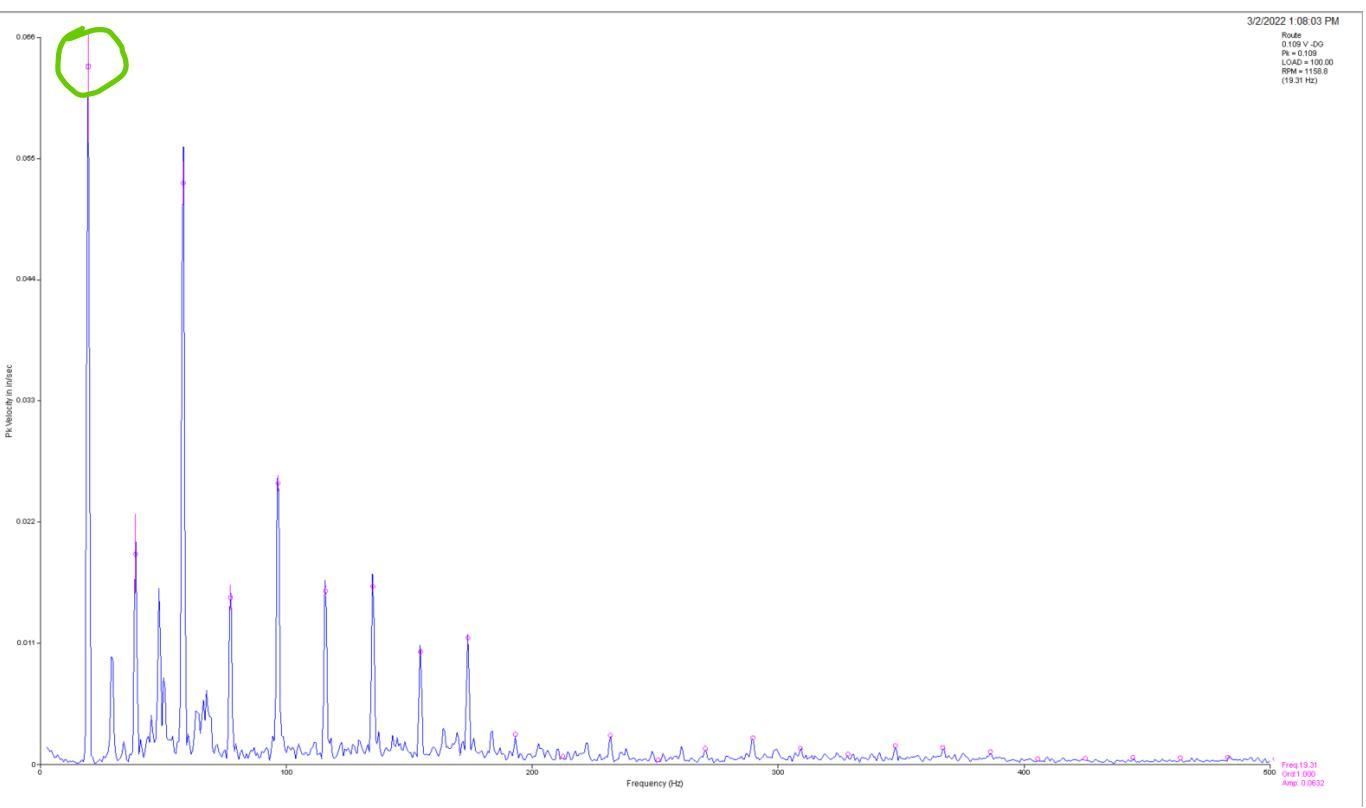
Spectral velocity data of SH-2 above shows overall amplitude of .109 ips-pk. Circled peak is operating speed. and has an amplitude .06 ips-pk. There does appear to be some rpm harmonics present in the data which is typically caused by fit looseness. Amplitudes are low at this time, so no actions are recommended.

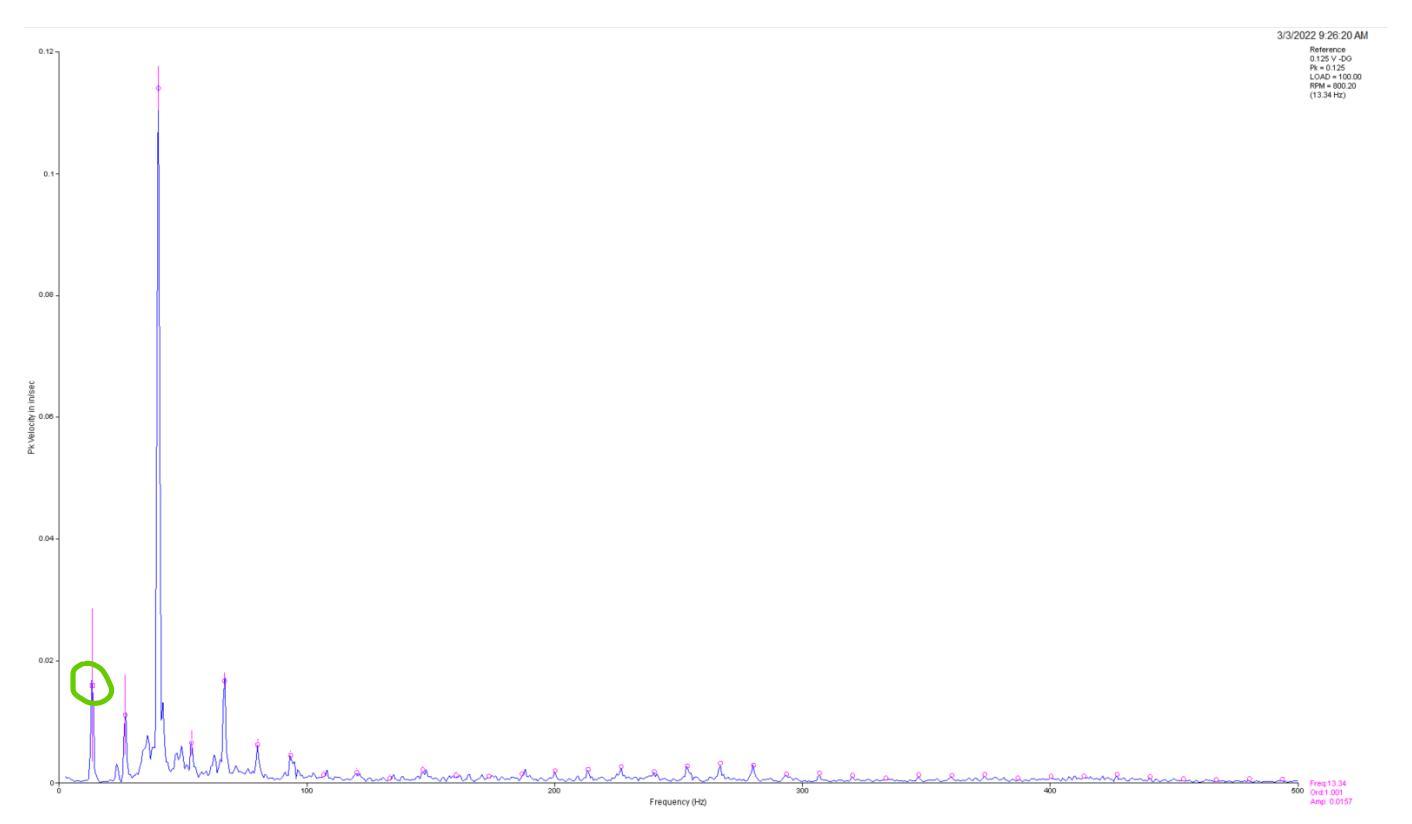
SH-3 was set-up for balance on 3/4/22. This unit was operating at 800 rpm during the balance test. 1 x rpm amplitude at 800 rpm was very low. Peak amplitude showed to be .01 ips-pk. 1 x rpm peak amplitude in displacement was .4 mil pk-pk. These amplitudes are well within tolerance for 800 rpm. The average speed for this unit is also around 500 rpm. See data below.

Velocity spectral data above is SH-3 at 800 rpm. Circled peak is operating speed. Notice the highest peak in data is at 3 x rpm. This type of vibration is typically caused by bent shaft, misalignment, cocked bearing. Overall amplitude of SH-3 is still rather low overall at .125 ips-pk, but this may cause issues in the future.
