Motion Amplification Study, T.E. Maxson Waste Water Treatment Facility Memphis, TN

1: Executive Summary

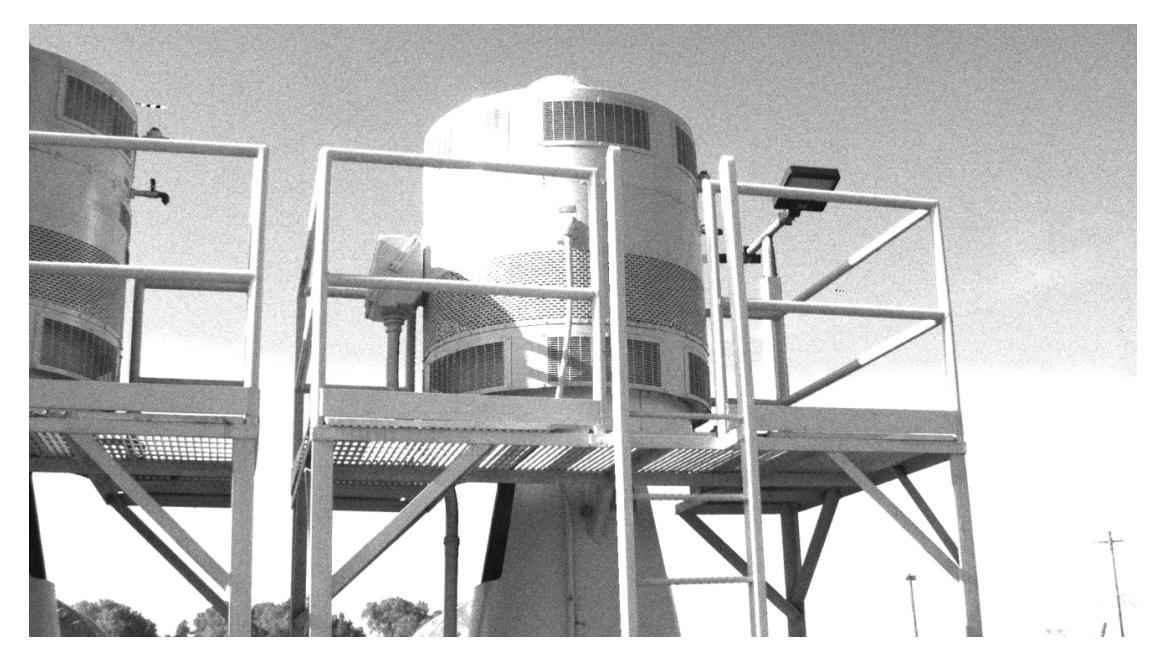
Figure 1: Motion Amplification, Effluent Pump 1

Notice in the MA video in Figure 1, the axial motion of the motor. This motion appear to be synchronous to the motor at a frequency of 4 x motor rpm. This may be vane pass frequency of the pump if the pump has four vanes. This could also be caused of some type of coupling issue. Coupling issues typically cause a 4 x rpm vibration. See spectral plot of the DE motor axial below.

In conclusion, there appears to be some axial vibration in Pumps 1 and 2. According to vibration data that was taken from Motion Amplification software, this appears to be occurring at 4 x motor/speed. This could be pump vane pass frequency if the impellers have four vanes. Coupling issue will also cause a 4 x rpm vibration as well.

It is recommended to perform vibration analysis on each pump to help determine the exact amplitude and frequency of all vibrations occurring in these units.

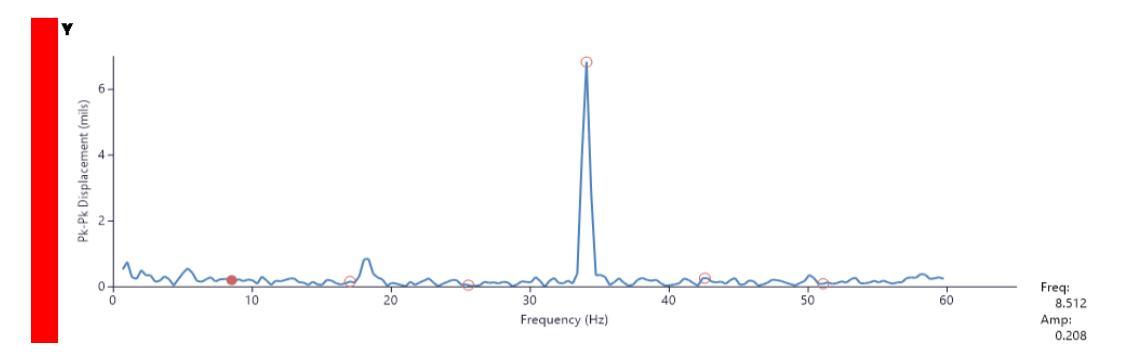
Figure 2: Spectral plot DE motor axial

Vibration plot above shows a vibration peak at 4 x 8.5 Hz. which is motor shaft speed. Amplitude shows to be over 6 mil- pk.

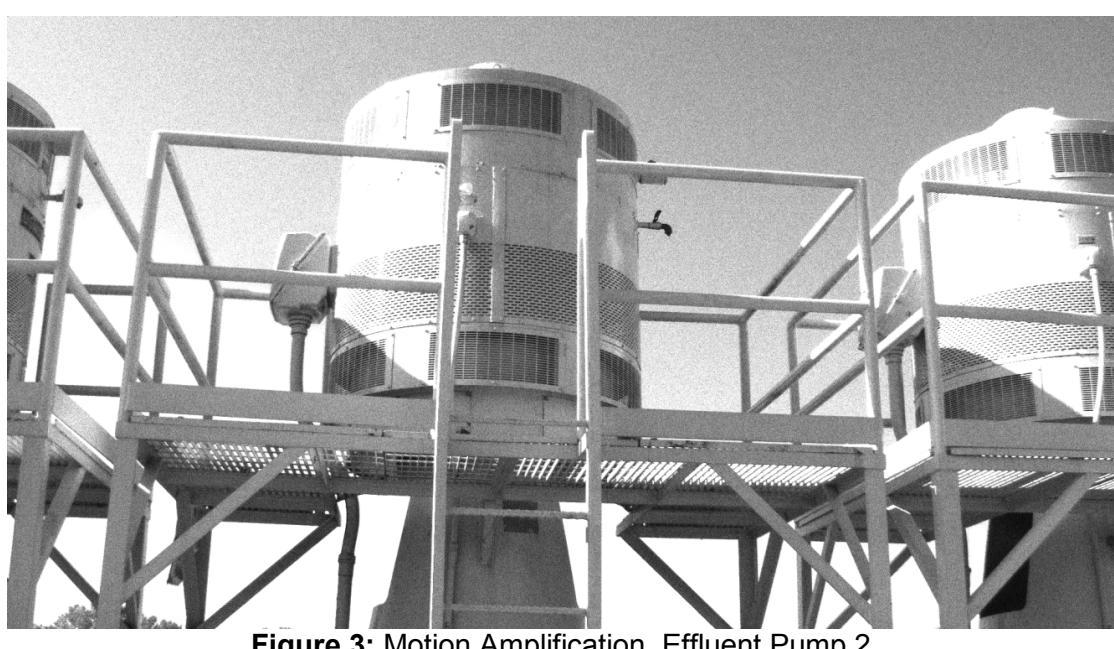
Figure 3: Motion Amplification, Effluent Pump 2

Figure 3 above shows similar motion as #1 Pump in the axial position. There is some background motion in this video due to the wind blowing during the acquisition; however, it is clear that the motor has some axial movement. Amplitudes do not appear to be as high as Pump 1. Frequency of the motor vibration is at 4 x rpm same as Pump 1.

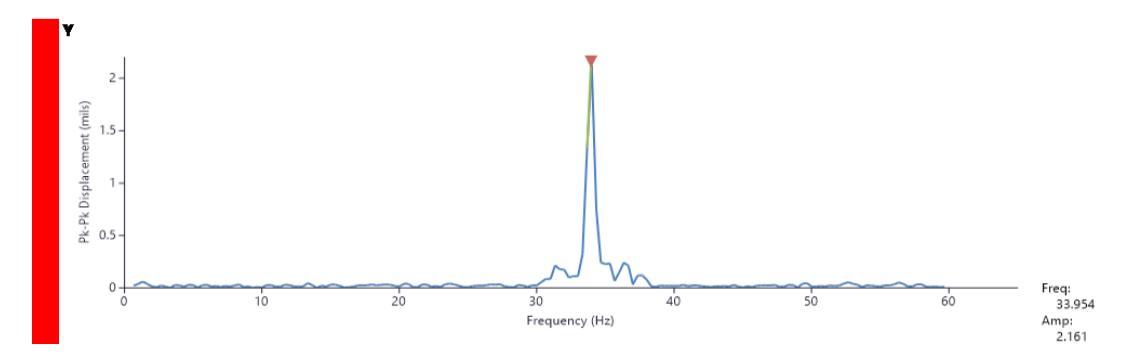
Figure 4: Motor DE axial spectral plot

Figure 4 shows a spectral plot of the DE of the motor at the axial position. The amplitude of vibration in this pump appears to be lower than Pump 1.

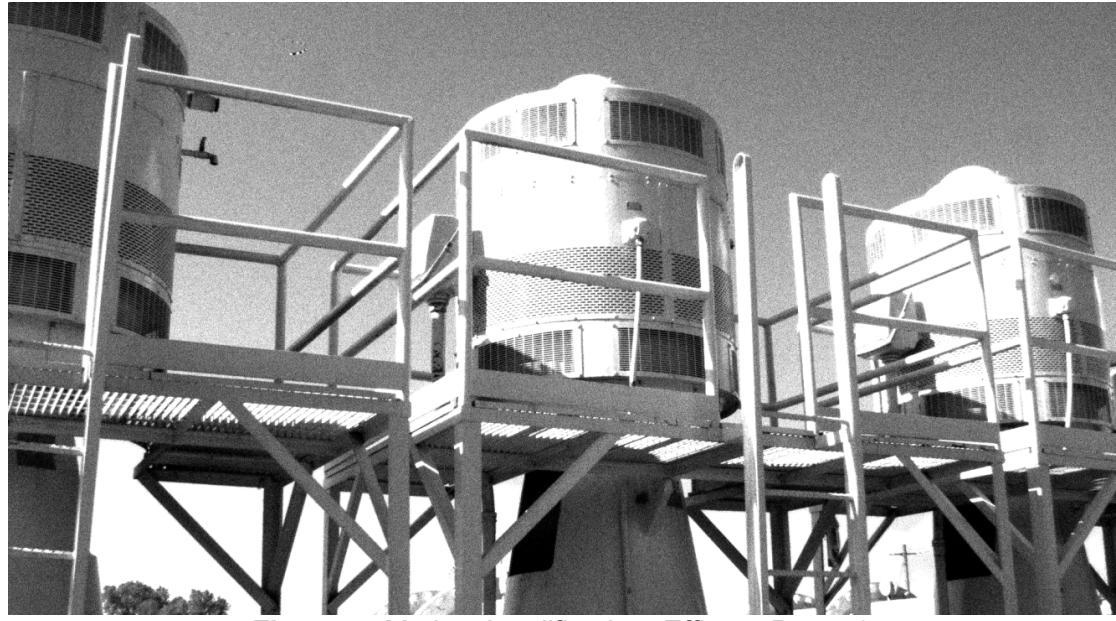
Figure 5: Motion Amplification, Effluent Pump 3

Figure 5 shows Pump 3 Motor having minimal movement except at the junction box. Junction box does appear to have some excessive motion.

Pump 3 had some minimal motor/pump vibration. Motion amplification did show some excessive motion on the electrical junction box on the side of the motor. This may need to be checked for loose fasteners.

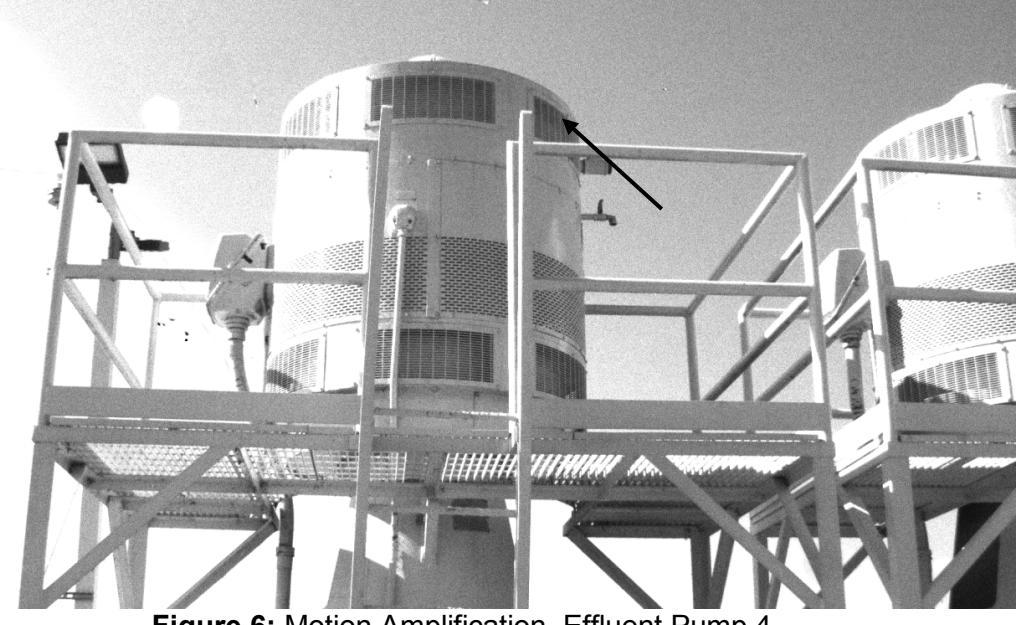
Figure 6: Motion Amplification, Effluent Pump 4

Figure 6 MA video shows Pump 4 having some pump frame and motor motion. The frequency of vibration appears to be mainly at 1 x rpm. This vibration is present in both radial directions and axial as well. Arrow in picture shows where the vibration plots were measured from in the MA video. See vibration plots below.

Pump 4 has some 1 x rpm vibration according to vibration plots taken form the Motion Amplification. This vibration or motion shows to be at both radial directions and axial direction. This could be due issues in the pump. It is not uncommon for the motor to have vibrations cause by pump shaft issues such as bent shaft or bushing wear of the pump shaft. Unbalance of the impeller can also cause this type of vibration.

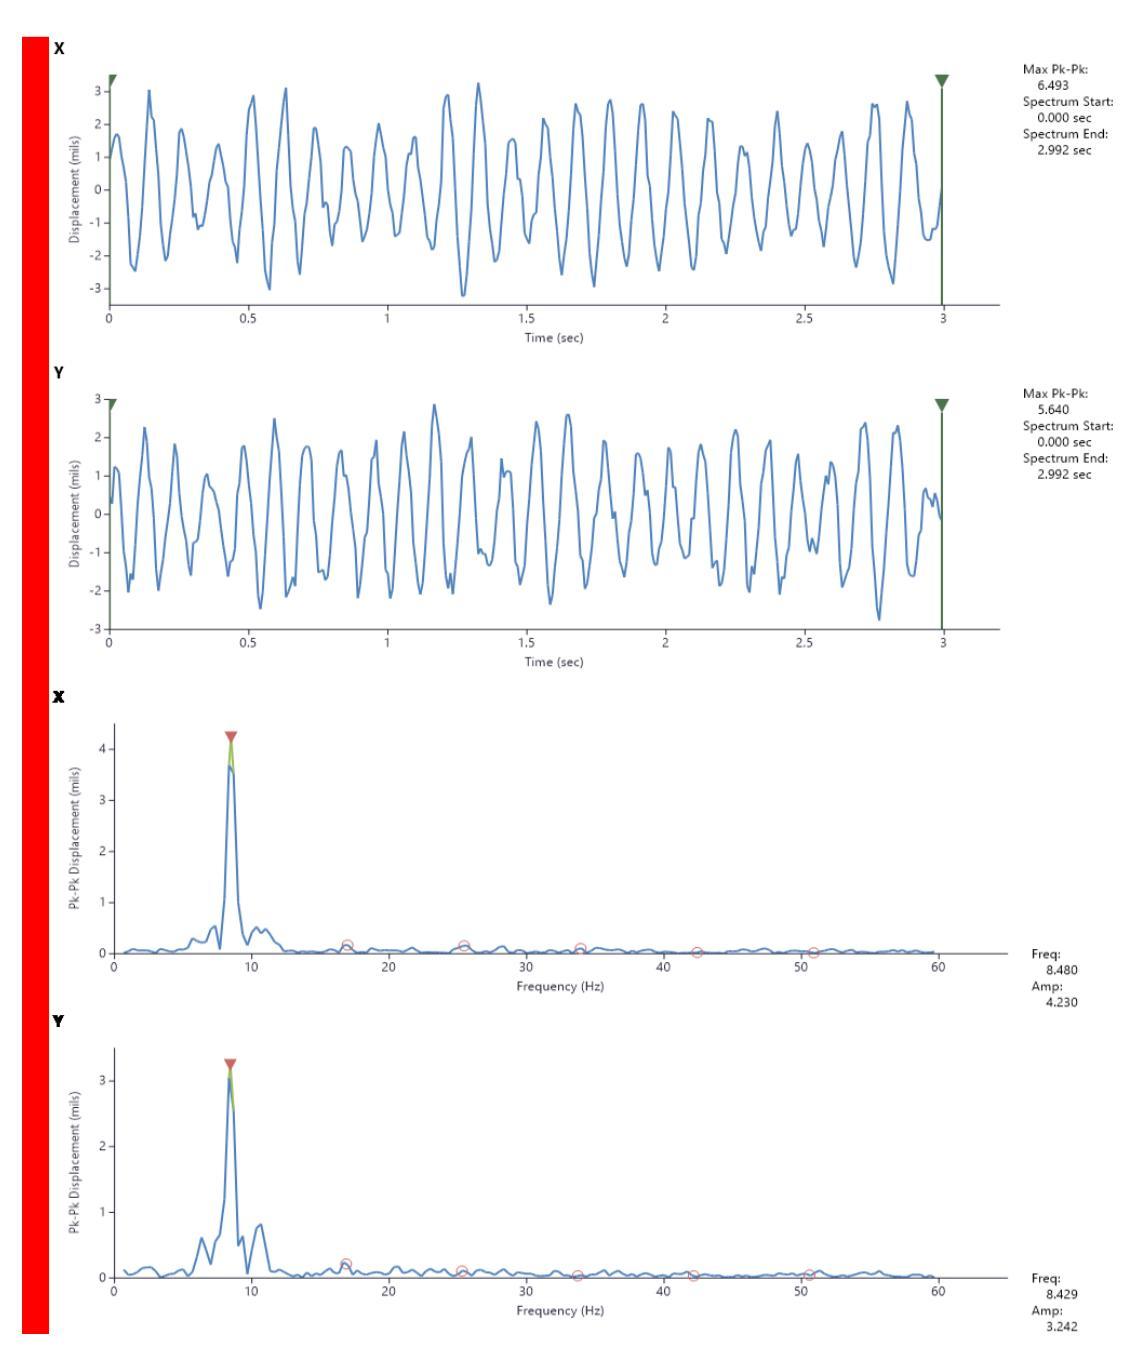
Figure 6: Vibration plots

X axis is side to side and Y axis is axial or straight up and down. Notice peaks are at 8.49 Hz. which is very close to motor rpm

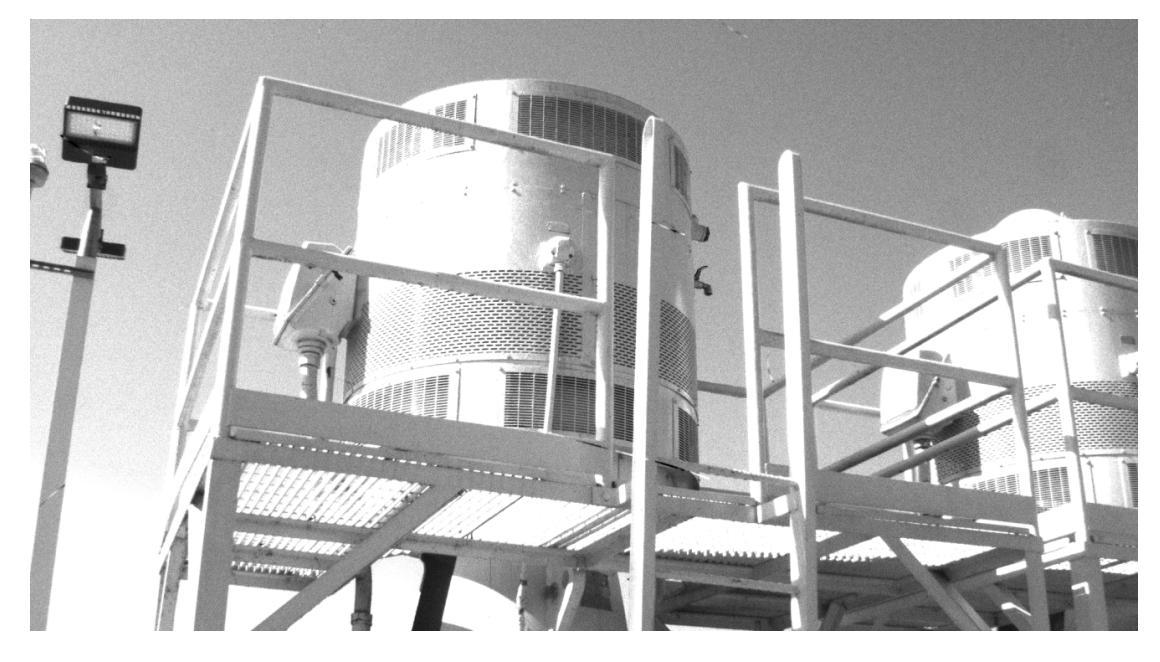
Figure 7, Motion Amplification Pump 4 (slightly different angle focused more on motor)
