AC Recondition As Found

Sage V Foods

AC Recondition - Rev. 2

Location: MOTOR SHOP LR
Serial Number: EF5T46663N-F4-4-12/20
Description: 0.5HP SWECO 1200RPM 143TZX

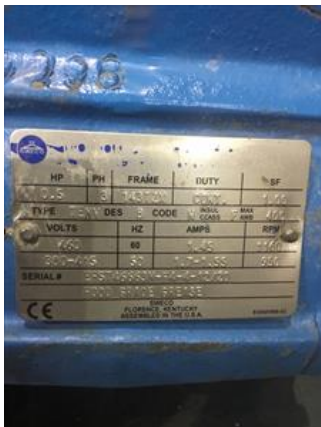
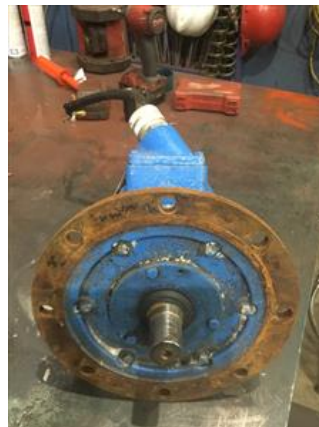
P21

1. Report Date
2. Nameplate Picture

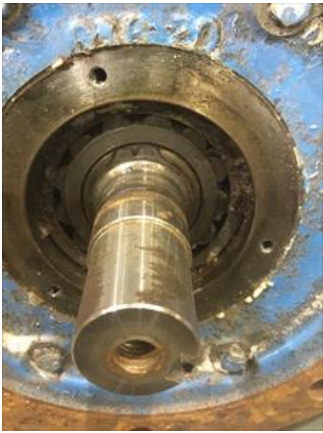
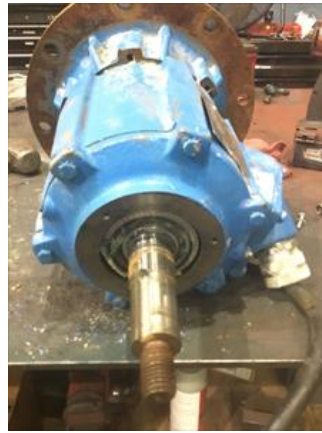
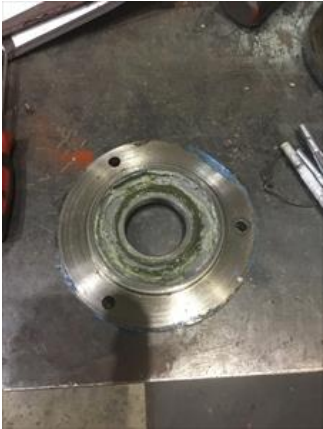
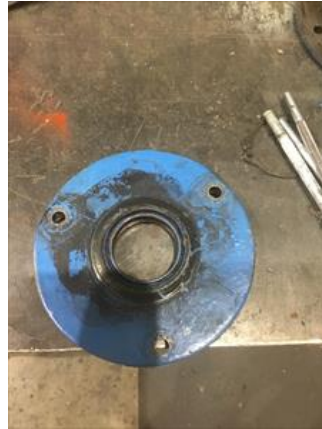
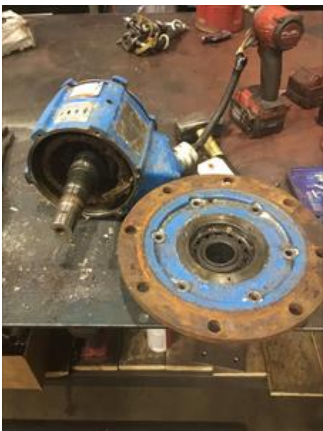
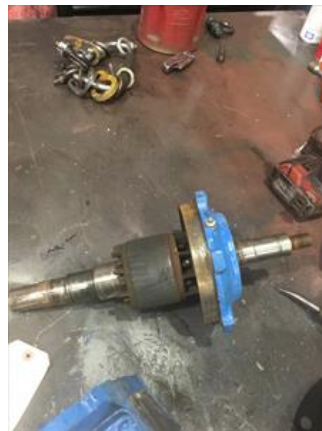
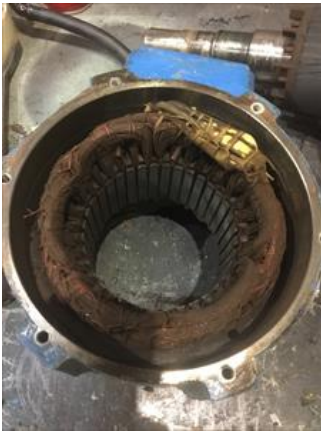
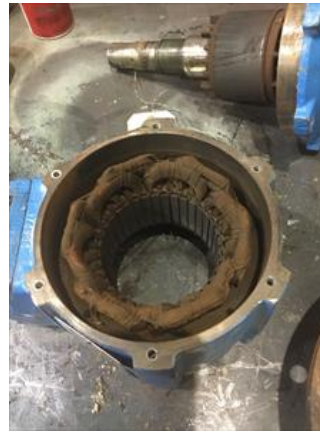
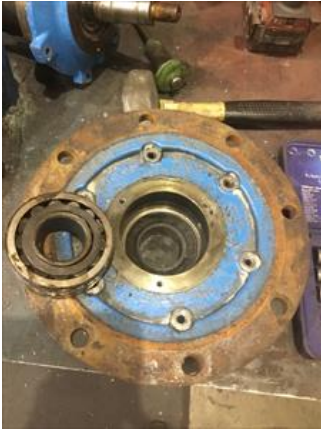
3. Photos of all six sides of the machine.
4. Describe the Overall Condition of the Equipment as Received

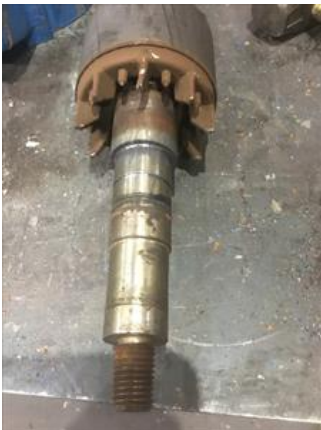
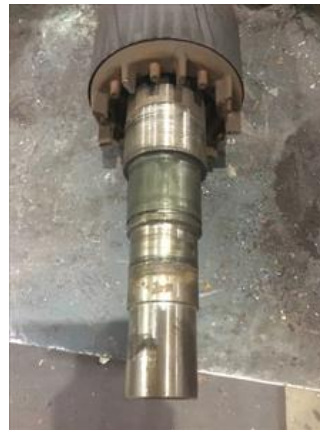
| ● | 5. Does Shaft Turn Freely? | (Yes) Yes | |
| | 6. Does Shaft Have Visible Damage? | (No) No | P12 |

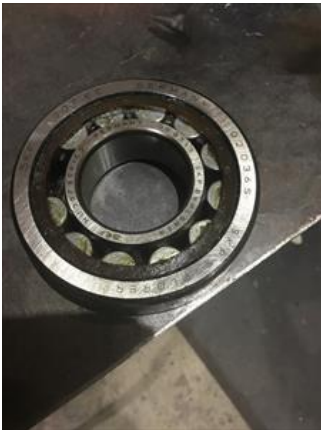
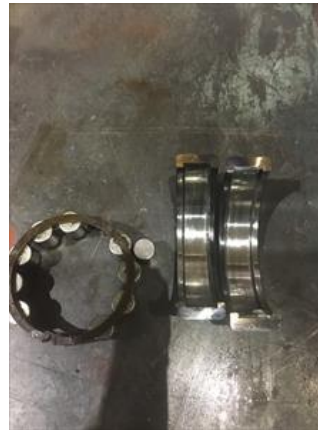
P56

27. Opposite Drive End Bearing Qty.	1
28. Opposite Drive End Bearing Type	(Roller) Roller Bearing
29. Opposite Drive End Lubrication Type	(Grease) Grease Lubricated
30. Opposite Drive End Bearing Insulation or Grounding Device?	none
31. Opposite Drive End Wavy Washer/Snap-Ring Other Retention Device?	none
32. Opposite Drive End Bearing Condition	worn/ dirty grease

Bearings and seals

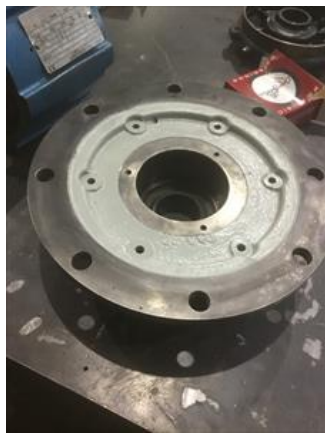
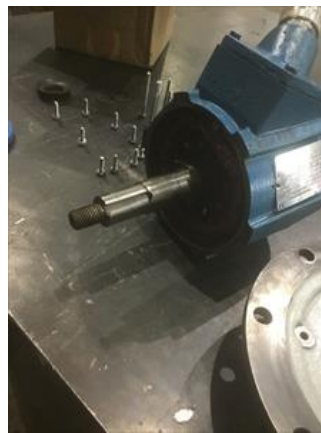
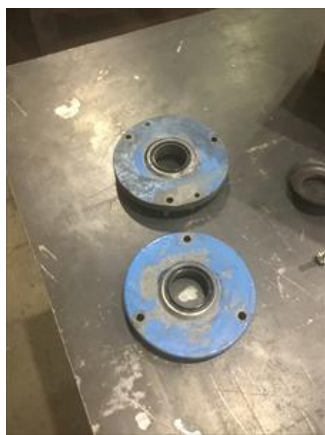
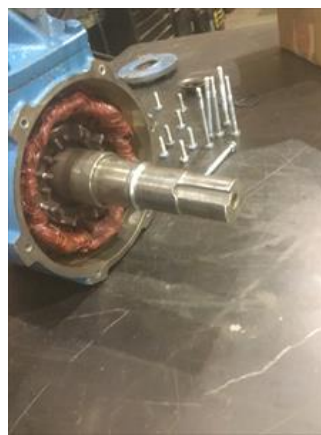
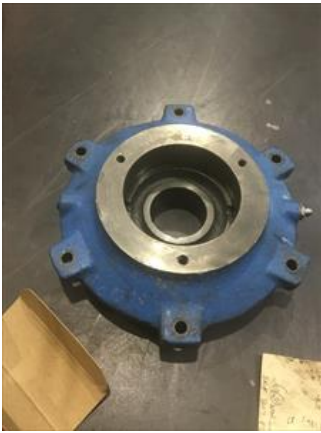
98. Final Pics and QC Review

89. Test Run Voltage			
Volts	Volts	Volts	
90. Test Run Amperage			
Amps	Amps	Amps	
91. Drive End Vibration Readings - Inches Per Second			
Horizontal	Vertical	Axial	
92. Opposite Drive End Vibration Readings - Inches Per Second			
Horizontal	Vertical	Axial	
93. Ambient Temperature - Fahrenheit			
94. Drive End Bearing Temps - Fahrenheit			
5 Minutes	10 Minutes	15 Minutes	
95. Opposite Drive End Bearing Temps - Fahrenheit			
5 Minutes	10 Minutes	15 Minutes	
96. Final Test Run Sign-off			
97. Document Final Condition with Pictures after paint			P2200
