AC Recondition As Found

Remington (10243)

AC Recondition - Rev. 2

Description: 1HP US MOTORS 1800RPM 182

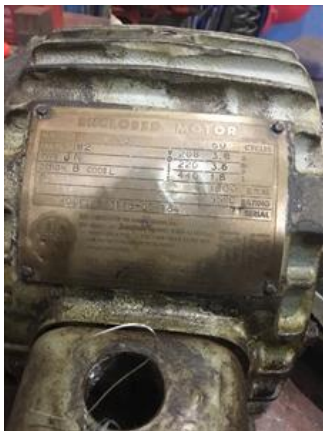
P21

2. Nameplate Picture

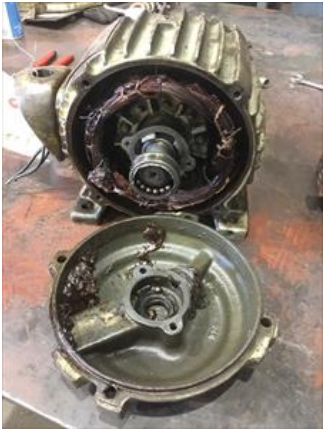
7. Does Shaft Have Visible Damage?	(No) No	
8. Assembled Shaft Runout		
9. Assembled Shaft End Play		
10. Air Gap Variation <10%		
11. Lead Condition		
12. Lead Length	8 Inches	
13. Frame Condition	pass	
14. Fan Condition	(N) NA	
15. Broken or Missing Components	ode bearing cap has broken inner tab	P58

Root Cause of Failure		
59.	Failure locations	
	<i>Windings</i>	
60.	Root cause of failure	
	<i>Piece of ode bearing cap broke off and shorted the windings.</i>

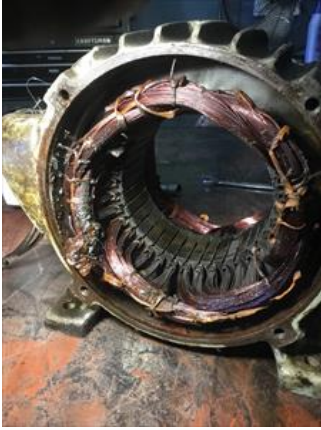
Initial Electrical Inspection			
16. Insulation Resistance/Megger		Megohms	
17. Winding Resistance			
1-2	1-3	2-3

19. Stator Condition

rewind

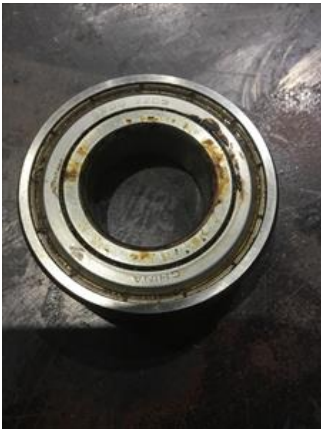
P8

20. Drive End Bearing Number-

6205

26. Drive End Bearing Condition

replace

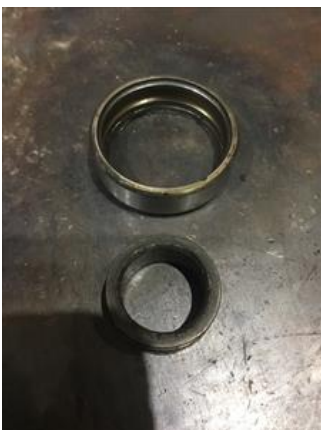
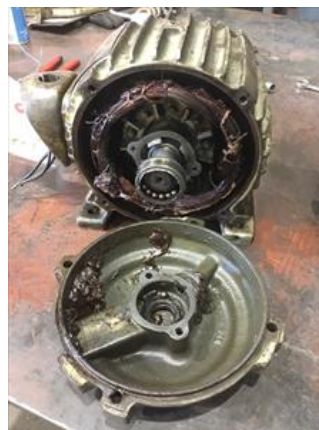
P47

27. Opposite Drive End Bearing Number-

6205

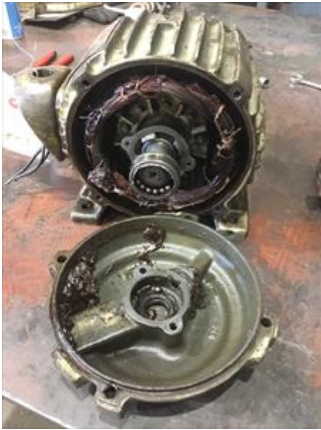
28. Opposite Drive End Bearing Qty.	1	
29. Opposite Drive End Bearing Type	(Ball) Ball Bearing	
30. Opposite Drive End Lubrication Type	(Grease) Grease Lubricated	
31. Opposite Drive End Bearing Insulation or Grounding Device?	none	
32. Opposite Drive End Wavy Washer/Snap-Ring Other Retention Device?	none	
33. Opposite Drive End Bearing Condition	destroyed	P57

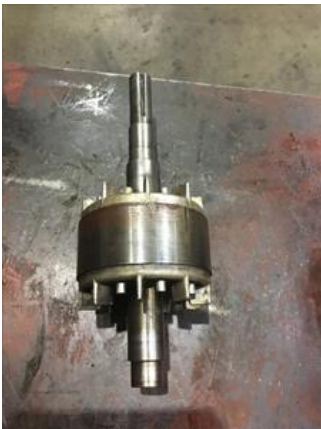
36. Rotor Type/Material	(Squirrel Aluminum) Squirrel Cage Aluminum Die Cast	P3
-------------------------	--	----

37. Growler Test	(Pass) Pass	
38. Number of Rotor Bars		
39. Rotor Condition	good	
40. List the Parts needed for the Repair Below		
	<i>Bearings and rewind stator.</i>	
41. Signature of Technician that Disassembled Motor	Terrence. Holland
