AC Recondition As Found

Almatis Inc/RCP Bauxite (10014)

Description: 350HP LOUIS ALLIS 900RPM
7110Z

Hi-Speed Job Number: 100368

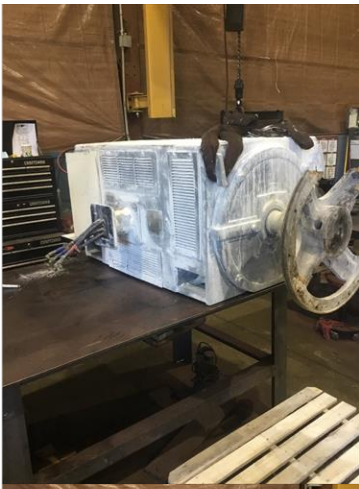
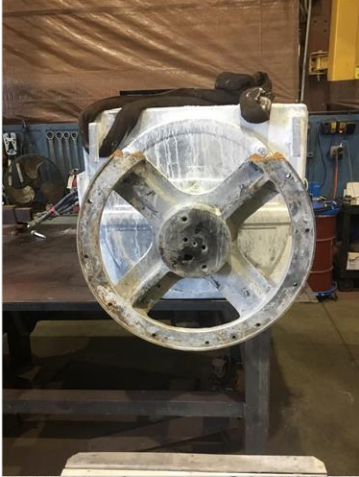
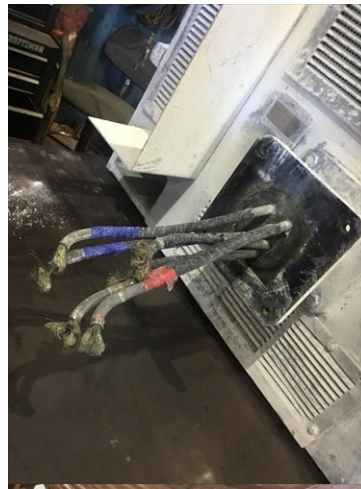
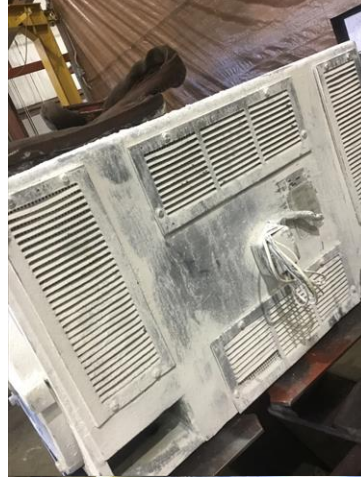
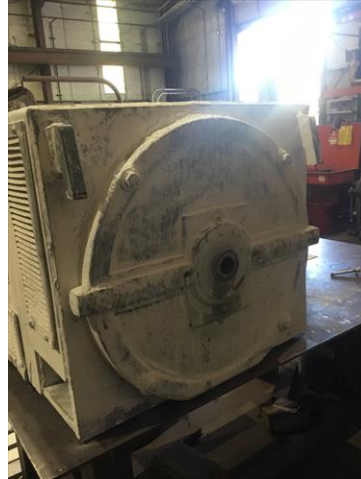
3. Photos of all six sides of the machine.

4.	Describe the Overall Condition of the Equipment as Received <i>Dirty</i>		
5.	Distance from the end of the shaft to the Coupling/Sheave	inches	
Initial Mechanical/Electrical

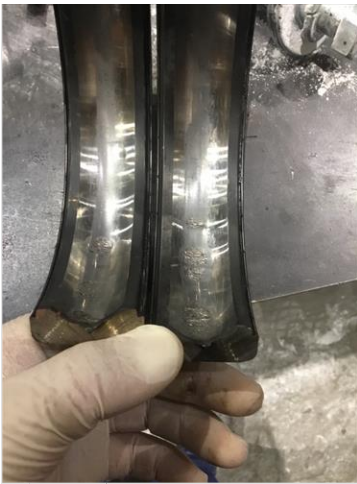
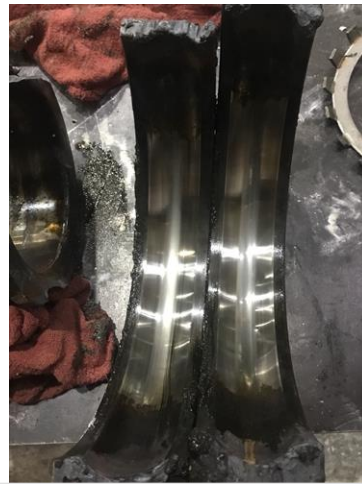
11.	Lead Condition	(P) Pass	
12.	Lead Length	12 Inches	
13.	Frame Condition	pass	
14.	Fan Condition	(N) NA	
15.	Broken or Missing Components	coupling is broken and ODE bearing cap bolt
