DC Repair Report
International Paper - Conway Graphics
730 Enterprise Ave
Conway, AR 72032

DC Repair Report Rev. 2

Location: Shop
Job Number: 100458
Serial Number: BB50R451018
Status: In For Repair
Description: 40HP GE DC 1750RPM AD328AT

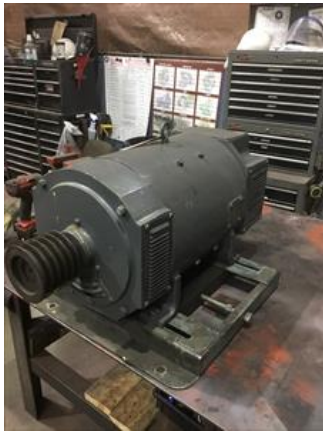
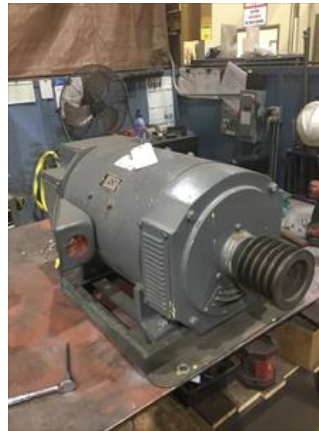
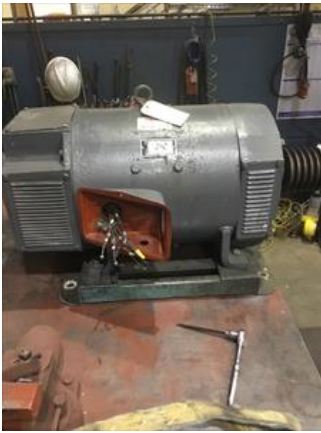
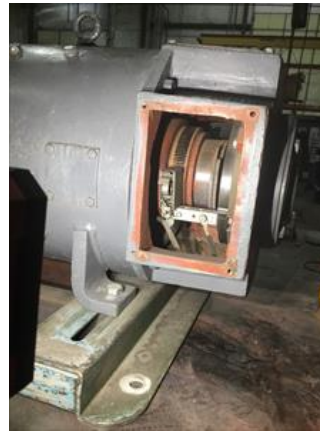
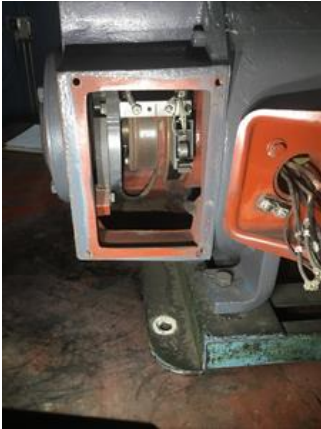
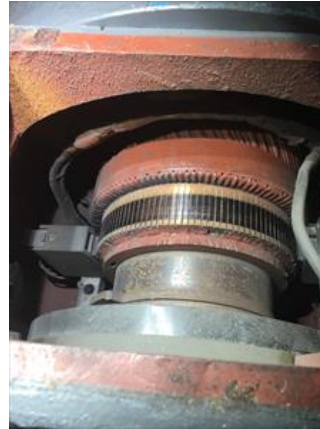
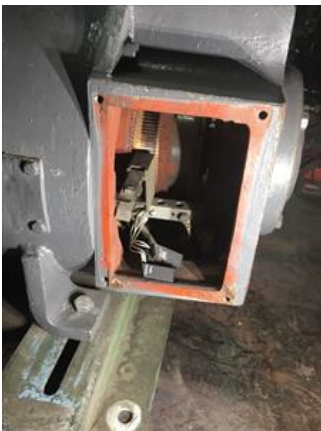
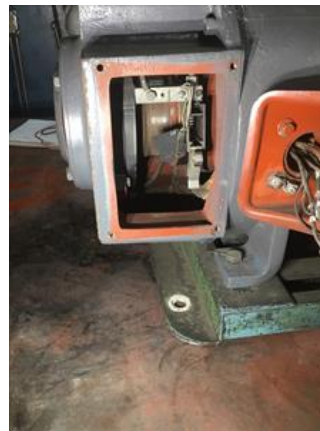
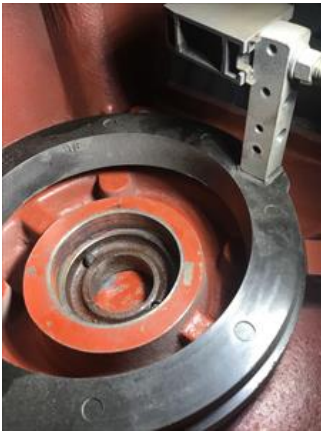
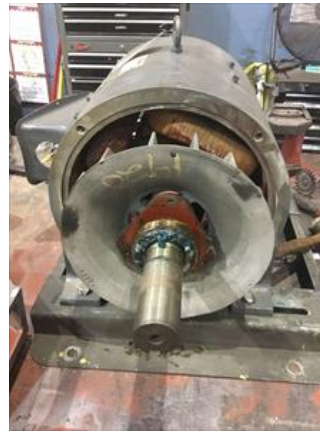
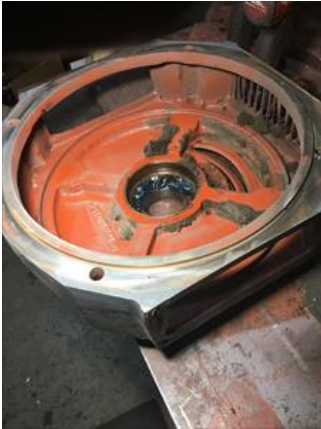
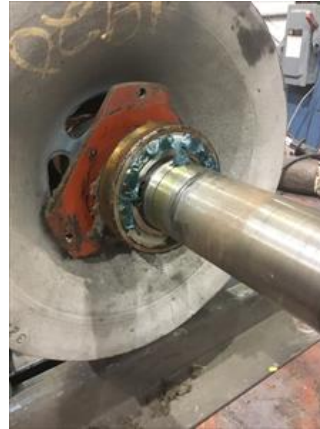
P1

1. Describe the Overall Condition of the Equipment as Received
Serviceable

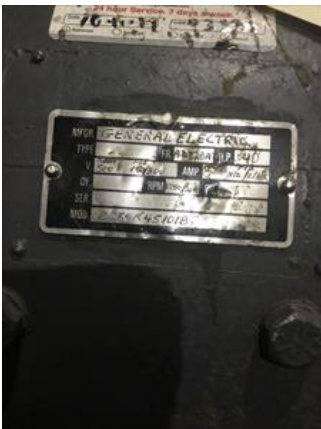
P17

2. Nameplate Picture

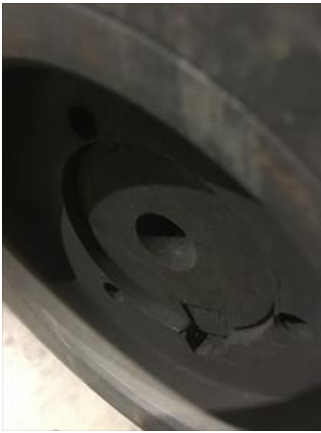
P31

3. Distance From the End of the Shaft to the end of the Face of the Sheave/Coupling

0.125

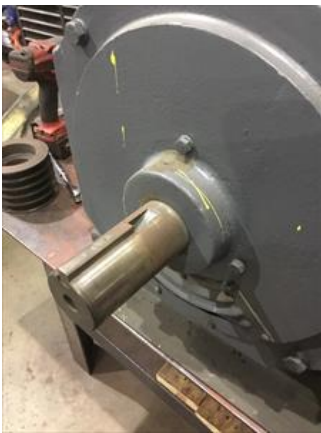
| 5. | Does Shaft Have Visible Damage? | (No) No | P22 |

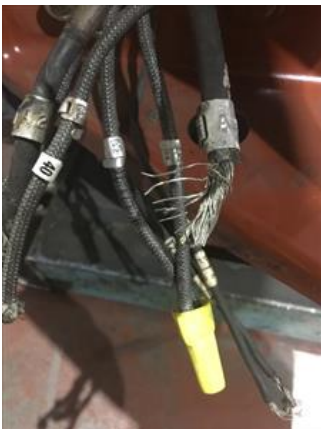
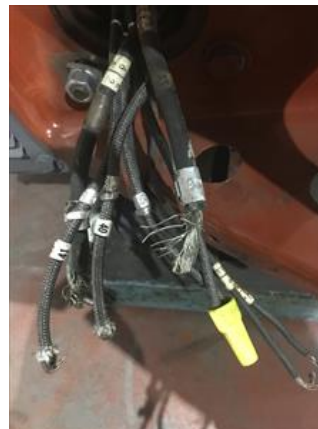
| 9. | Lead Condition | (P) Pass | P59 |

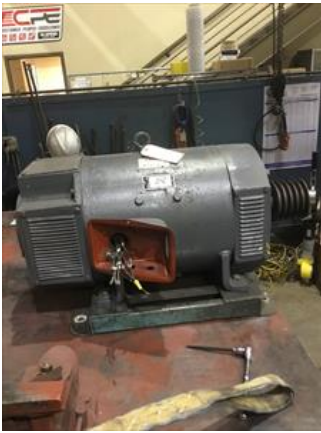
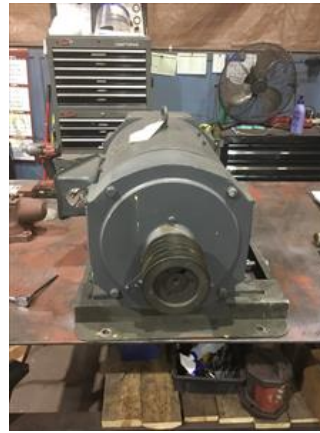
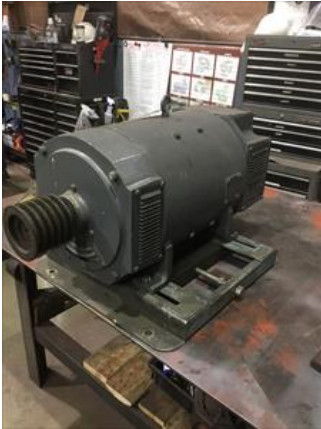
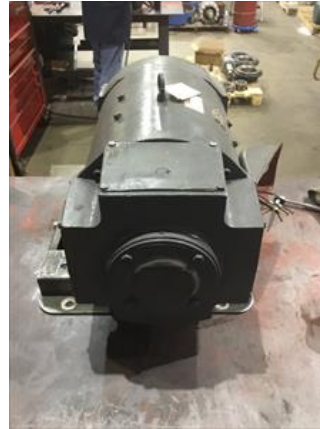
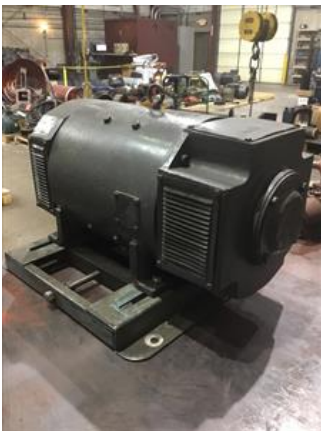
| 11. | Frame Condition | (P) Pass | P76 |

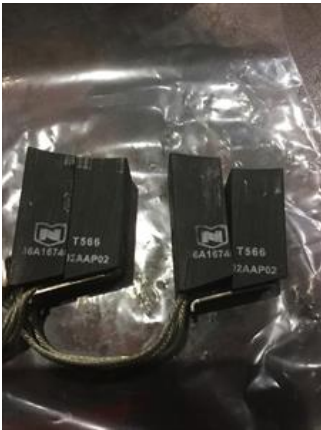
P89

13. Brush Information

Brush Number	Quantity	Condition
T566	2	good

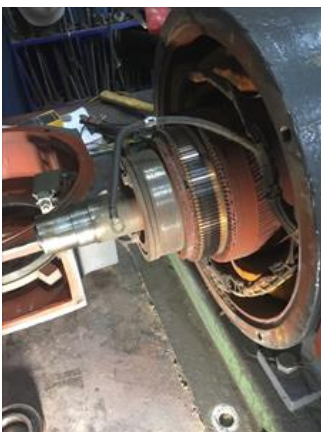
P6

15. General Condition of the Armature/Commutator

61.	Failure Locations <i>Both housing fits and ode shaft bearing journal. Polish comm.</i>		
62.	Root Cause of Failure		
Commutator Data			
63.	Total Copper Segment Length

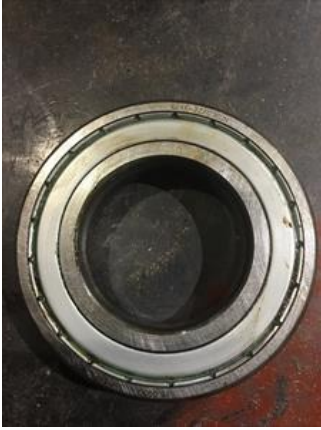
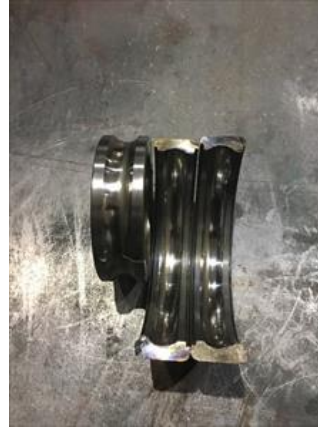
P28

30. Drive End Bearing Number

6211-2Z/C3

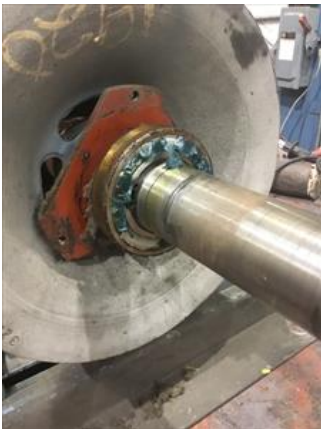
P70

35. Drive End Wavy Washer/Snap-Ring Other Retention Device?

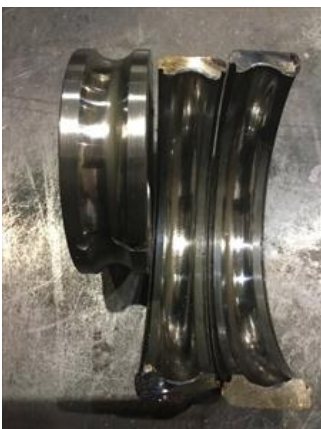
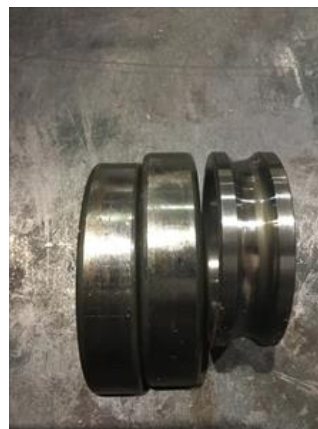
P77

36. Drive End Bearing Condition

replace

45. List Parts Needed Prior to Reassembly
Bearings: 6211 & 6210. Aegis ring D.E. 2.455. Insulated 6210 sleeve.

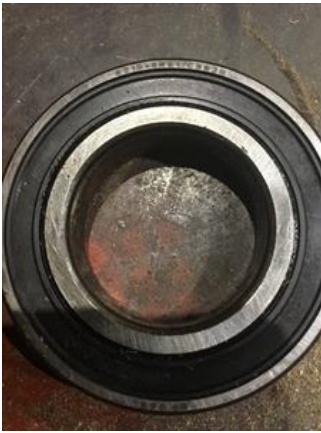
P88

37. Opposite Drive End Bearing Number

6210 2RS/C3

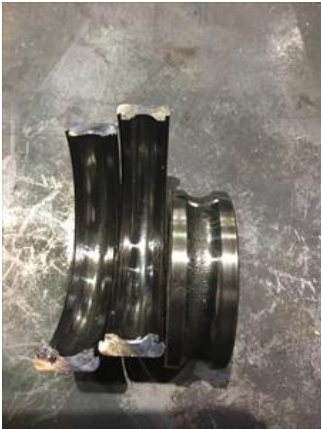
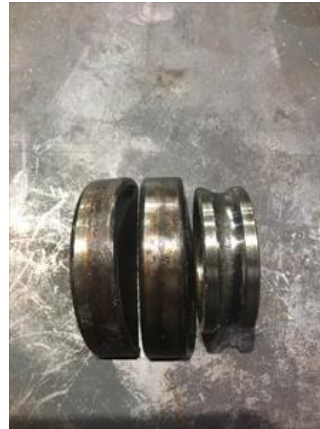
38. Opposite Drive End Bearing Quantity	1	
39. Opposite Drive End Bearing Type	(Ball) Ball Bearing	
40. Opposite Drive End Lubrication Type	(Grease) Grease Lubricated	
41. Opposite Drive End Bearing Insulation or Grounding Device?	(NA)	
42. Opposite Drive End Wavy Washer/Snap-Ring Other Retention Device?	none	
43. Opposite Drive End Bearing Condition	replace	P114

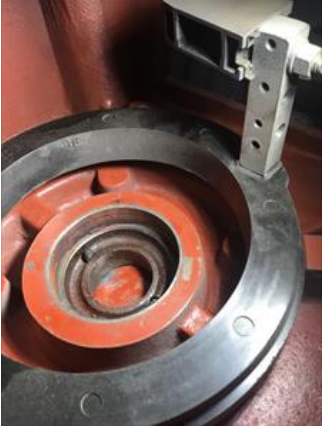
53.	Drive End - End Bell Bearing Fit		
	0 Degrees	60 Degrees	120 Degrees
	3.9381	3.9382	
54.	Drive End - Endbell Bearing Fit Condition		(F) Fail
55.	Opposite Drive End - End Bell Bearing Fit		P25
	0 Degrees	60 Degrees	120 Degrees

56.	Opposite Drive End - Endbell Bearing Fit Condition		(F) Fail
57.	Bearing Cap Condition		
	Drive End	Opposite Drive End	
	pass		
58.	End Bell Air Seal Fits		
	Drive End Air Seal	Opposite Drive End Air Seal

59.	List any Machine work Needed Below	O.D.E shaft bearing journal & housing fits.	
60.	Signature of Technician Performing Measurements	Terrence Holland
