AC Recondition Repair Report

FUTURE FUEL CHEMICAL
2800 GAP RD HWY 394 SO
BATESVILLE, AR 72501

1. Job Number	100504
2. Report Date	10/31/2022
3. Customer	FUTURE FUEL

4. Manufacturer	RELIANCE	P5
-----------------	----------	----

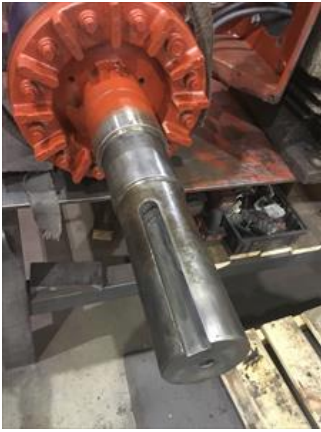
P94

28. Does Shaft Have Visible Damage

none

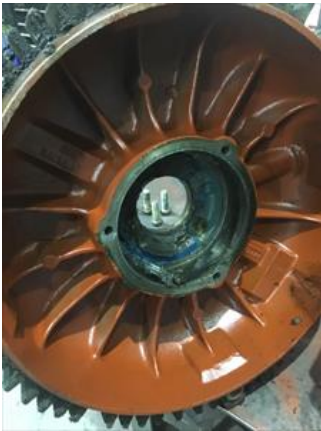
P104

31. Contamination

Water inside stator.

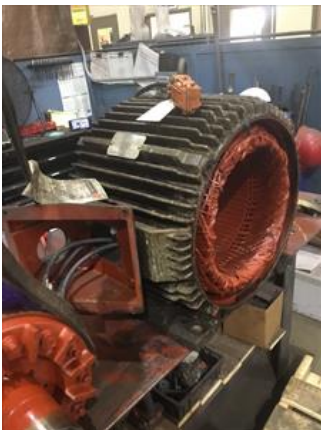
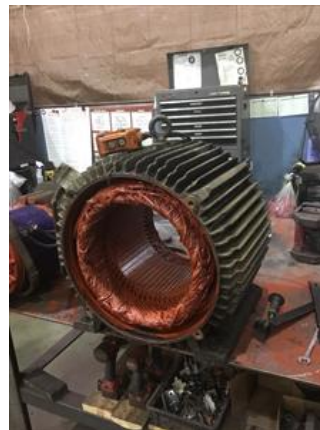
P106

32. Frame Condition

(P) Pass

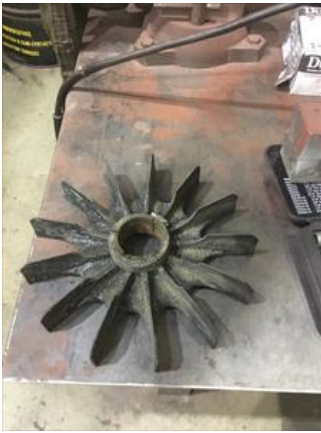
P109

33. Fan Condition

(P) Pass

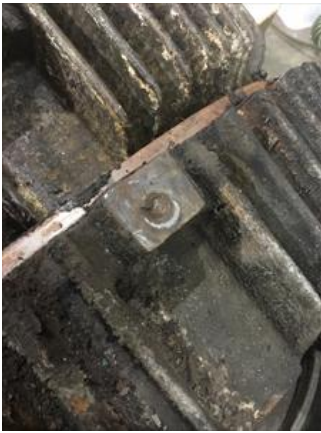
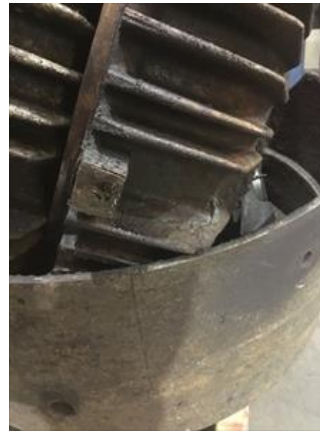
P113

34. Broken or missing components
3 each fan cover bolts broken off and require drill and tap.

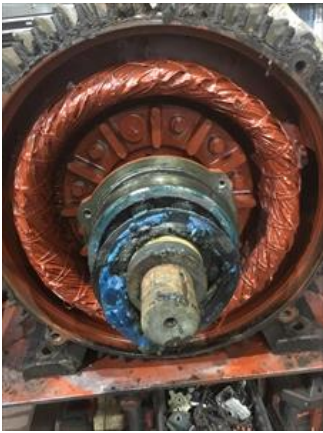
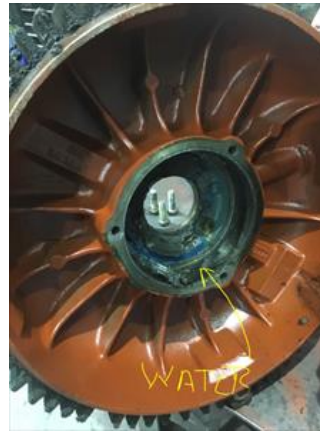
P74

59. Grease Condition

(F) Fail

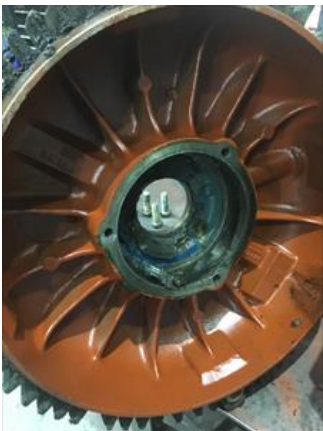
P14

66. Component Failure

bearings

67. Cause of Failure

Water contaminated grease.

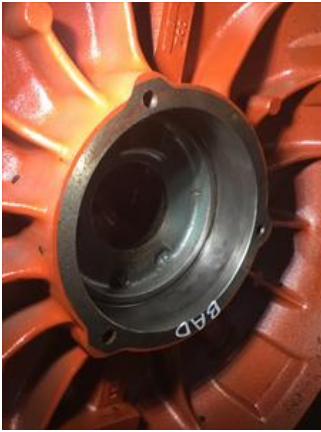
*Pitted*
