## AC Recondition As Found

### AC Recondition - Rev. 2

Location: LR MOTORSHOP

Description: SMALL BLOWER FAN

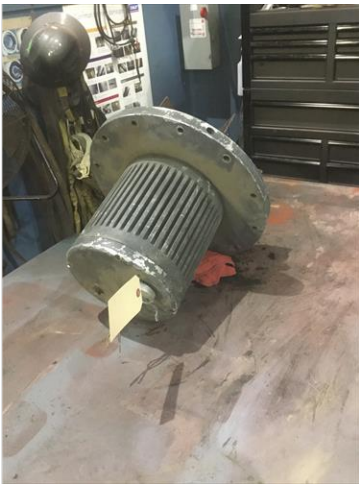
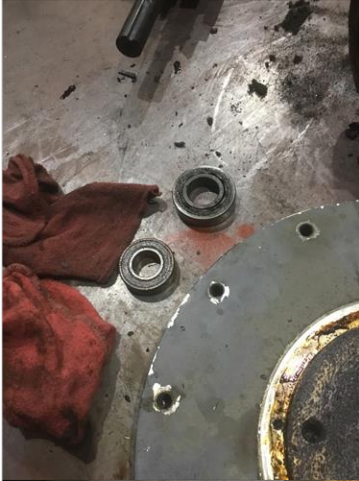
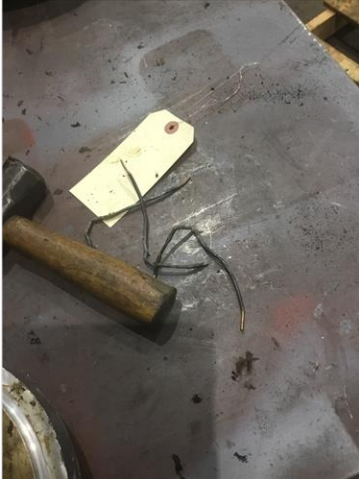
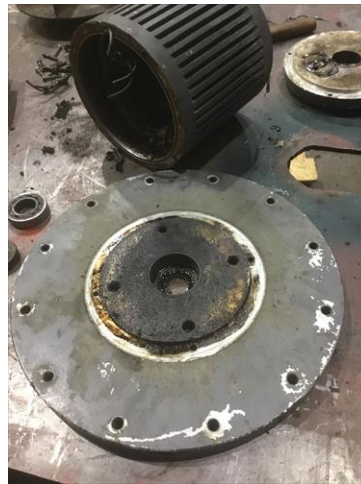
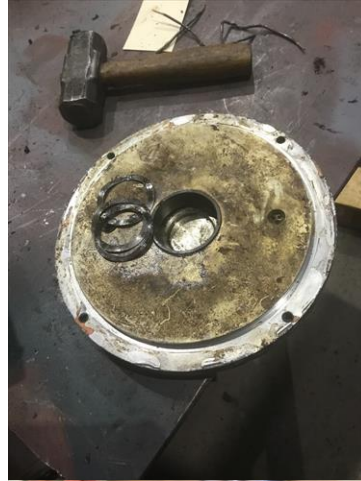
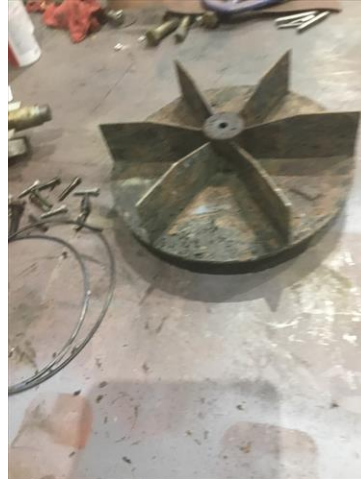
3.	Photos of all six sides of the machine.	
4.	Describe the Overall Condition of the Equipment as Received	
5.	Distance from the end of the shaft to the Coupling/Sheave	
<b>Initial Mechanical/Electrical</b>

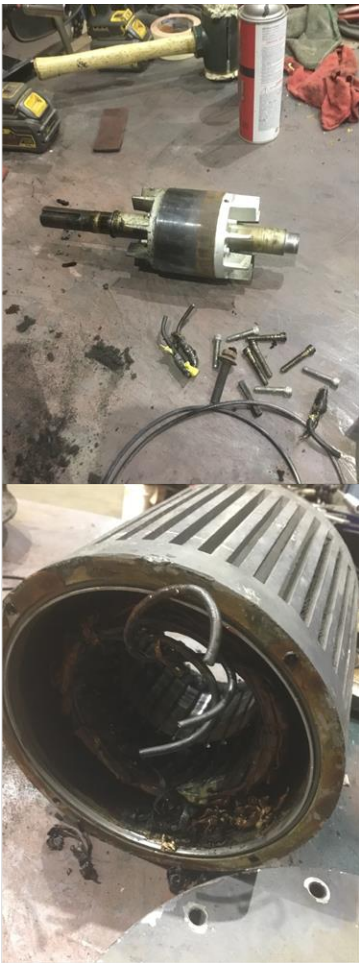
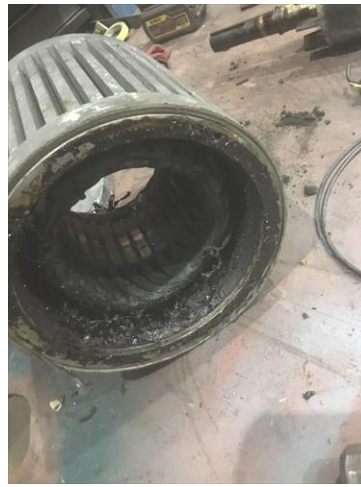
6.	Does Shaft Turn Freely?	<b>(Yes) Yes</b>
7.	Does Shaft Have Visible Damage?	<b>(No) No</b>
8.	Assembled Shaft Runout	
9.	Assembled Shaft End Play	
10.	Air Gap Variation <10%	
11.	Lead Condition	<b>(F) Fail</b>
12.	Lead Length	<b>10 Inches</b>
13.	Frame Condition	<b>pass</b>

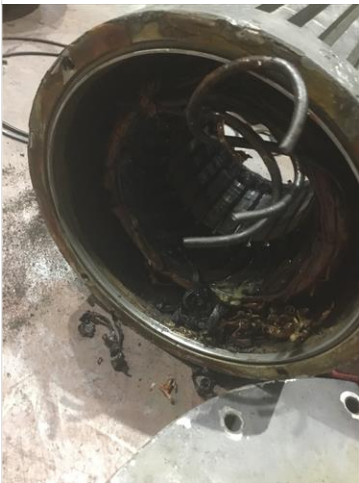
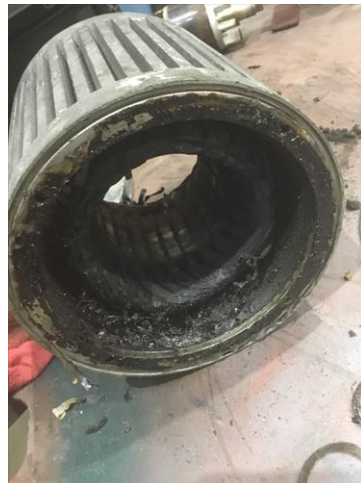
18. Perform Surge Test

(F) Fail

19. Stator Condition

rewind

69.	Post Rewind Surge Test		
70.	Post Rewind Hi-Pot		
71.	Technician		
Root Cause of Failure			
72.	Failure locations		
	De bearing failed causes the rotor to drag iron and burn up winding

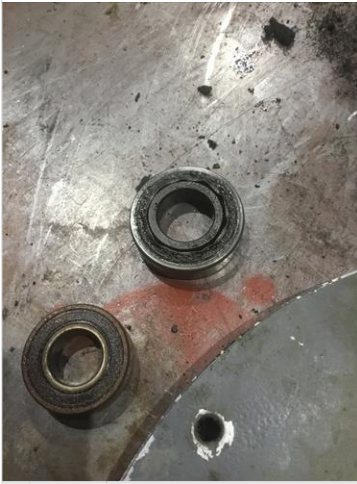
22. Drive End Bearing Qty.	1
23. Drive End Bearing Type	(Ball) Ball Bearing
24. Drive End Lubrication Type	(Grease) Grease Lubricated
25. Drive End Bearing Insulation or Grounding Device?	no
26. Drive End Wavy Washer/Snap-Ring Other Retention Device?	no
27. Drive End Bearing Condition	carriage came apart
28. Opposite Drive End Bearing Number-	6205 2RS
29. Opposite Drive End Bearing Qty.	1
30. Opposite Drive End Bearing Type	(Ball) Ball Bearing
31. Opposite Drive End Lubrication Type	(Grease) Grease Lubricated
32. Opposite Drive End Bearing Insulation or Grounding Device?	no
33. Opposite Drive End Wavy Washer/Snap-Ring Other Retention Device?	wavy washer

1-6206 2RS 1-6205 2RS

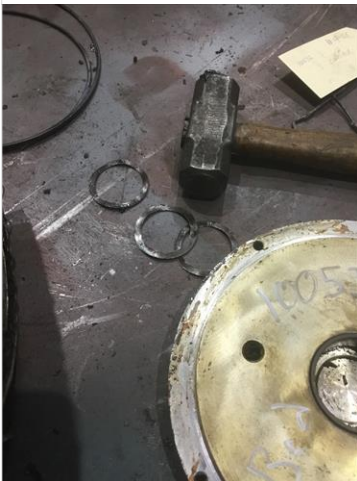
P56

34. Opposite Drive End Bearing Condition	okay
35. Drive End Seal	
36. Opposite Drive End Seal

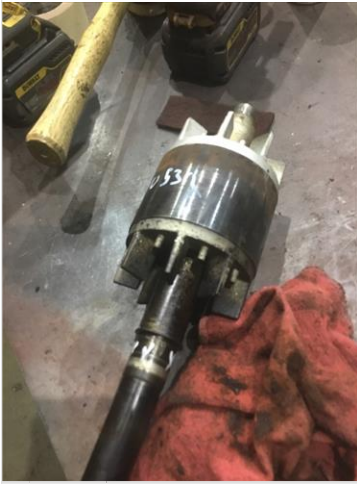
37. Rotor Type/Material	(Squirrel Aluminum) Squirrel Cage Aluminum Die Cast
38. Growler Test	(Pass) Pass
39. Number of Rotor Bars

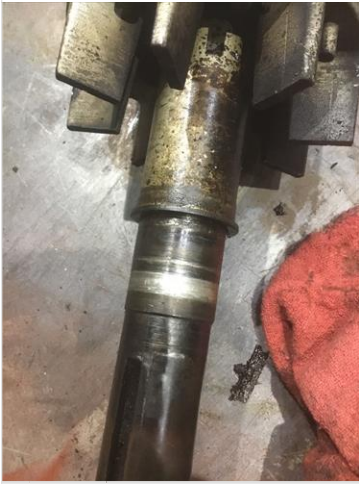
48. Drive End Bearing Shaft Fit Condition

(F) Fail

*De shaft bearing fit bad also ode end bell housing fit bad*

78.	Drive End Bearing Shaft Fit Post Repair		
	0 Degrees	60 Degrees	120 Degrees
	1.1815	1.1814	1.1814

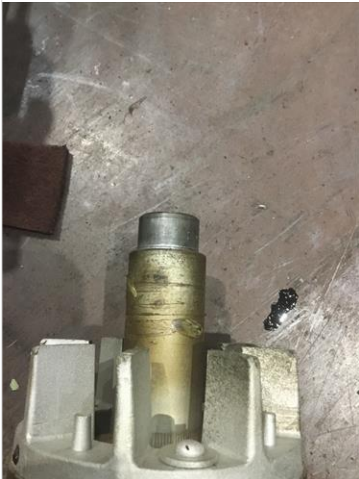
50. Opposite Drive End Bearing Shaft Fit Condition

(P) Pass

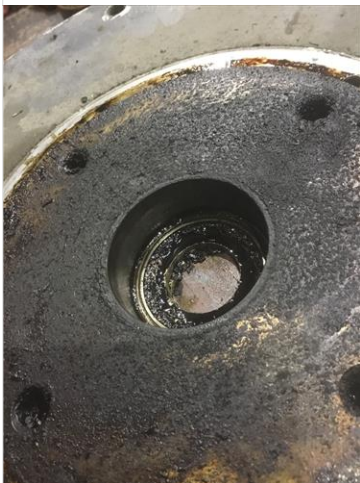
55. Opposite Drive End - Endbell Bearing Fit Condition

(F) Fail

Resleeve

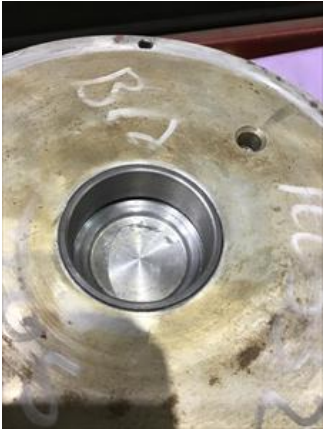
83. Opposite Drive End - Endbell Bearing Fit Post Repair <span style="float: right;">P100</span>			
0 Degrees	60 Degrees	120 Degrees	
<b>2.0475</b>	<b>2.0475</b>	<b>2.0474</b>

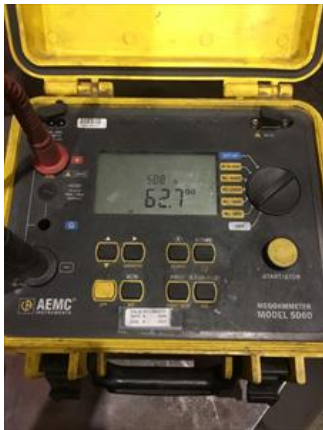
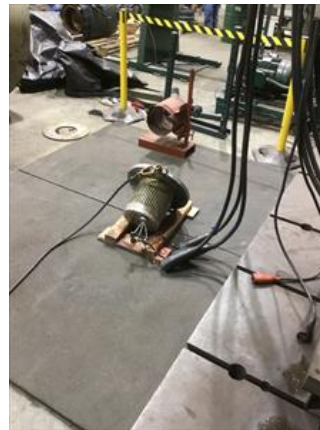
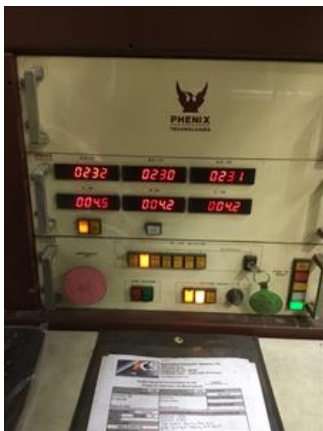
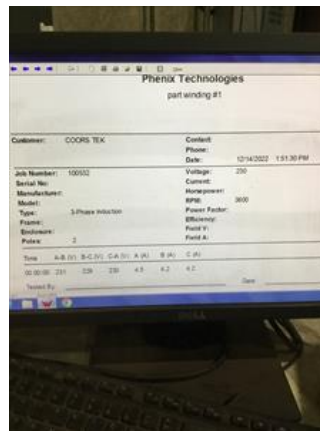
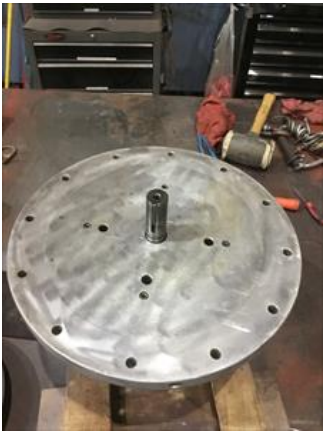
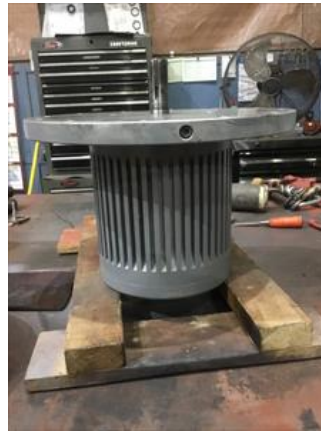
99. Document Final Condition with Pictures after paint

100. Final Pics and QC Review
