AC Recondition As Found

Remington (10243)

AC Recondition - Rev. 2

Description: 15HP ALLIS-CHALMERS 1800RPM
254T

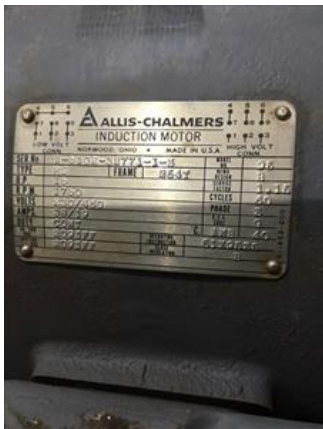
1. Report Date
2. Nameplate Picture

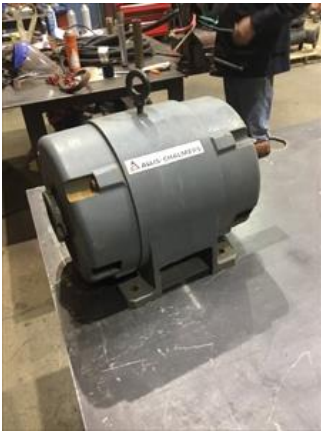
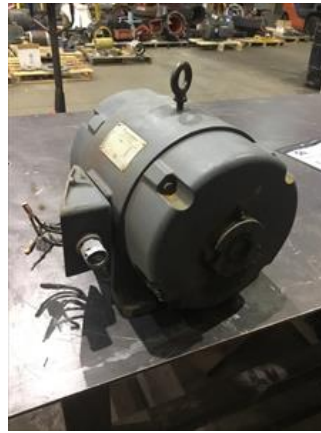
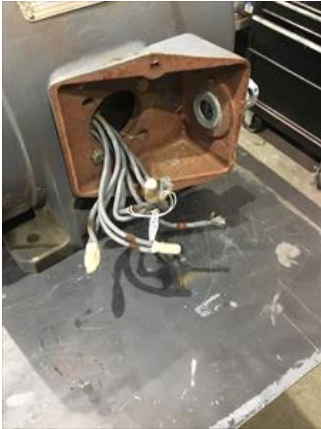
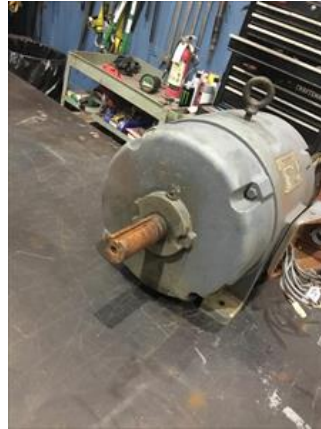
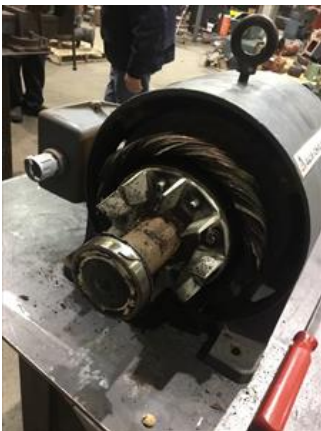
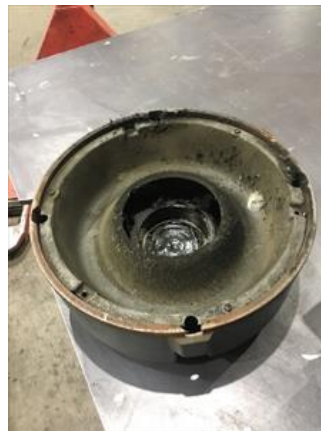
3. Photos of all six sides of the machine.

4. Describe the Overall Condition of the Equipment as Received
Dirty

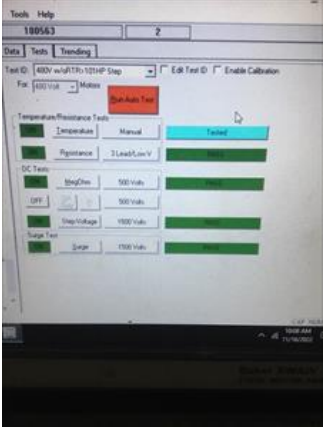
17.	Perform Surge Test	(P) Pass	P35

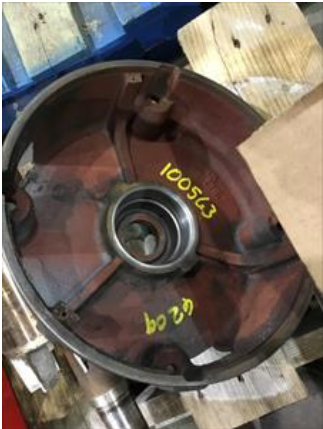
81. Drive End - Endbell Bearing Fit Post Repair			P0
0 Degrees	60 Degrees	120 Degrees	
3.347	3.347	3.347

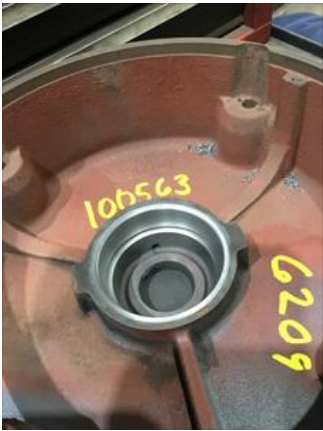
82. Opposite Drive End - Endbell Bearing Fit Post Repair			P100
0 Degrees	60 Degrees	120 Degrees	
3.3471	3.3471	3.3471

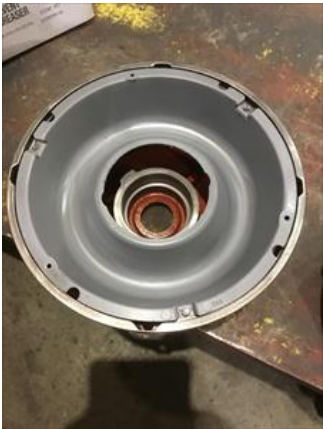
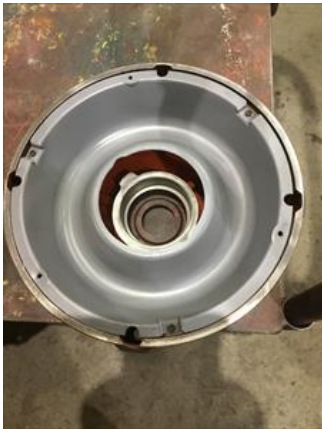
96.	Opposite Drive End Bearing Temps - Fahrenheit		
	5 Minutes	10 Minutes	15 Minutes
97.	Final Test Run Sign-off		
98.	Document Final Condition with Pictures after paint
