AC Recondition As Found

Sage V Foods

AC Recondition - Rev. 2

Description: 50HP BALDOR 1800RPM 326TDZ

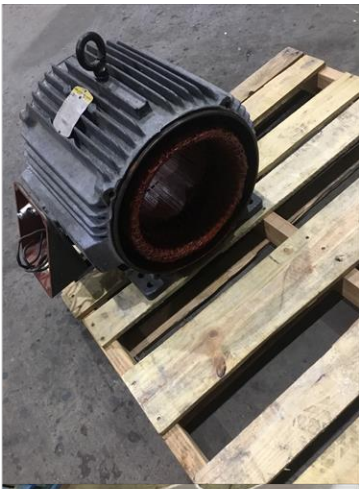
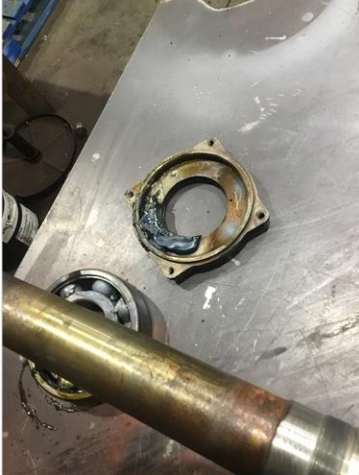
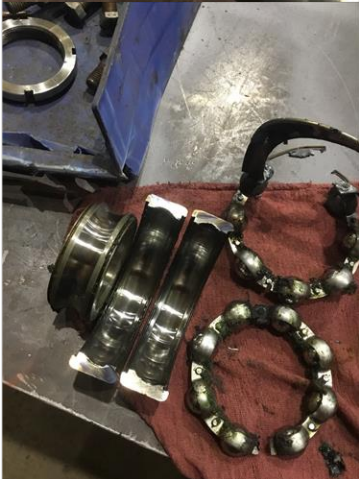
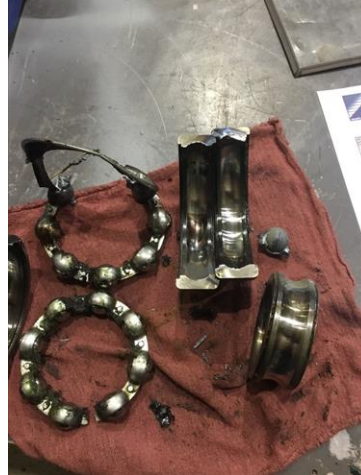
3. Photos of all six sides of the machine.
4. Describe the Overall Condition of the Equipment as Received
Dirty

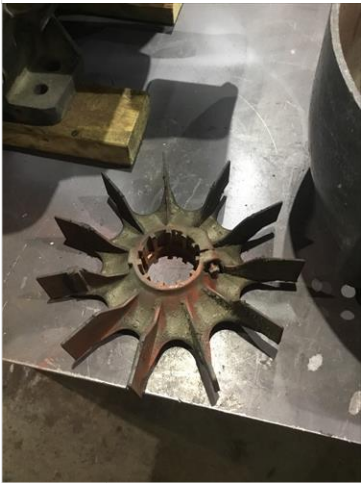
12. Frame Condition	pass	
13. Fan Condition	(P) Pass	P54

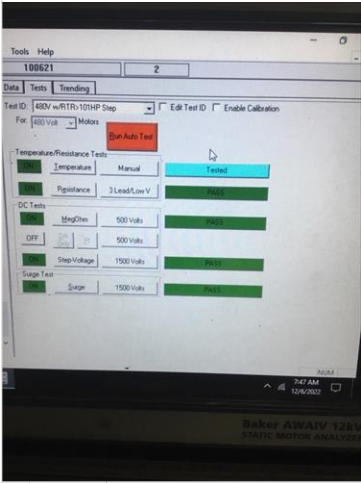
15. Insulation Resistance/Megger		
16. Winding Resistance		
1-2	1-3	2-3
17. Perform Surge Test	(P) Pass	P35

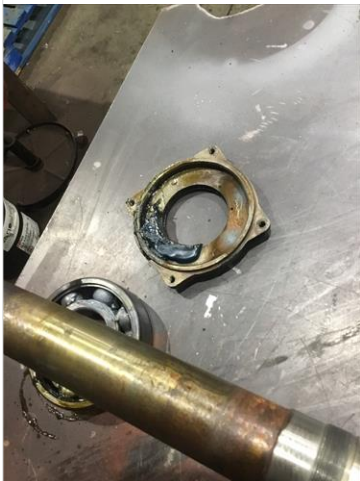
52. Drive End - Endbell Bearing Fit Condition		(P) Pass
53. Opposite Drive End - Endbell Bearing Fit		
0 Degrees	60 Degrees	120 Degrees
<div style="display: flex; align-items: center;"> <div style="width: 15px; height: 15px; background-color: #ccc; margin-right: 5px;"></div> <div>Egg shaped</div> </div>

54. Opposite Drive End - Endbell Bearing Fit Condition		(F) Fail
55. Bearing Cap Condition		P30
Drive End Bearing Cap	Opposite Drive End Bearing Cap	
<div style="display: flex; align-items: center;"> <div style="width: 15px; height: 15px; background-color: #ccc; margin-right: 5px;"></div> <div>Pass</div> </div>

Bearings and ODE end bell bearing fit

*Wear***Mechanical Fits- Rotor - Post Repair**

56. End Bell Air Seal Fits		
Drive End Air Seal	Opposite Drive End Air Seal	
57. List Machine Work Needed Below <i>ODE end bell bearing fit</i>		
58. Technician		Cw

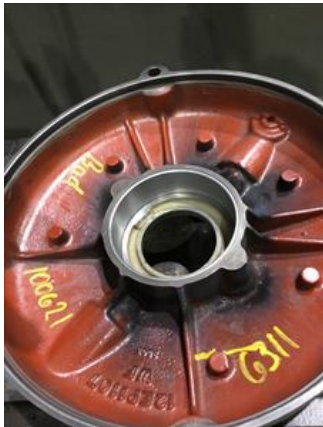
81.	Drive End - Endbell Bearing Fit Post Repair		
	0 Degrees	60 Degrees	120 Degrees
82.	Opposite Drive End - Endbell Bearing Fit Post Repair		
	0 Degrees	60 Degrees	120 Degrees

4.725	4.725	4.725

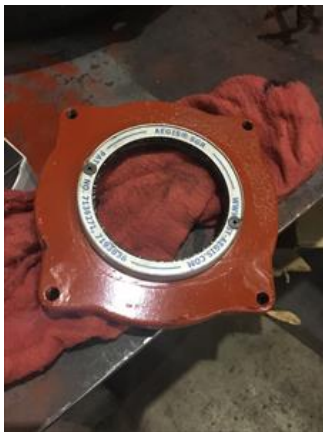
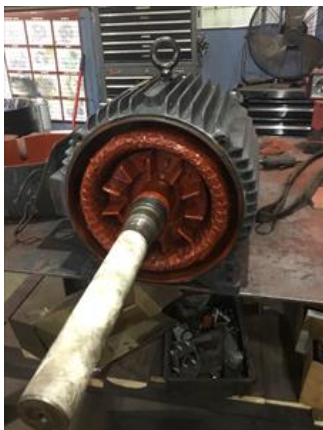
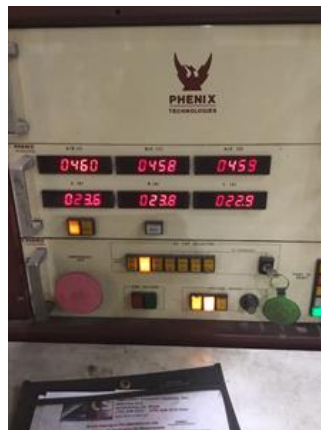
90. Test Run Voltage			
Volts	Volts	Volts	
91. Test Run Amperage			
Amps	Amps	Amps	
92. Drive End Vibration Readings - Inches Per Second			
Horizontal	Vertical	Axial	
93. Opposite Drive End Vibration Readings - Inches Per Second			
Horizontal	Vertical	Axial	
94. Ambient Temperature - Fahrenheit			
95. Drive End Bearing Temps - Fahrenheit			
5 Minutes	10 Minutes	15 Minutes	
96. Opposite Drive End Bearing Temps - Fahrenheit			
5 Minutes	10 Minutes	15 Minutes	
97. Final Test Run Sign-off			
98. Document Final Condition with Pictures after paint			
99. Final Pics and QC Review			P2300
