AC Recondition Repair Report

Phelps Fan Manufacturing Co.
10701 Interstate 30
Little Rock, AR 72209

1. Job Number	100634
2. Report Date	12/08/2022
3. Customer	PHELPS FAN

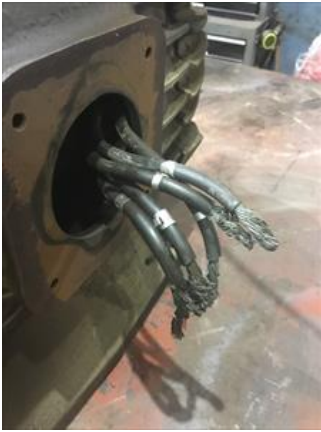
P13

18. Number of Leads

6

1,2,3 & 7,8,9

19. Lead Length **6 Inches**

☒ 21. Lead Condition **(P) Pass**
22. Lead Markings **1,2,3 & 7,8,9**

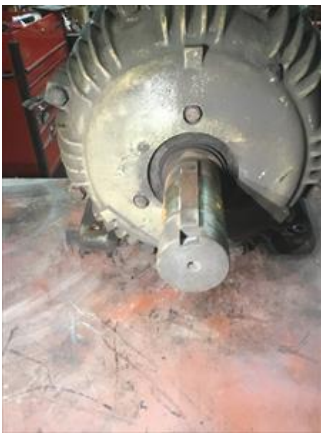
26. Shaft Run Out **0.002**27. Does Shaft Turn Freely **yes**28. Does Shaft Have Visible Damage **no** P94

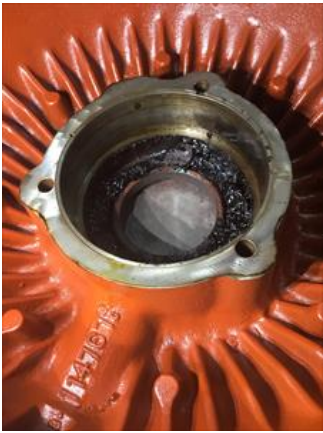
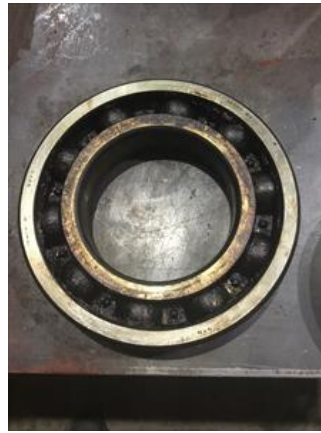
31. Contamination P104

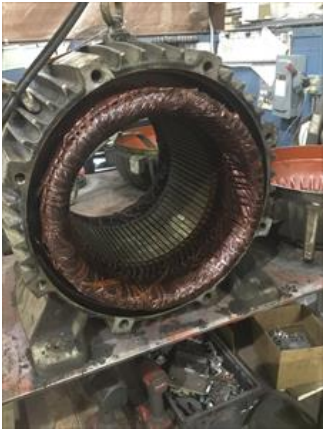
P106

32. Frame Condition

(P) Pass

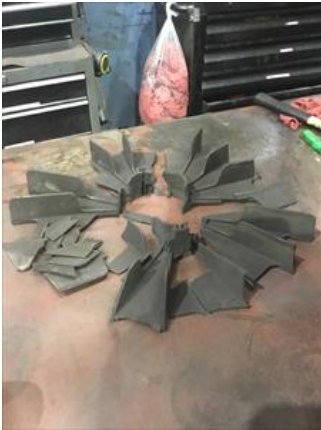
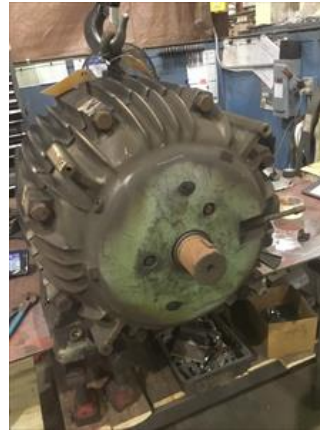
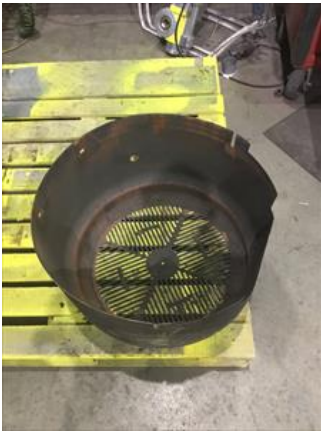
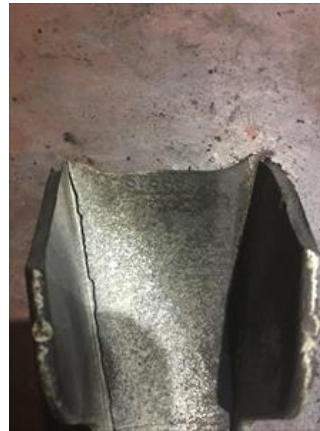
P109

33. Fan Condition
Destroyed! Fan # 375880

(F) Fail

66. Component Failure	Fan blade destroyed. Bearing grease contaminated.
67. Cause of Failure	
68. Comments	
69. Service Technician	Terrence Holland

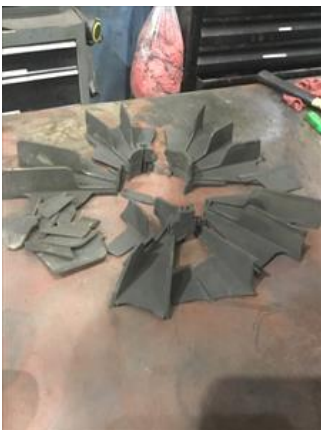
P113

34. Broken or missing components
Fan

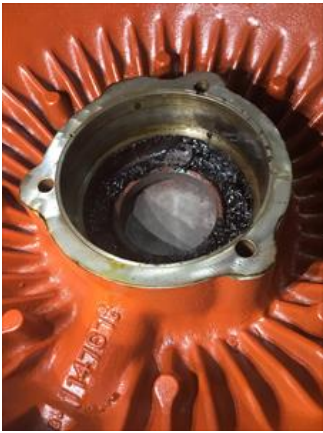
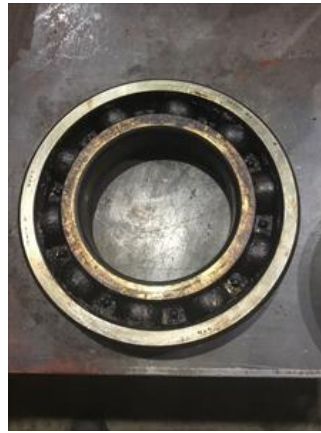
56. ODE Bearing Qty.	1	
57. Insulated Bearing	none	
58. Lubrication Type	grease	
<div> <div></div> <div>59. Grease Condition</div> </div> <div> <div></div> <div>Dirty and contaminated.</div> </div>	(F) Fail	P74

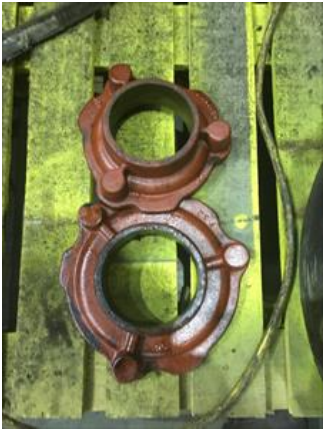
<input checked="" type="radio"/>	60. Bearing Retainers	(Y) Yes	P80
----------------------------------	-----------------------	---------	-----

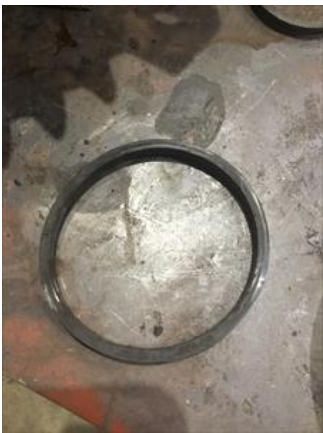
<input checked="" type="radio"/>	62. DE Seal	(Y) Yes	
----------------------------------	-------------	---------	--

63. DE Seal Type/Size	lip seal	P90
--	-----------------------	----------	-----

☐ Replace lip seal
