AC Recondition As Found

Almatis Inc/RCP Bauxite (10014)

Description: 12.5HP IMPERIAL ELECTRIC
1200/360RPM 326T

Hi-Speed Job Number: 100793

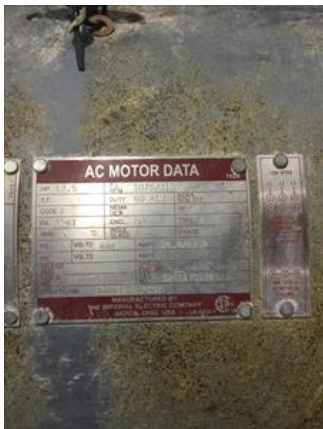
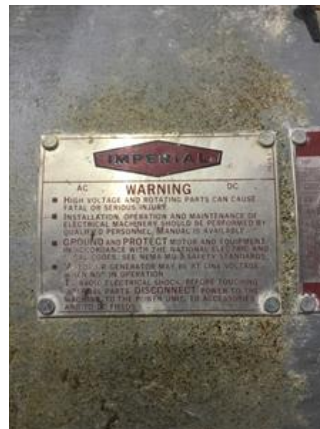
P37

- Report Date
- Nameplate Picture

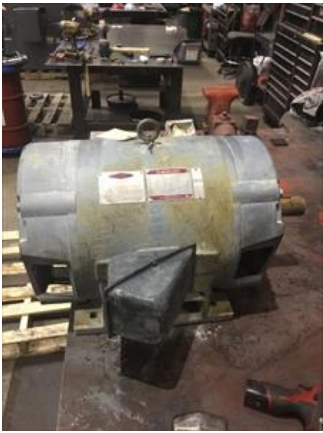
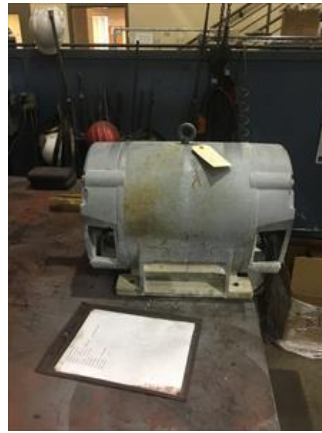
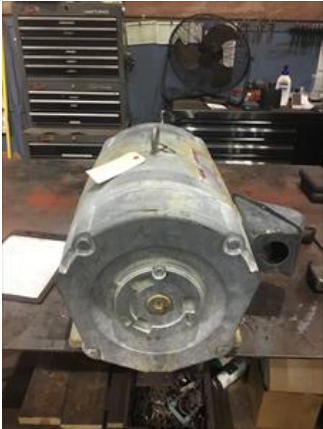
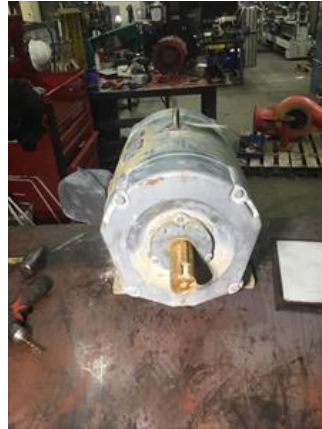
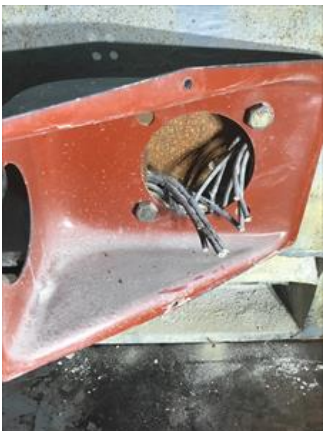
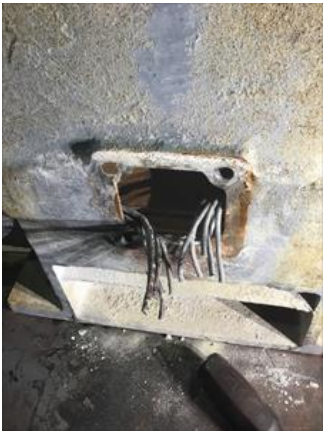
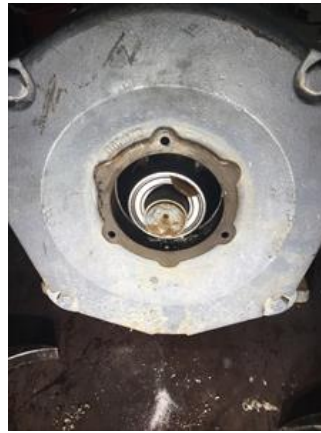
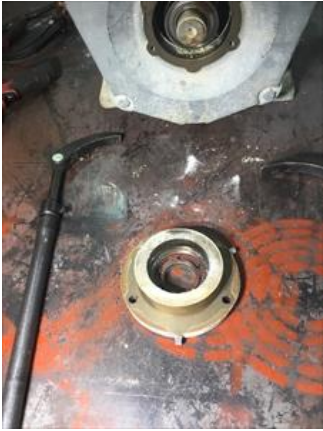
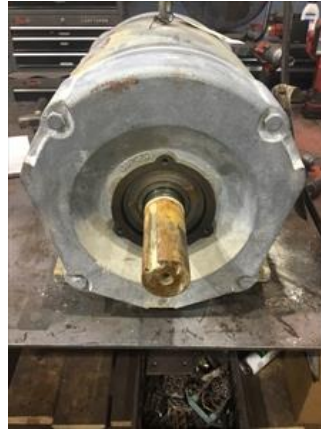
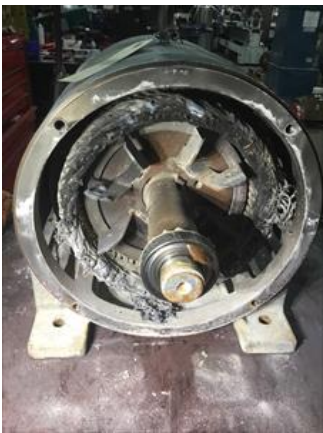
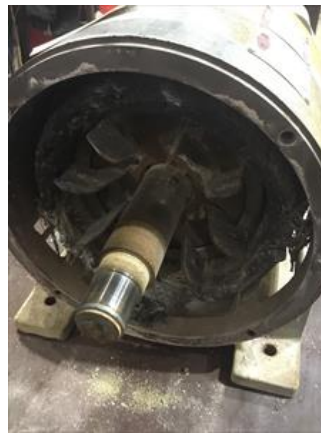
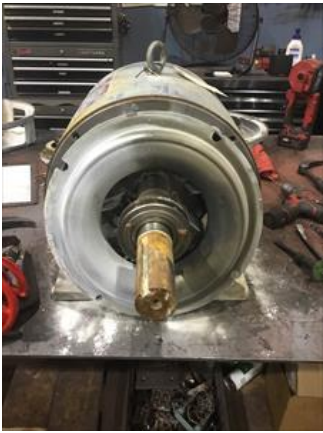
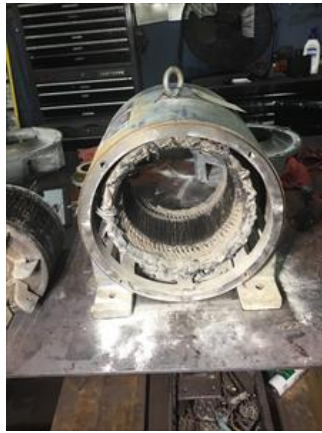
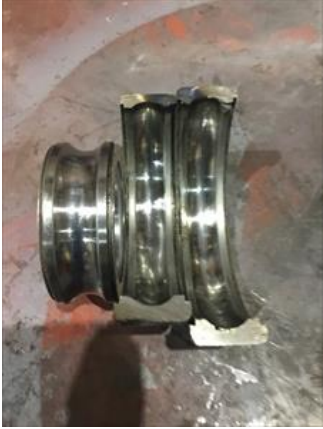
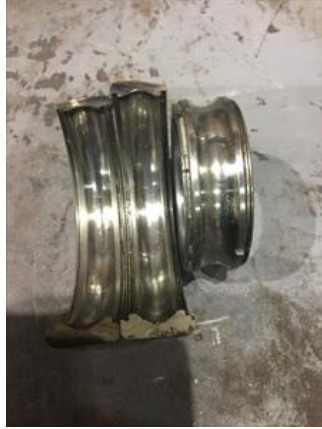
P45

- Photos of all six sides of the machine.

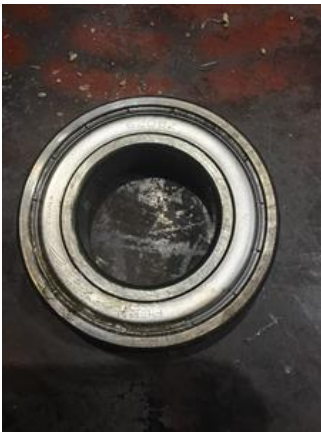
P81

27. Opposite Drive End Bearing Number-

6209Z

33. Opposite Drive End Bearing Condition

replace
