AC Recondition As Found

Kimberly Clark (10176-KCM)

AC Recondition - Rev. 2

Description: 50HP BALDOR 3600RPM 326T

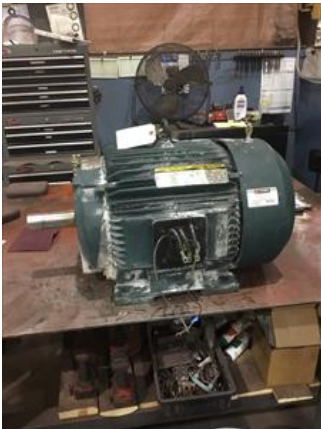
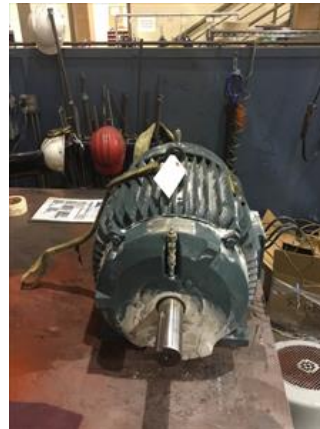
3. Photos of all six sides of the machine.

4. Describe the Overall Condition of the Equipment as Received
Serviceable

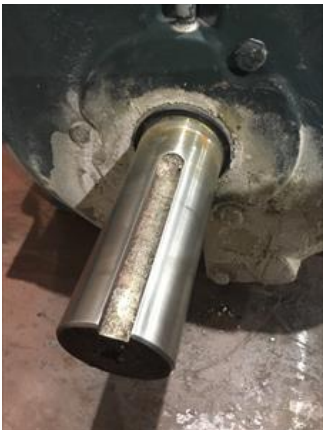
5. Does Shaft Turn Freely? (Yes) Yes
6. Does Shaft Have Visible Damage? (No) No P20

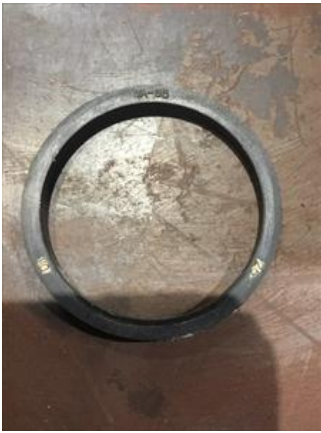
28.	Opposite Drive End Bearing Qty.	1	
29.	Opposite Drive End Bearing Type	(Ball) Ball Bearing	
30.	Opposite Drive End Lubrication Type	(Grease) Grease Lubricated	
31.	Opposite Drive End Bearing Insulation or Grounding Device?	none	
32.	Opposite Drive End Wavy Washer/Snap-Ring Other Retention Device?		
33.	Opposite Drive End Bearing Condition	replace	
34.	Drive End Seal	VA 55	P95

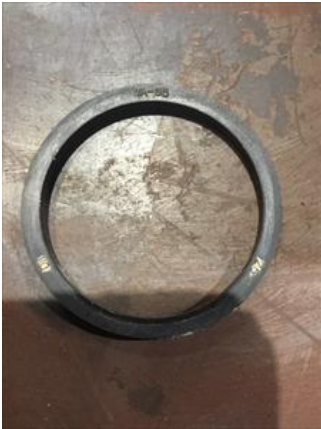
35. Opposite Drive End Seal

VA 55

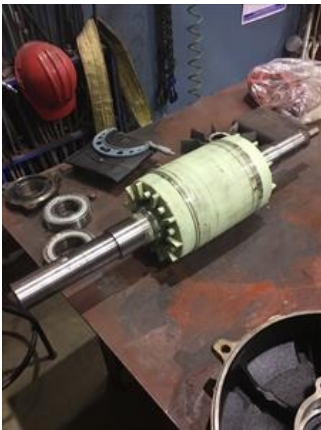
36. Rotor Type/Material

(Squirrel Aluminum) Squirrel
Cage Aluminum Die Cast

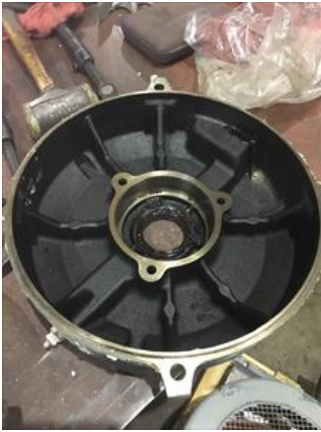
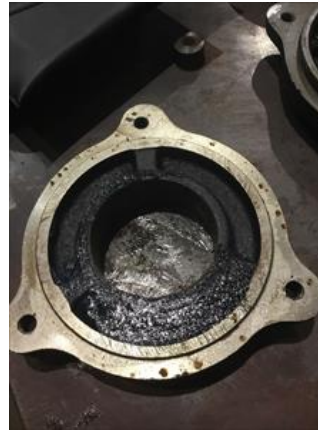
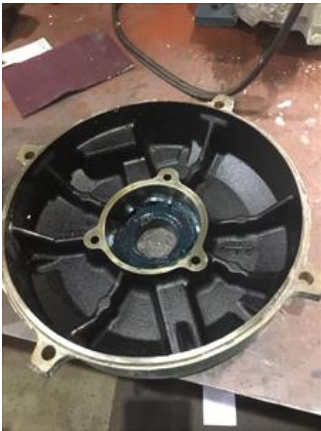
61. Final Balance Readings		
Drive End	Opposite Drive End	
62. Technician		
Rewind		
63. Core Test Results - Watts loss per Pound		
Pre-Burnout	Post Burnout	
64. Core Hot Spot Test		
Pre-Burnout	Post-Burnout	
65. Post Rewind Electrical Test- Insulation Resistance		
66. Post Rewind Polarization Index		
67. Post Rewind Winding Resistance		
1-2	1-3	2-3
68. Post Rewind Surge Test		
69. Post Rewind Hi-Pot		
70. Technician		
Root Cause of Failure		
71. Failure locations		
<i>Bearing wear</i>

Bearings frosted from dirty contaminated grease.

Replace bearings/recondition.
