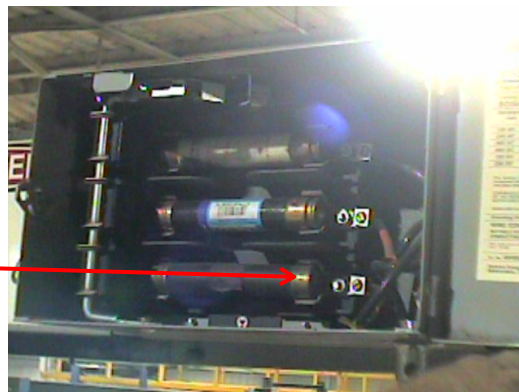
IR_1927.jpg S60 NTSC 21801575

Sp1	150.2 °F
Sp2	97.3 °F
Sp3	95.9 °F

Infrared data indicate that Phase C has a high resistance connection on the fuse clip. Replace fuses with matching fuses and clean and check fuse holder for looseness and damage.
