IR\_1917.jpg S60 NTSC 21801575

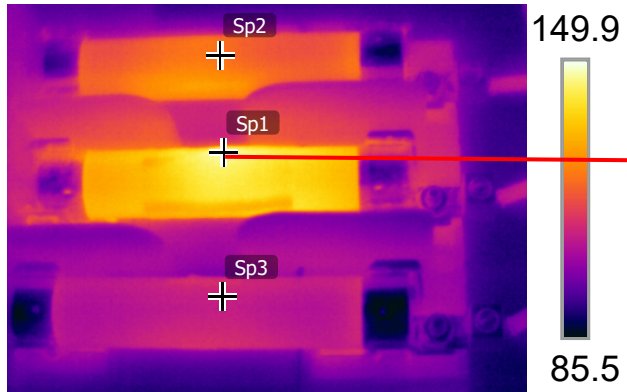
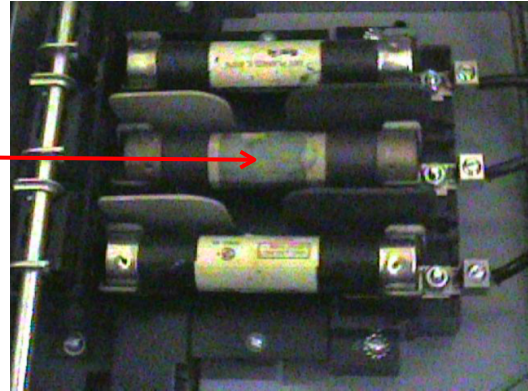
| Sp1 | 148.5 °F |
| Sp2 | 124.0 °F |
| Sp3 | 111.2 °F |

Phase B is operating 20\* higher than Phases A and C. Clean fuse clips and replace all 3 fuses.
