Hi-Speed Industrial Service 7030 Ryburn Dr Millington, Tn 38053 901-873-5300

AC Recondition As Found

Sage V Foods 5901 SLOAN DRIVE **LITTLE ROCK, AR 72206**

Description: 25HP BALDOR 1800RPM 284T

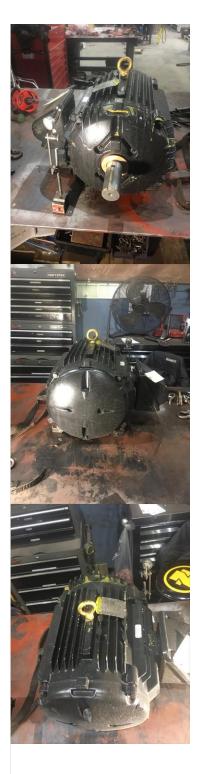
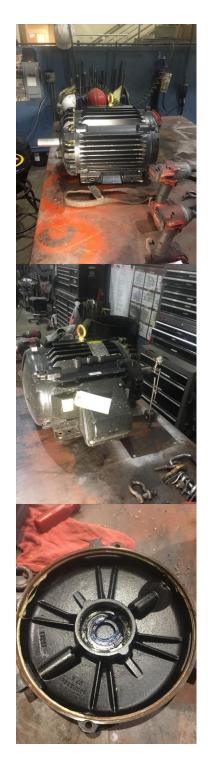
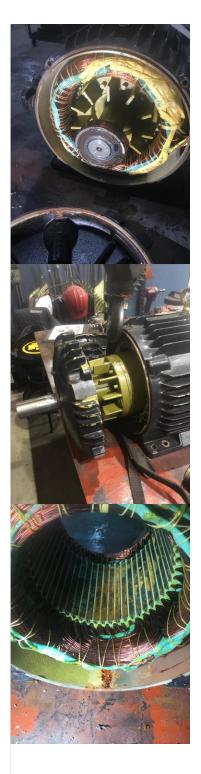
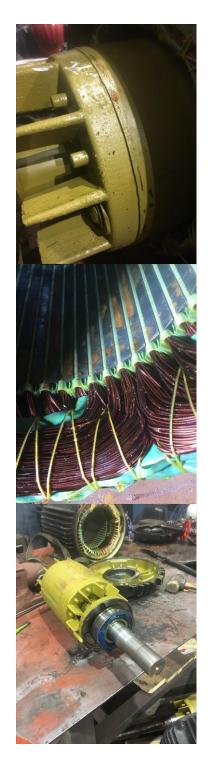
3. Photos of all six sides of the machine. P45

Describe the Overall Condition of the Equipment as Received

Serviceable **Initial Mechanical/Electrical**
