AC Recondition As Found

Georges Inc
1810 S. St. Louis Street
Batesville, AR 72501

AC Recondition - Rev. 2

Description: 40HP BALDOR 1800RPM 324TC

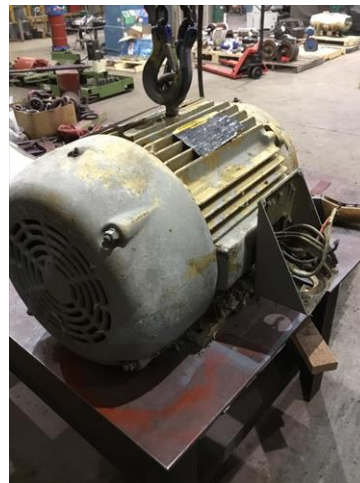
1. Report Date
2. Nameplate Picture

Manufacturer: Baldor

HP/kW: 40 (HP)

Frame: 324TC

Voltage: 230 / 460

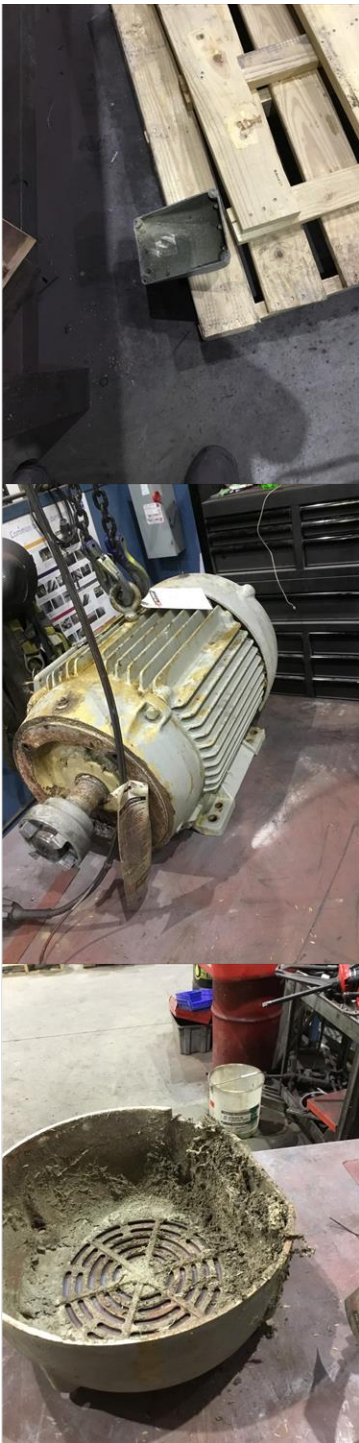
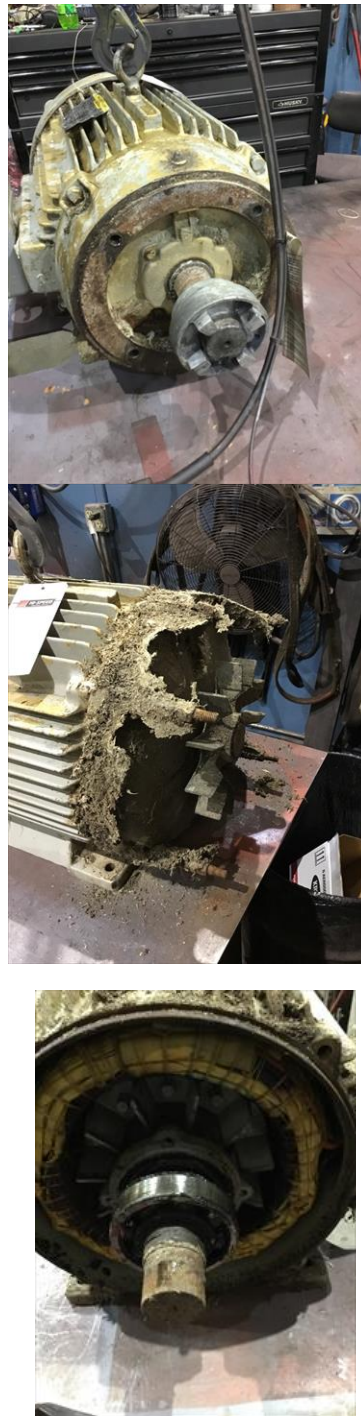
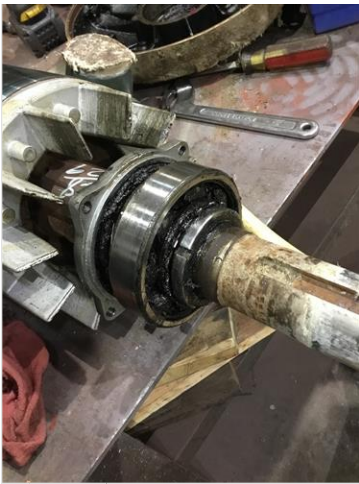
3. Photos of all six sides of the machine.
4. Describe the Overall Condition of the Equipment as Received

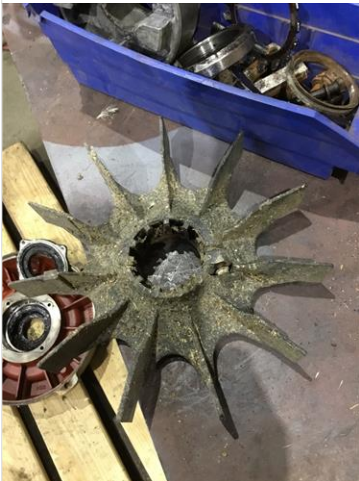
● 5.	Does Shaft Turn Freely?	(Yes) Yes	
6.	Does Shaft Have Visible Damage?	(No) No	
7.	Assembled Shaft Runout		
8.	Assembled Shaft End Play		
9.	Air Gap Variation <10%		
● 10.	Lead Condition	(P) Pass	
11.	Lead Length	12 Inches	
12.	Frame Condition	wash	
● 13.	Fan Condition	(P) Pass	P91

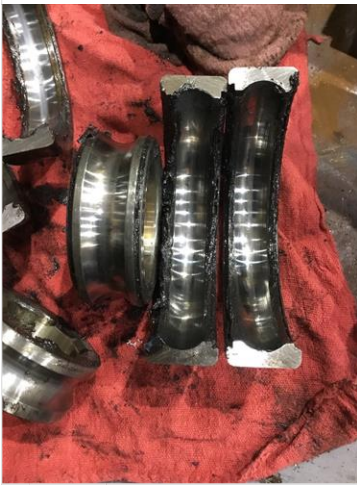
21. Drive End Bearing Number-

6312

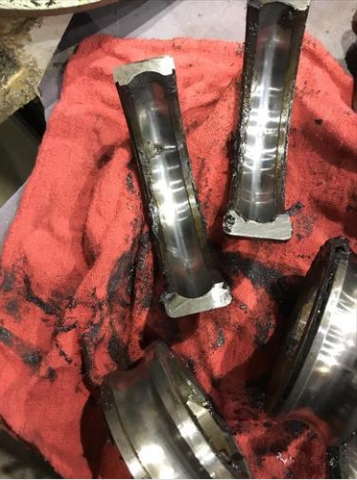
29. Opposite Drive End Bearing Number-	6311	P85

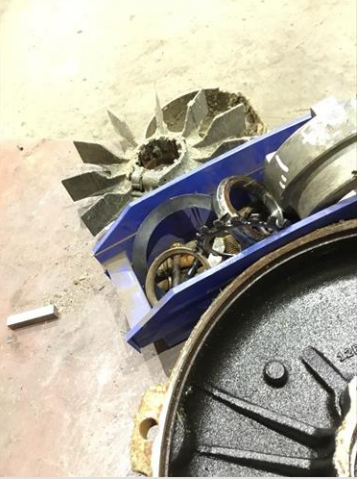
33. Opposite Drive End Bearing Insulation or Grounding Device?	na	
34. Opposite Drive End Wavy Washer/Snap-Ring Other Retention Device?	wavy washer	P95

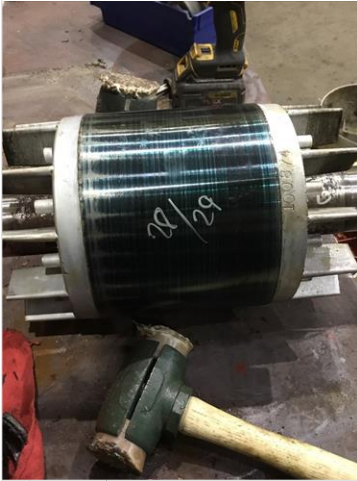
38. Rotor Type/Material

(Squirrel Aluminum) Squirrel
Cage Aluminum Die Cast

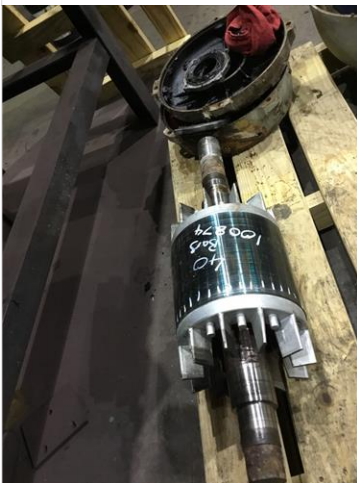
41. Rotor Condition

dirty

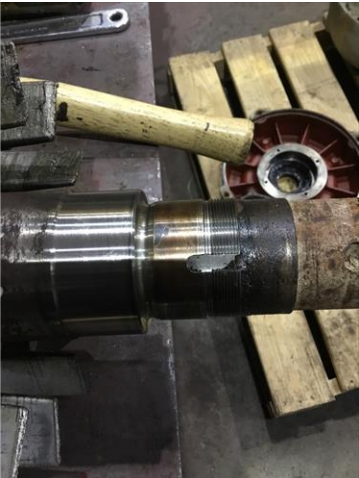
47.	Coupling Fit Closest to the end of the Shaft				
	0 Degrees	60 Degrees	120 Degrees		
48.	Drive End Bearing Shaft Fit				
	0 Degrees	60 Degrees	120 Degrees		
	2.3624	2.3624	2.3624		
49.	Drive End Bearing Shaft Fit Condition			(P) Pass	P75

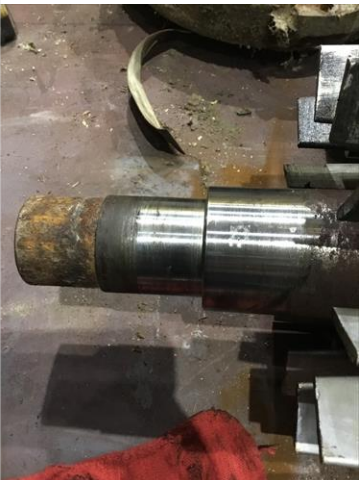
50.	Opposite Drive End Bearing Shaft Fit				
	0 Degrees	60 Degrees	120 Degrees		
	2.1655	2.1655	2.1655		
51.	Opposite Drive End Bearing Shaft Fit Condition			(P) Pass	P83

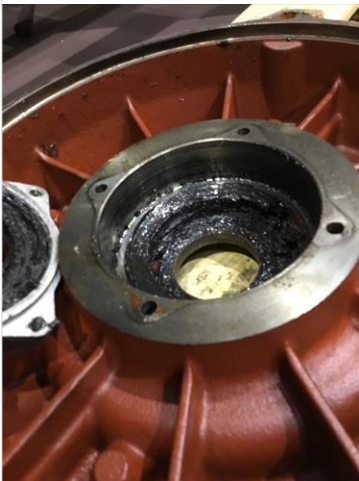
53.	Drive End - Endbell Bearing Fit			P2
	0 Degrees	60 Degrees	120 Degrees	
	5.1183	5.1183	5.1183

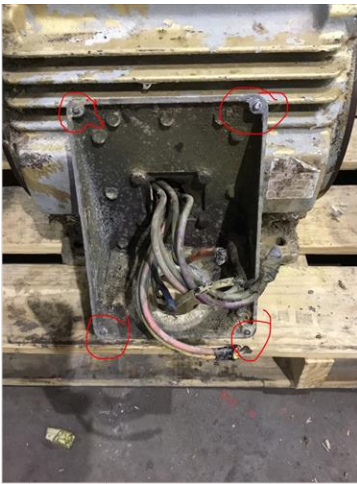
56.	Opposite Drive End - Endbell Bearing Fit Condition			(P) Pass
57.	Bearing Cap Condition			
	Drive End Bearing Cap	Opposite Drive End Bearing Cap		
	pass	pass		
58.	End Bell Air Seal Fits			
	Drive End Air Seal	Opposite Drive End Air Seal		
59.	List Machine Work Needed Below			P64
	Broke bolts in electrical box

Noisy bearings and bad connection electrical box
