AC Recondition As Found
SWEET HOME, HIGGINS & RED OAK
PO BOX 281
SWEET HOME, AR 72164

AC Recondition - Rev. 2

Location: MOTOR SHOP LR
Serial Number: 127.185-0859 248
Description: 11HP FLYGT SUBMERSIBLE PUMP

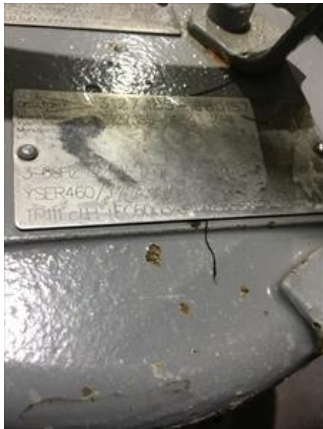
P37

1. Report Date
2. Nameplate Picture

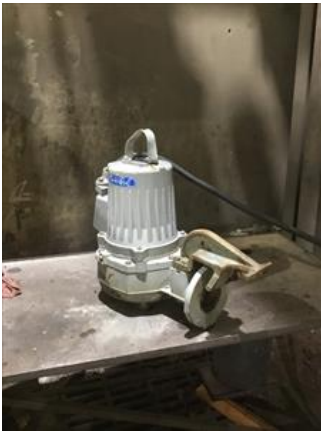
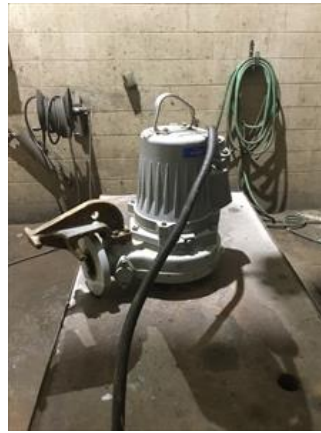
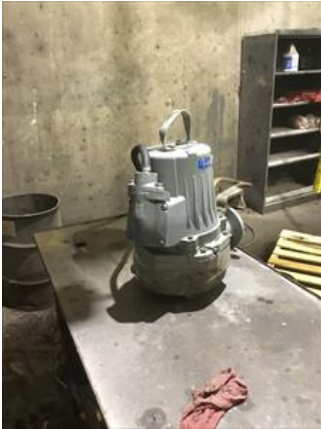
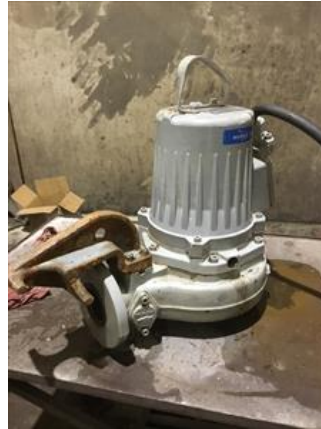
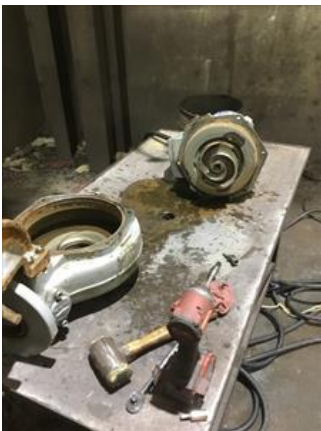
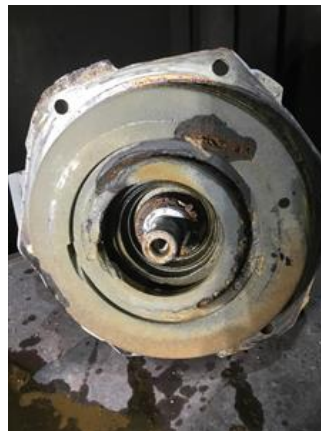
P44

3. Photos of all six sides of the machine.

4. Describe the Overall Condition of the Equipment as Received
Serviceable

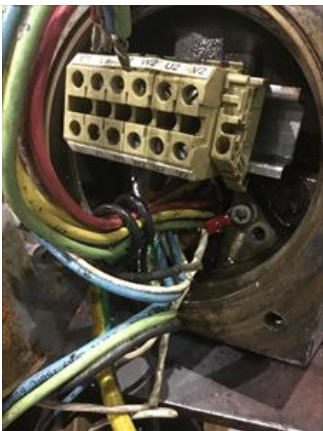
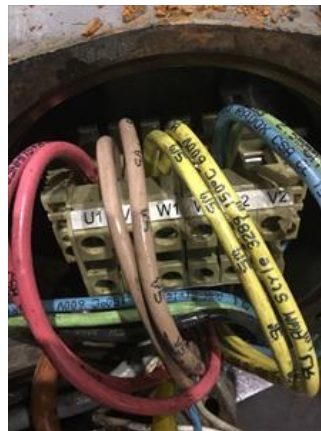
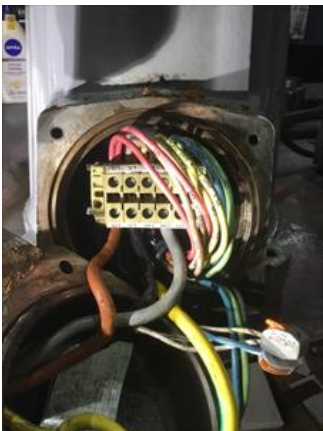
P53

- 6. Does Shaft Turn Freely?
- 7. Does Shaft Have Visible Damage?
- 8. Assembled Shaft Runout
- 9. Assembled Shaft End Play
- 10. Air Gap Variation <10%
- 11. Lead Condition

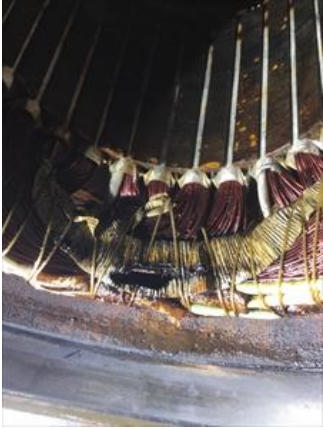
16.	Insulation Resistance/Megger	Megohms	
17.	Winding Resistance		
	1-2	1-3	2-3
18.	Perform Surge Test	(NA) Not Applicable	
19.	Number of Stator Slots		
20.	Stator Condition	rewind	P70

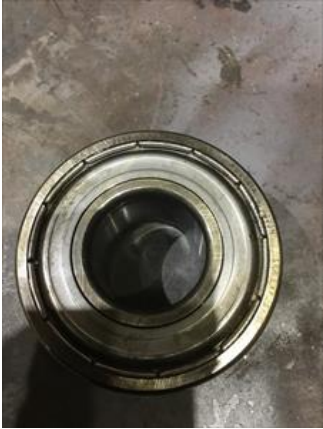
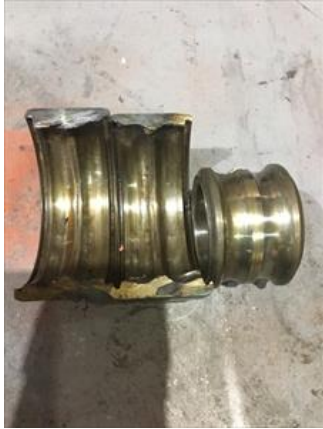
21.	Drive End Bearing Brand	Skf	
22.	Drive End Bearing Number-	3307 A-2Z TN9/C3	P33

23.	Drive End Bearing Qty.	1	
24.	Drive End Bearing Type	(Ball) Ball Bearing	
	<i>Double wide double row.</i>		
25.	Drive End Lubrication Type	(Oil) Oil Lubricated	
26.	Drive End Bearing Insulation or Grounding Device?	none	
27.	Drive End Wavy Washer/Snap-Ring Other Retention Device?	bearing cap	
28.	Drive End Bearing Condition	worn	
29.	Opposite Drive End Bearing Brand	Fag

40. Growler Test	
41. Number of Rotor Bars	
42. Rotor Condition	pass
43. List the Parts needed for the Repair Below <i>Seal kit/o ring kit. Bearings: 3307 & 6207 2Z</i>	
44. Signature of Technician that Disassembled Motor	Terrence Holland

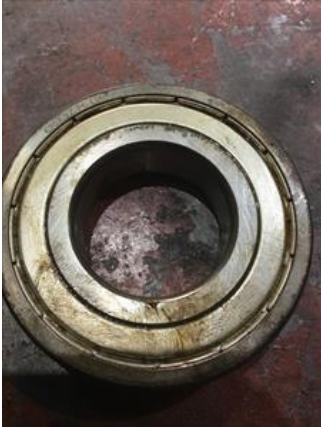
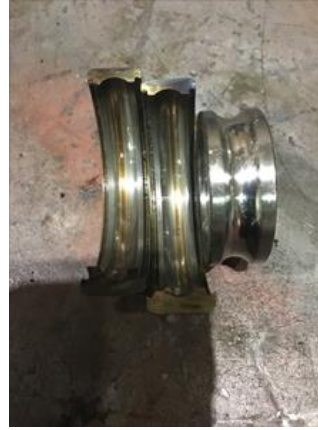
31. Opposite Drive End Bearing Qty.	1
32. Opposite Drive End Bearing Type	(Ball) Ball Bearing
33. Opposite Drive End Lubrication Type	(Oil) Oil Lubricated
34. Opposite Drive End Bearing Insulation or Grounding Device?	
35. Opposite Drive End Wavy Washer/Snap-Ring Other Retention Device?	none
36. Opposite Drive End Bearing Condition	worn
37. Drive End Seal	replace
38. Opposite Drive End Seal

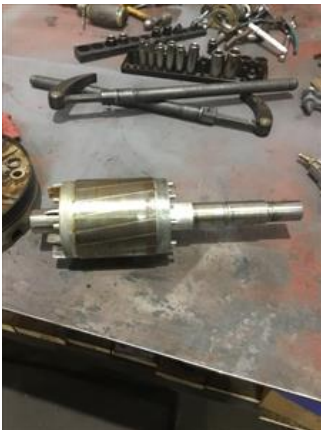
P3

39. Rotor Type/Material	(Squirrel Aluminum) Squirrel Cage Aluminum Die Cast
-------------------------	--
