AC Recondition As Found

Bryce Corporation (10053-BRC)

AC Recondition - Rev. 2

Description: 125HP WEG 3600RPM 444/5TS

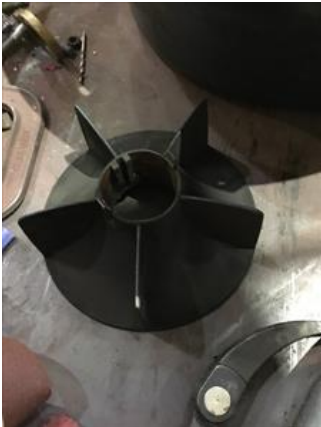
5.	Does Shaft Turn Freely?	(No) No	
6.	Does Shaft Have Visible Damage?	(Yes) Yes	
7.	Assembled Shaft Runout		
8.	Assembled Shaft End Play		
9.	Air Gap Variation <10%		
10.	Lead Condition	(P) Pass	
11.	Lead Length	18 Inches	
12.	Frame Condition	pass	
13.	Fan Condition	(P) Pass	P91

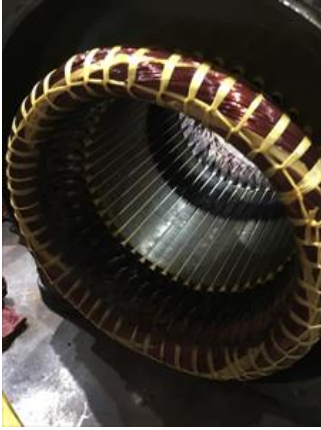
15.	Insulation Resistance/Megger	0 Megohms	
16.	Winding Resistance		
	1-2	1-3	2-3
17.	Perform Surge Test	(F) Fail	
18.	Number of Stator Slots

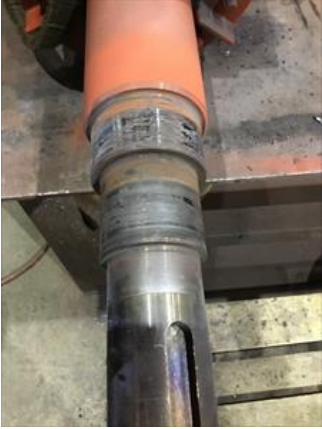
48.	Drive End Bearing Shaft Fit			
		0 Degrees	60 Degrees	120 Degrees
49.	Drive End Bearing Shaft Fit Condition			(F) Fail
	Inner race spoon on shaft			P75

*Machined new shaft*

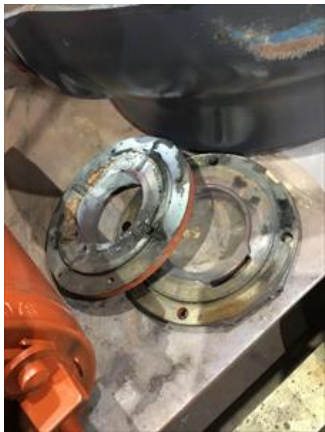
Drive end

Drive End Bearing Cap
repair both caps

New shaft both end bells need resleeved de bearing caps need repaired.ode bearing cap cracked

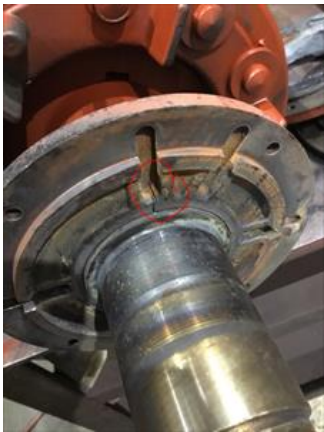
Opposite Drive End Bearing Cap
repair inside cap cracked

ODE CRACK

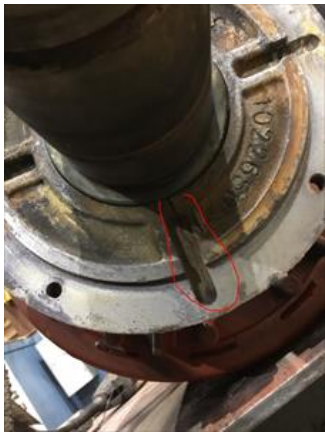
ODE CRACK

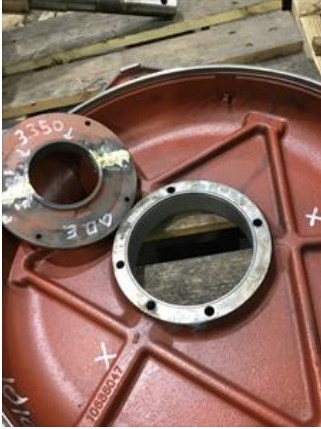
84. Opposite Drive End - Endbell Bearing Fit Post Repair

5.906
