## AC Recondition As Found

### Sage V Foods

#### AC Recondition - Rev. 2

Description: 25HP BALDOR 1800RPM 284T

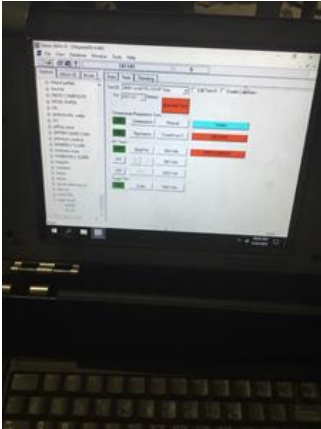
17.	Perform Surge Test	(F) Fail	P57

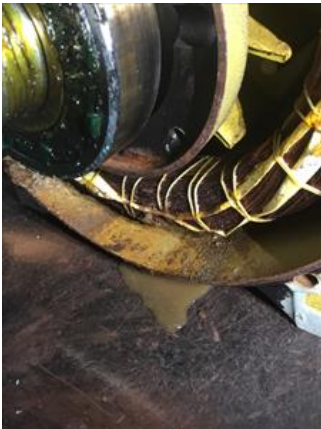
18.	Number of Stator Slots			
19.	Stator Condition	water logged		P68

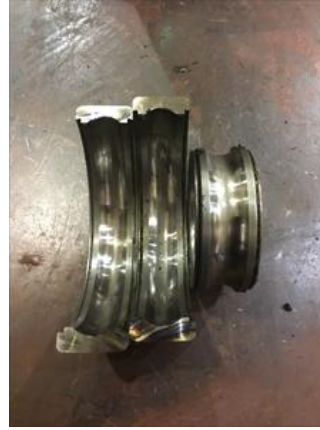
20.	Drive End Bearing Brand	fag

6311 2rs

27. Drive End Bearing Condition

replace

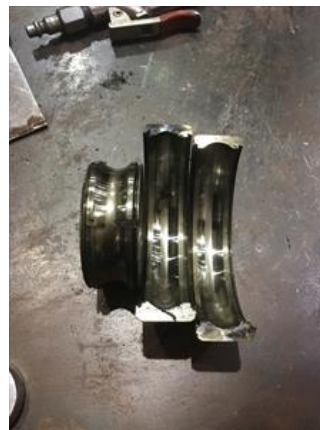
28. Opposite Drive End Bearing Brand

nachi

29. Opposite Drive End Bearing Number-

6309

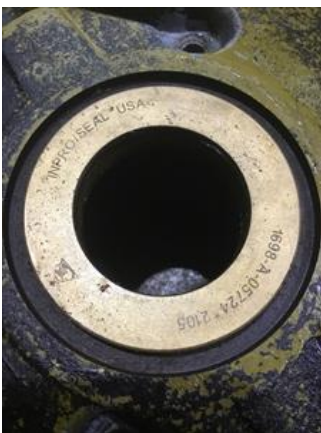
35. Opposite Drive End Bearing Condition	replace	
36. Drive End Seal	in pro	P98

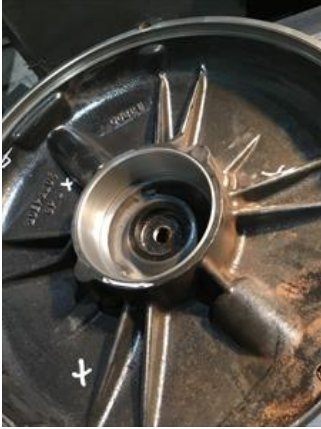
## 84. Opposite Drive End - Endbell Bearing Fit Post Repair

3.9376
