## AC Recondition As Found

### AC Recondition - Rev. 2

Description: 20HP US MOTORS 3600RPM 254T

Hi-Speed Job Number: 101123

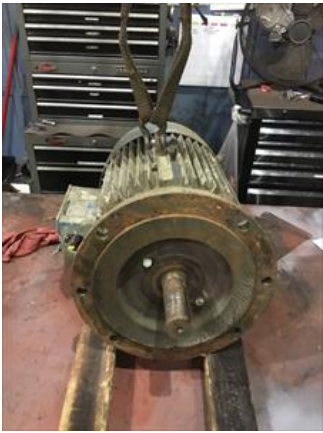
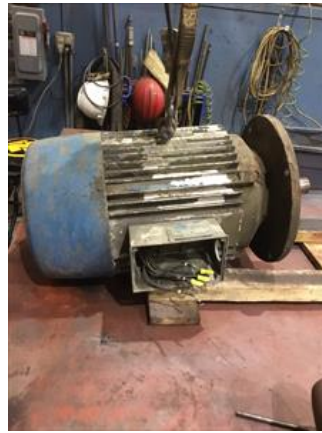
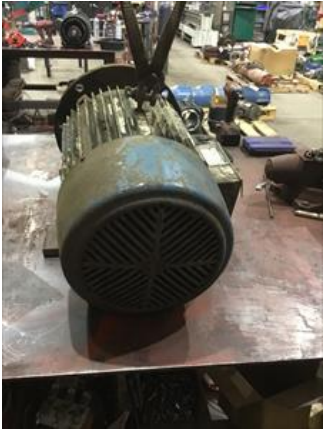
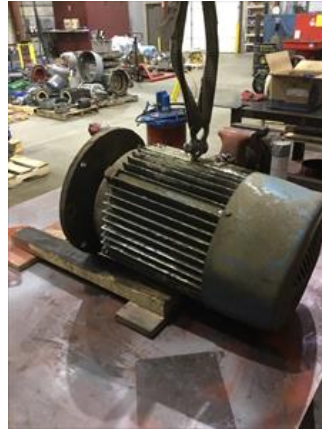
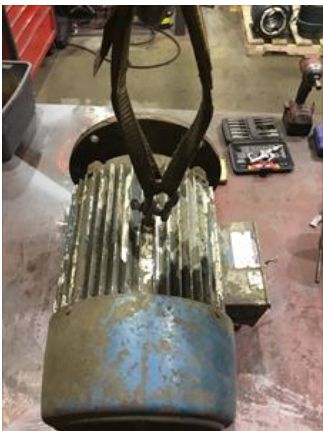
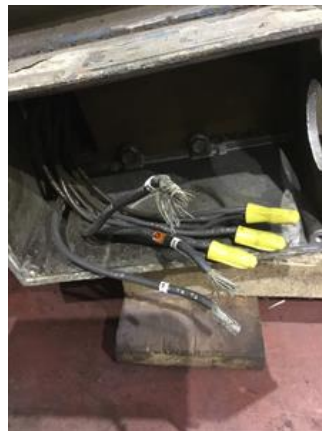
3. Photos of all six sides of the machine.

4. Describe the Overall Condition of the Equipment as Received  
*Serviceable*

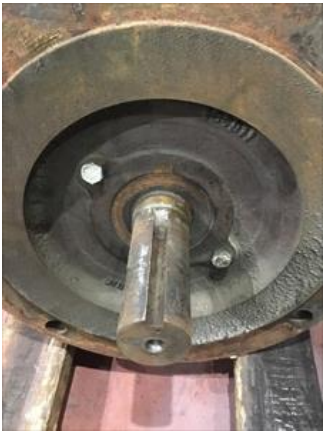
| 6. Does Shaft Have Visible Damage? | (No) No | P18 |

| 7. Assembled Shaft Runout | 0.015 Inches | |

*Repair bent shaft*

58. End Bell Air Seal Fits	Drive End Air Seal	Opposite Drive End Air Seal	
59. List Machine Work Needed Below	Repair bent d.e shaft extension. Re-sleeve both end bell housing fits.

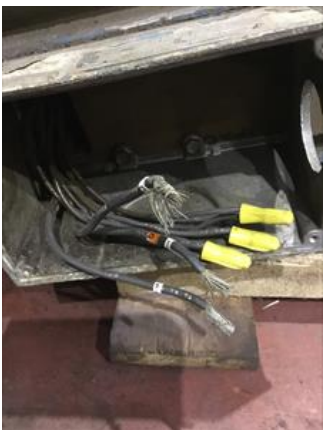
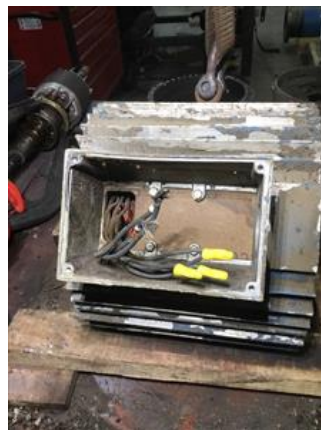
| 10. Lead Condition | (P) Pass | P54 |

| 11. Lead Length | 8 Inches |

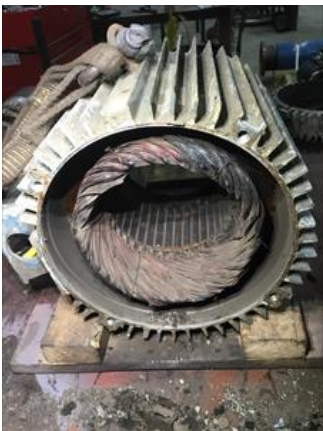
17. Perform Surge Test (F) Fail

19. Stator Condition rewind. P68

70.	Post Rewind Surge Test		
71.	Post Rewind Hi-Pot		
72.	Technician		
Root Cause of Failure			
73.	Failure locations		
	Winding coil shorted. D.E bearing cage failure.

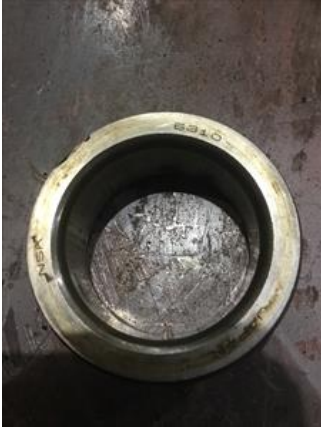
20. Drive End Bearing Brand nsk

21. Drive End Bearing Number-

6310

27. Drive End Bearing Condition

worn

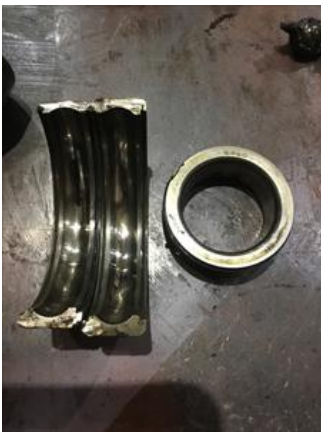
23. Drive End Bearing Type

(Ball) Ball Bearing

26. Drive End Wavy Washer/Snap-Ring Other Retention Device?

snap ring

Needs replacing

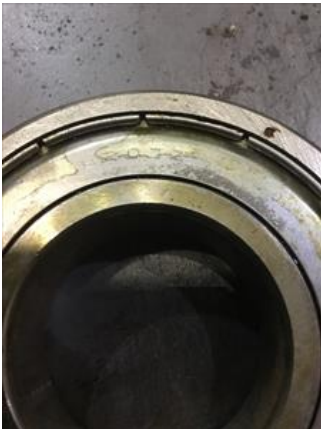
28. Opposite Drive End Bearing Brand

nachi

29. Opposite Drive End Bearing Number-

6207

35. Opposite Drive End Bearing Condition

worn

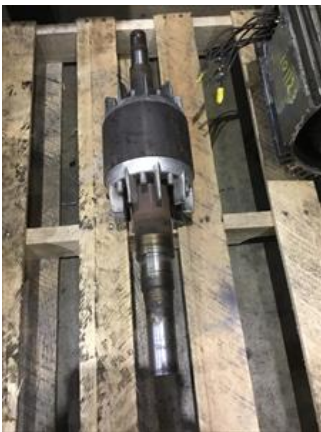
38. Rotor Type/Material

(Squirrel Aluminum) Squirrel  
Cage Aluminum Die Cast

(Pass) Pass

pass
