AC Inspection as Found

Sage V Foods

AC Inspection - Rev. 2

Description: 25HP BALDOR 1800RPM 284T

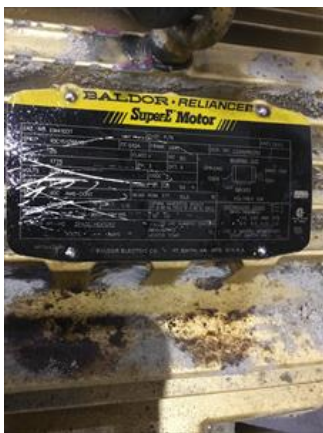
2. Nameplate Picture

Manufacturer: Baldor

Product Number: EM4103T

HP/kW: 25 (HP)

RPM: 1775 (RPM)

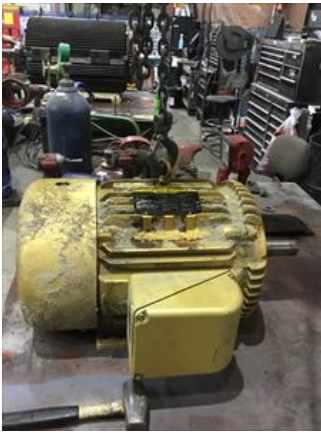
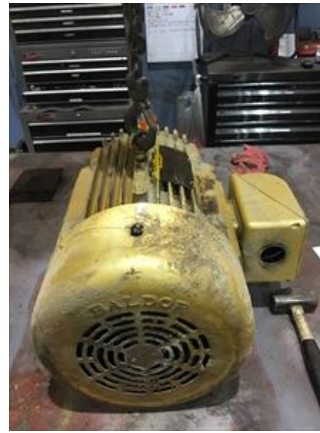
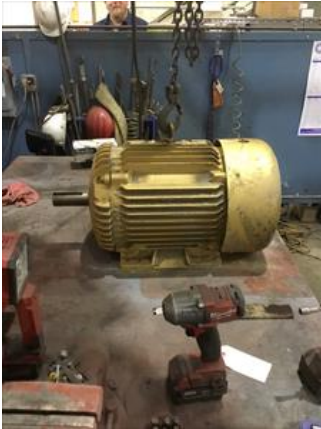
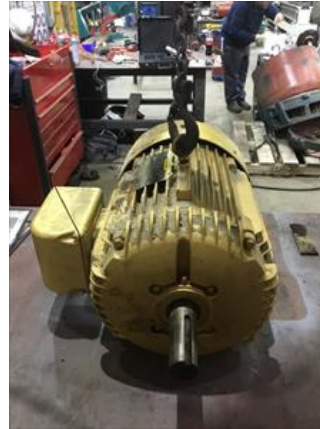
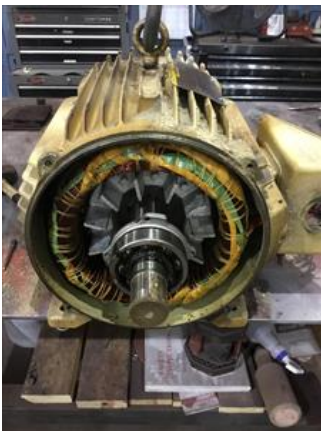
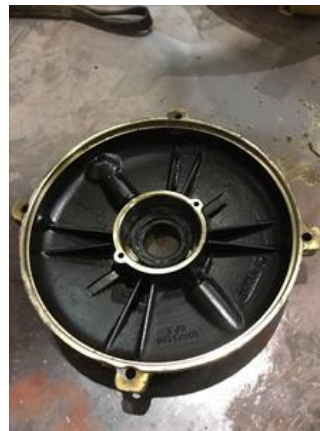
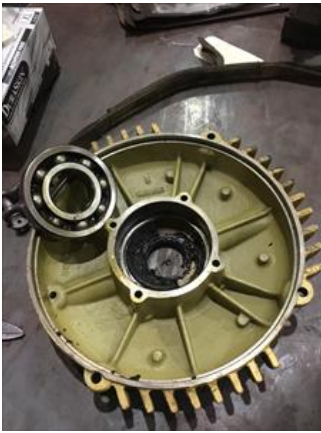
3. Photos of all six sides of the machine.

4. Describe the Overall Condition of the Equipment as Received
Serviceable

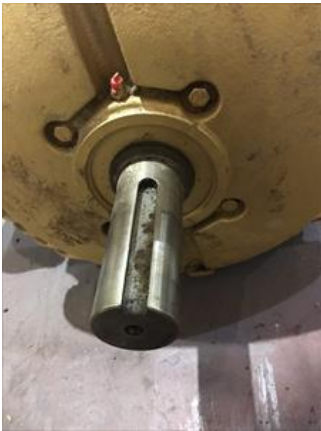
5. Does Shaft Turn Freely? (Yes) Yes
6. Does Shaft Have Visible Damage? (No) No P18

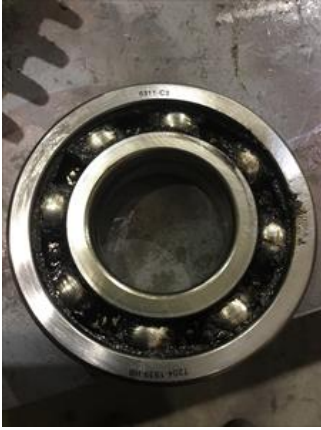
22. Drive End Bearing Qty.	1
23. Drive End Bearing Type	(Ball) Ball Bearing
24. Drive End Lubrication Type	(Grease) Grease Lubricated
25. Drive End Bearing Insulation or Grounding Device?	none
26. Drive End Wavy Washer/Snap-Ring Other Retention Device?	none
27. Drive End Bearing Condition	replace
28. Opposite Drive End Bearing Brand	Fag
29. Opposite Drive End Bearing Number-

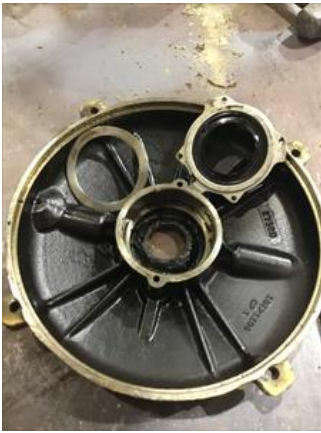
| 35. Opposite Drive End Bearing Condition | replace |
| 36. Drive End Seal | dust seal |

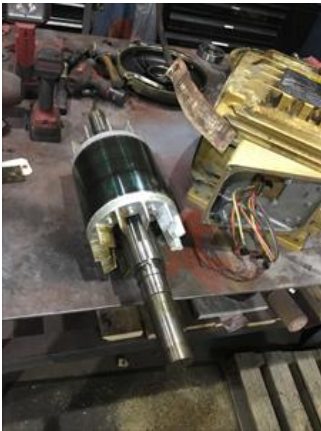
38. Rotor Type/Material

| 39. Growler Test | (Pass) Pass |
| 41. Rotor Condition | pass |

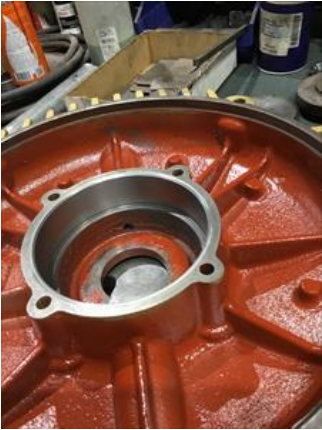
4.7257	4.7256	
54.	Drive End - Endbell Bearing Fit Condition (F) Fail		
55.	Opposite Drive End - Endbell Bearing Fit		
	0 Degrees	60 Degrees	120 Degrees
	3.9377	3.9378	3.9378

58.	End Bell Air Seal Fits		
	Drive End Air Seal	Opposite Drive End Air Seal	
59.	List Machine Work Needed Below <i>D.E. housing fit measures too large.</i>

83.	Drive End - Endbell Bearing Fit Post Repair		
	0 Degrees	60 Degrees	120 Degrees

4.7246	4.7246	4.7246

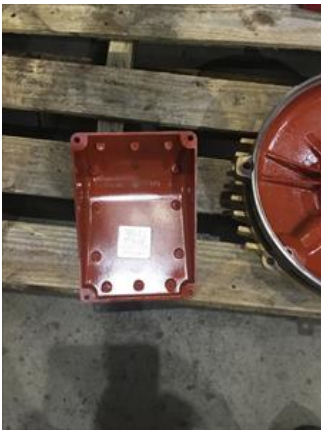
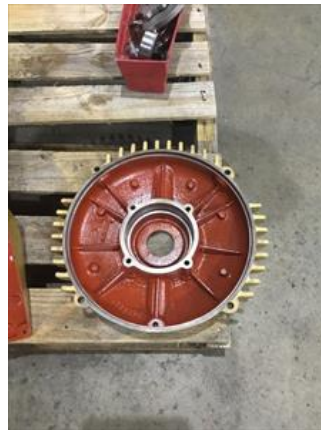
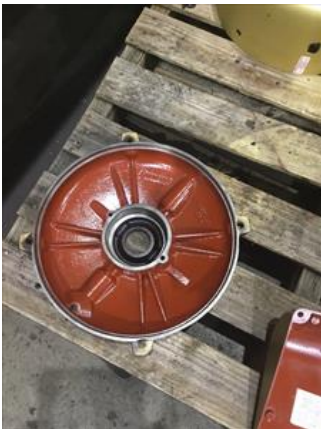
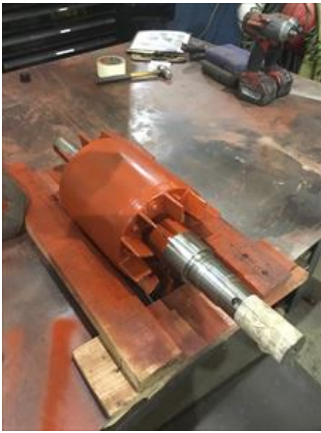
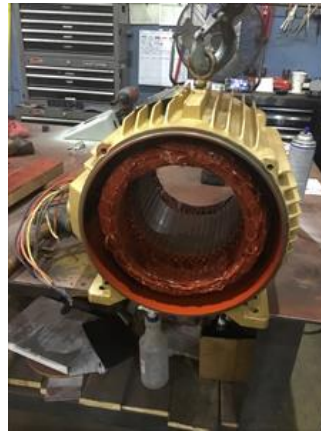
90.	Final Insulation Resistance Test		
91.	Assembled Shaft Endplay		
92.	Assembled Shaft Runout		
93.	Test Run Voltage		
	Volts	Volts	Volts
94.	Test Run Amperage		
	Amps	Amps	Amps
95.	Drive End Vibration Readings - Inches Per Second		
	Horizontal	Vertical	Axial
96.	Opposite Drive End Vibration Readings - Inches Per Second		
	Horizontal	Vertical	Axial
97.	Ambient Temperature - Fahrenheit		
98.	Drive End Bearing Temps - Fahrenheit		
	5 Minutes	10 Minutes	15 Minutes
99.	Opposite Drive End Bearing Temps - Fahrenheit		
	5 Minutes	10 Minutes	15 Minutes
100.	Document Final Condition with Pictures after paint
