## AC Inspection as Found

Arauco-Malvern MDF (10298)

### AC Inspection - Rev. 2

Description: 150HP SIEMENS 900RPM 447T

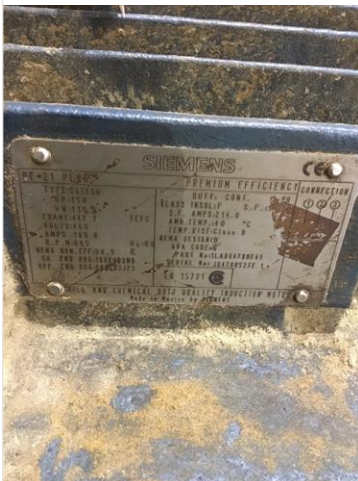
P37

2. Nameplate Picture

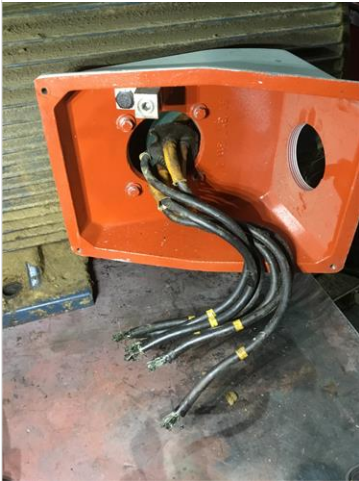
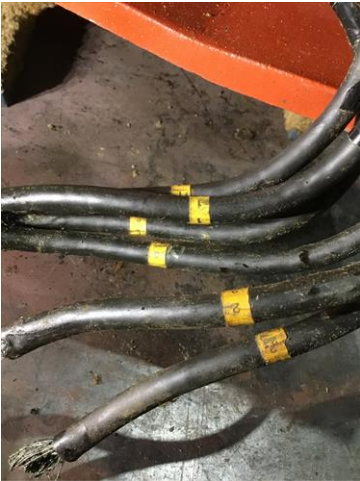
Initial Mechanical/Electrical		
5. Does Shaft Turn Freely?	(Yes) Yes	
6. Does Shaft Have Visible Damage?	(No) No	
7. Assembled Shaft Runout	0.002 Inches	
8. Assembled Shaft End Play		
9. Air Gap Variation <10%		
10. Lead Condition	(P) Pass	P54

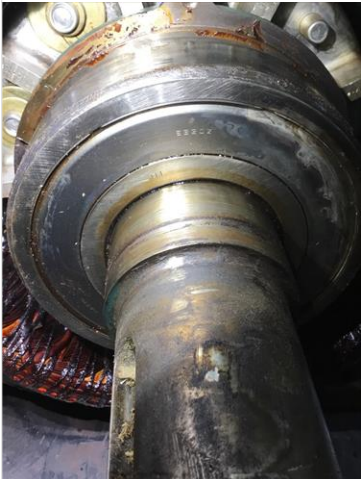
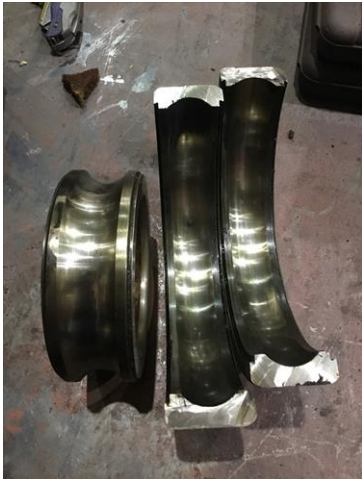
20. Drive End Bearing Brand		Nachi	
21. Drive End Bearing Number-		6320 Z	P32

22. Drive End Bearing Qty.		1	
23. Drive End Bearing Type		(Ball) Ball Bearing	
24. Drive End Lubrication Type		(Grease) Grease Lubricated	
25. Drive End Bearing Insulation or Grounding Device?		none	
26. Drive End Wavy Washer/Snap-Ring Other Retention Device?		none	
27. Drive End Bearing Condition		replace	
28. Opposite Drive End Bearing Brand		ORS

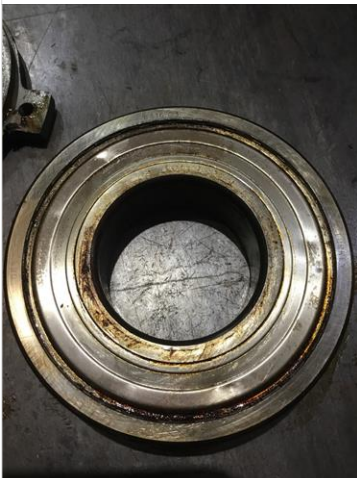
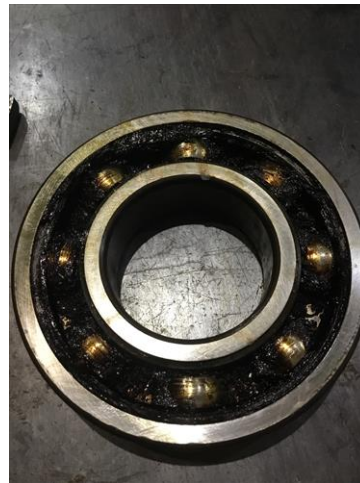
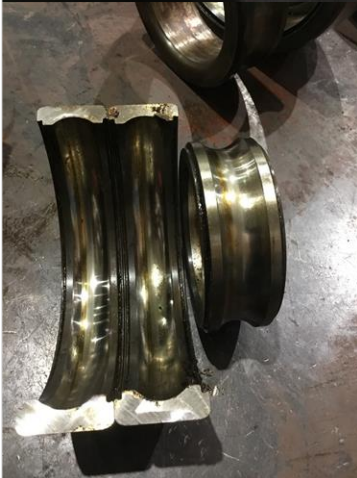
P90

35. Opposite Drive End Bearing Condition

replace

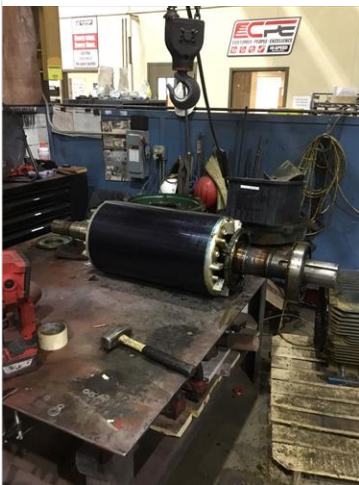
P3

(Squirrel Aluminum) Squirrel  
Cage Aluminum Die Cast

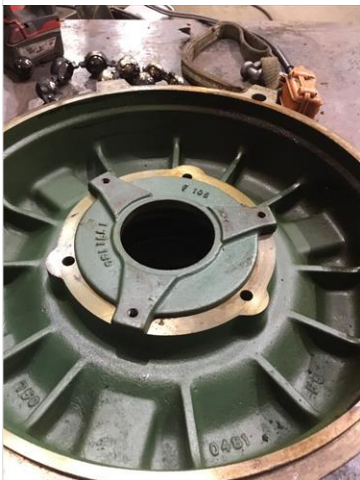
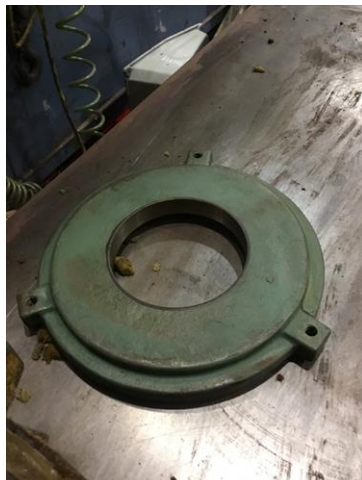
8.466200000000001	8.4664	8.4663
54.	Drive End - Endbell Bearing Fit Condition		(F) Fail
55.	Opposite Drive End - Endbell Bearing Fit		
	0 Degrees	60 Degrees	120 Degrees

6.694	6.6941	6.694
56.	Opposite Drive End - Endbell Bearing Fit Condition		(F) Fail
57.	Bearing Cap Condition		
	Drive End Bearing Cap	Opposite Drive End Bearing Cap	
	pass	pass	
<div>

58.	End Bell Air Seal Fits		
	Drive End Air Seal	Opposite Drive End Air Seal	
59.	List Machine Work Needed Below		
	Sleeve both end bell housings.

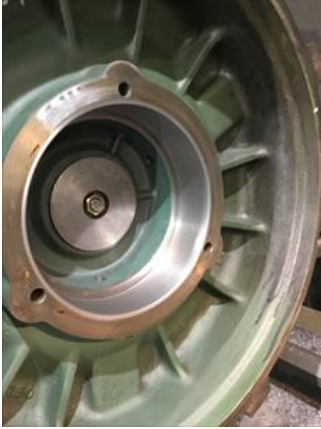
P20

## 84. Opposite Drive End - Endbell Bearing Fit Post Repair

6.6932

6.6933
