AC Inspection as Found
MKT FASTENING LLC
1 GUNNEBO DR
LONOKE, AR 72086

AC Inspection - Rev. 2

Hi-Speed Job Number: 99584
Manufacturer: Baldor
Product Number: 35E110-74
Serial Number: F494
HP/kW: 1 (HP)
RPM: 1725 (RPM)
Voltage: 220-240
Current: 6.6
Phase: Single
Hz: 60 (Hz)
Enclosure: DP
Date Received: 03/30/2022
Repair Stage: Teardown Inspection
Rewind: No
Shaft Machined Fit Repairs No
Required:

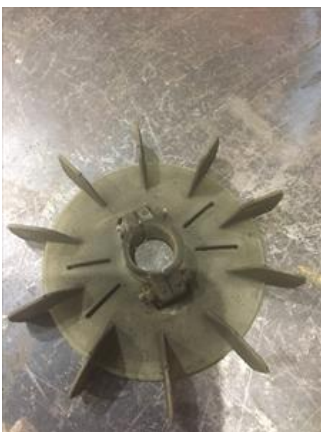
6.	Does Shaft Turn Freely?	(Yes) Yes	
7.	Does Shaft Have Visible Damage?	(No) No	
8.	Assembled Shaft Runout	Inches	
9.	Assembled Shaft End Play		
10.	Air Gap Variation <10%		
11.	Lead Condition	(P) Pass	
12.	Lead Length	8 Inches	
13.	Stator Temperature Detector Rating and Function		
	Quantity	Rating	Quantity Passed
14.	Bearing Temperature Detector Rating and Function		
	Quantity	Rating	Quantity Passed
15.	Frame Condition	pass	
16.	Fan Condition	(P) Pass	P68

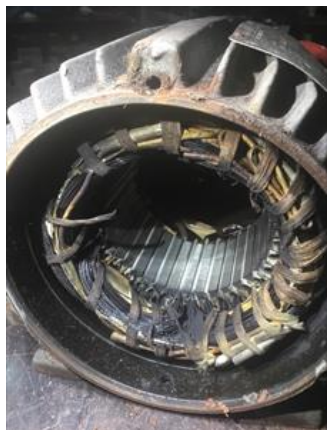
21. Perform Surge Test (F) Fail

Attached brake assembly tested good.

23. Stator Condition

rewind

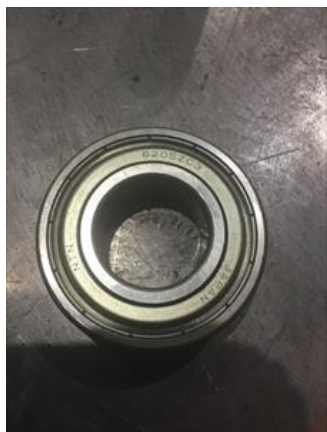
26. Drive End Bearing Brand

ntn

27. Drive End Bearing Number-

33. Drive End Bearing Condition

replace

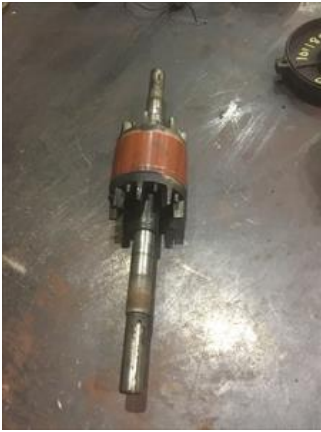
53. Growler Test (Pass) Pass

55. Rotor Condition pass

68. Drive End - Endbell Bearing Fit Condition (F) Fail

D.E housing fit bad.

56. List the Parts needed for the Repair Below
205 sleeve for D.E housing fit
