AC Inspection as Found

Sage V Foods

AC Inspection - Rev. 2

Description: 50HP BALDOR

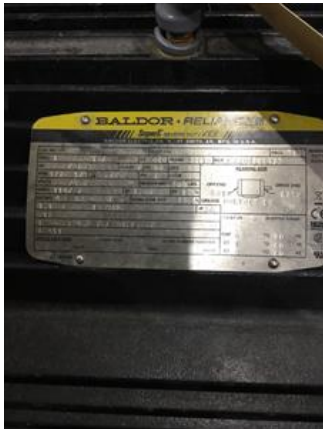
P37

2. Nameplate Picture

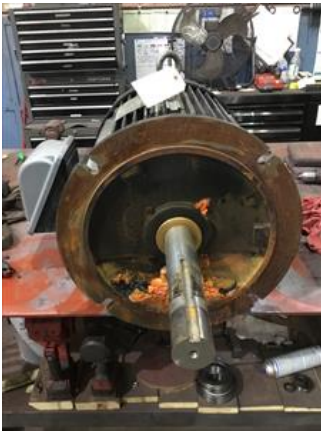
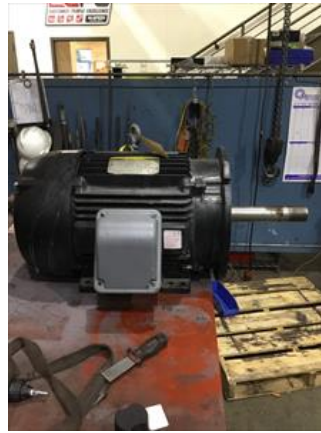
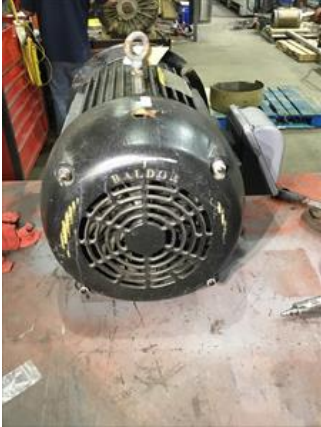
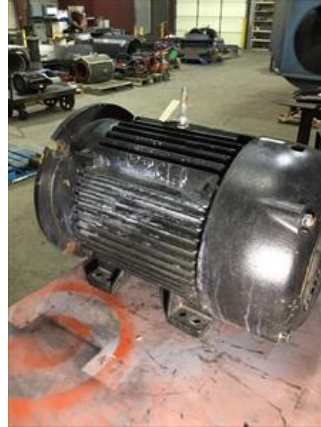
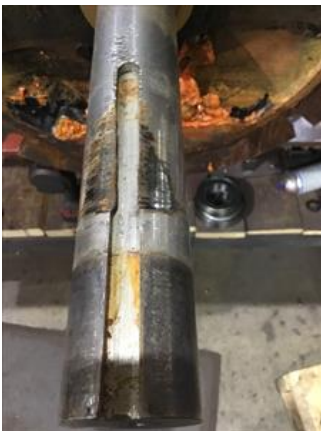
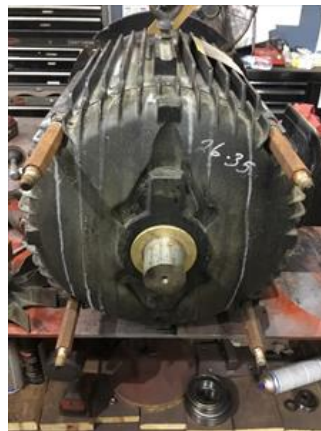
P45

3. Photos of all six sides of the machine.

4. Describe the Overall Condition of the Equipment as Received
Serviceable

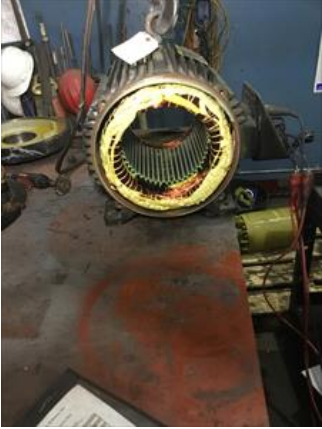
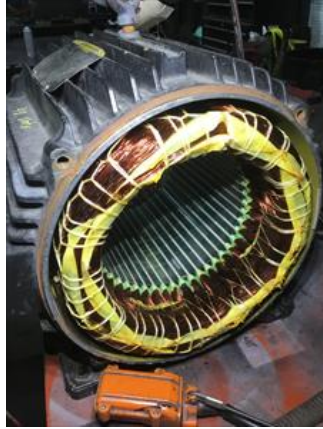
12.	Lead Numbers	1-9	
13.	Stator Temperature Detector Rating and Function		
	Quantity	Rating	Quantity Passed
14.	Bearing Temperature Detector Rating and Function		
	Quantity	Rating	Quantity Passed
15.	Frame Condition	pass	P105
<div style="display: flex; justify-content: space-around;">

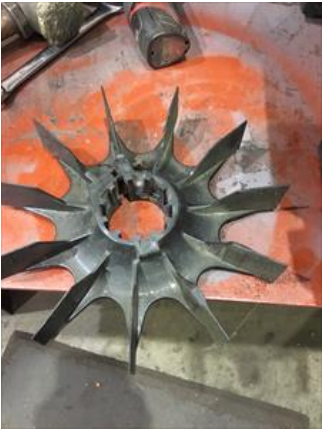
</div>			
16.	Fan Condition	(P) Pass	P109

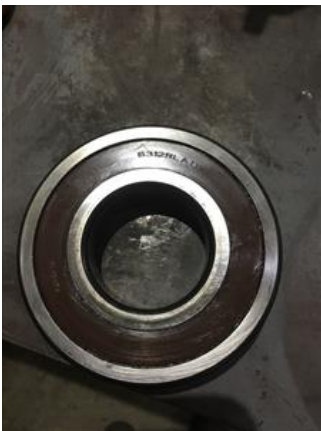
26. Drive End Bearing Brand	Peer	
27. Drive End Bearing Number-	6312	P28

28. Drive End Bearing Qty.	1
29. Drive End Bearing Type	(Ball) Ball Bearing
30. Drive End Lubrication Type	(Grease) Grease Lubricated
31. Drive End Bearing Insulation or Grounding Device?	none
32. Drive End Wavy Washer/Snap-Ring Other Retention Device?	star washer and gland nut
33. Drive End Bearing Condition	replace
34. Opposite Drive End Bearing Brand	PEER

New shaft, and new bearings.

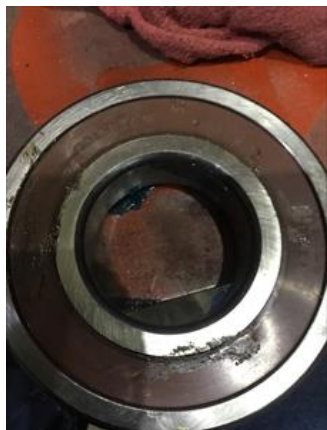
P99

35. Opposite Drive End Bearing Number-

6312

41. Opposite Drive End Bearing Condition

replace

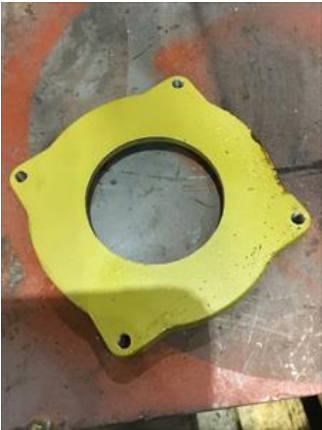
P52

72.	End Bell Air Seal Fits		
	Drive End Air Seal	Opposite Drive End Air Seal	
73.	List Machine Work Needed Below		
	New shaft
