## Submersible Pump Repair Report

Jacksonville Waste Water

Description: 5HP HYDROMATIC PUMP

Model: HRGF500M3-4

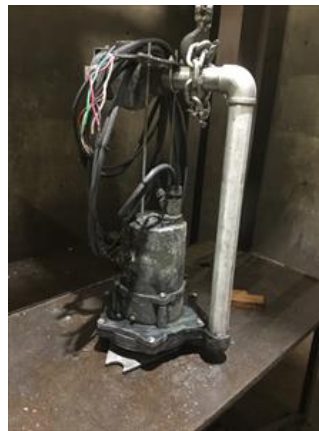
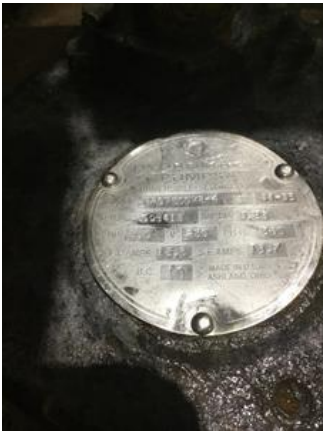
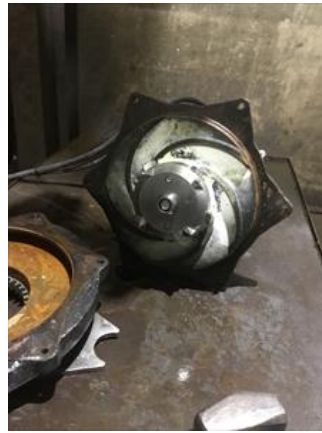
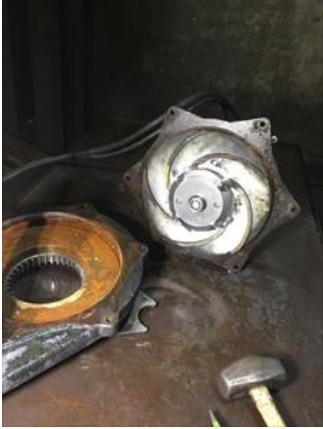
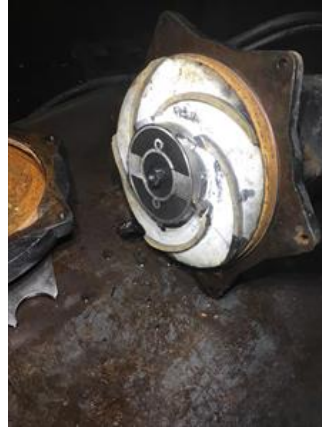
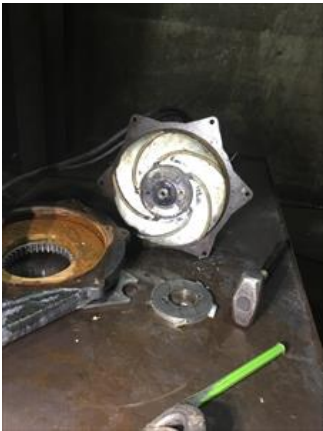
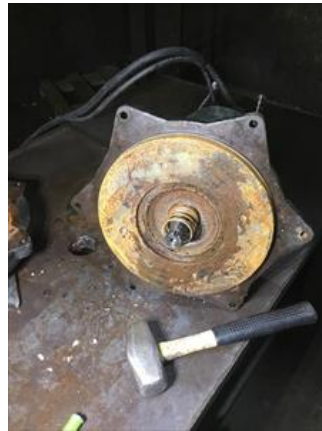
| 4. Power Cord Wire Size | 12 AWG | P7 |

5.	Power Cord # of Conductors	4
6.	Power Cord Length	19.1 ft
7.	Power Cord Condition	(P) Pass
8.	Sensor Cord Wire Size	16 AWG
9.	Sensor Cord # of Conductors	4
10.	Sensor Cord Length	19.1 ft
11.	Sensor Cord Condition	(P) Pass
12.	Sensor Cord for Thermal Protection?	(Y) Yes
13.	Sensor Cord for Water Protection	(Y) Yes
14.	Bowl Condition	(P) Pass
15.	Impeller Condition	(P) Pass

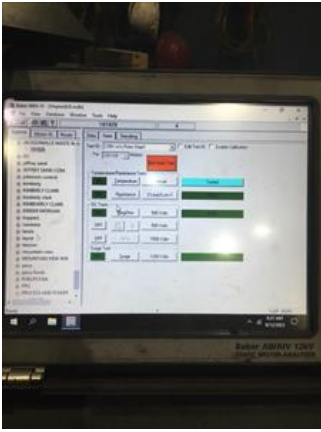
60. Stator Condition **good**

61. Failure Location **seals**
