## Submersible Pump Repair Report

Jacksonville Waste Water

Description: 5HP HYDROMATIC PUMP

Model: HRGF500M3-4

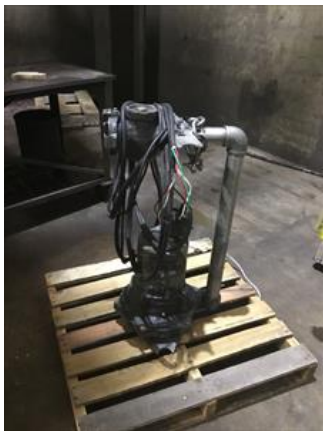
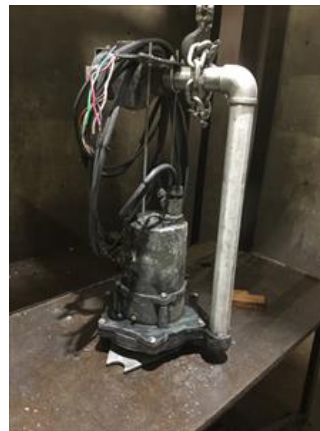
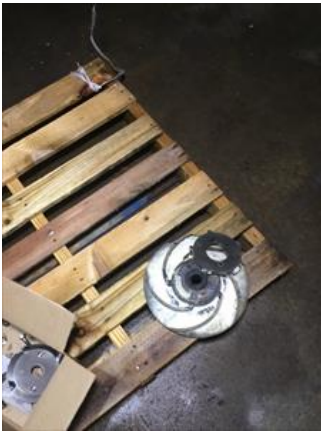
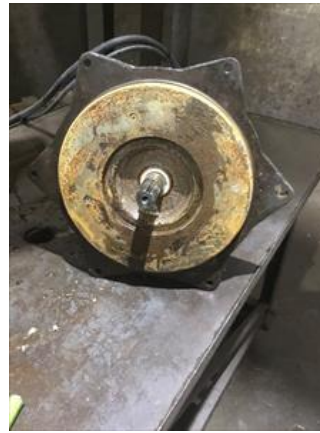
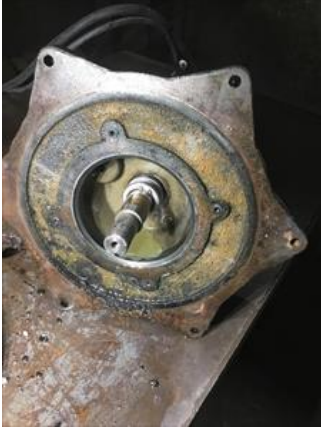
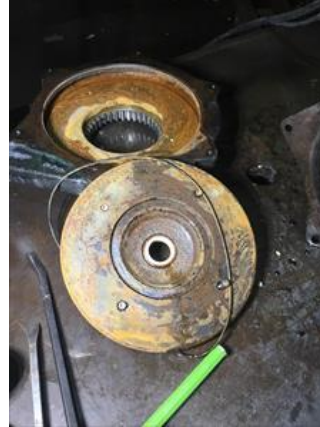
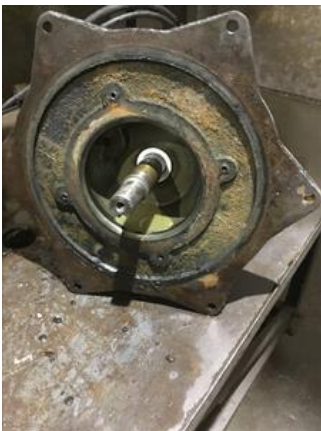
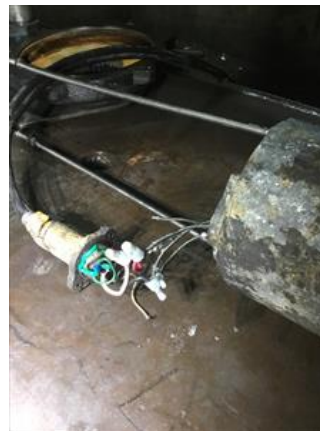
| 4. Power Cord Wire Size | 12 AWG | P7 |

5.	Power Cord # of Conductors	4
6.	Power Cord Length	19.1 ft
7.	Power Cord Condition	(P) Pass
8.	Sensor Cord Wire Size	16 AWG
9.	Sensor Cord # of Conductors	4
10.	Sensor Cord Length	19.1 ft
11.	Sensor Cord Condition	(P) Pass
12.	Sensor Cord for Thermal Protection?	(Y) Yes
13.	Sensor Cord for Water Protection	(Y) Yes
14.	Bowl Condition	(P) Pass
15.	Impeller Condition	(P) Pass

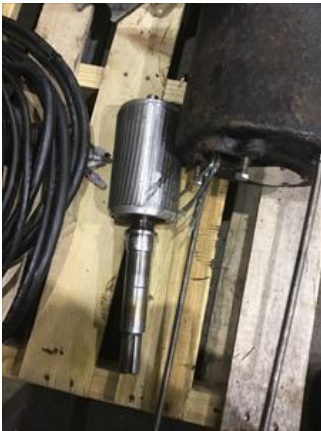
P2

62. Rotor Type **squirrel cage aluminum**

63. Air Gap <10% Variation

64. Number of Rotor Bars **48**

65. Number of Broken Rotor Bars **0**

66. Growler Test **(P) Pass**

67. Rotor Condition **(P) Pass**

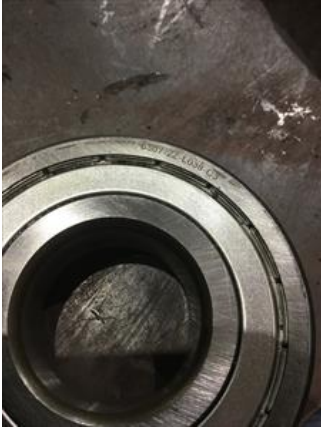
68. Bearing Manufacturer **FAG**

70. Bearing DE Type	regular ball bearing
71. DE Bearing Qty.	1
72. Bearing ODE Size	6303 Z
73. Bearing ODE Type	regular ball bearing
74. ODE Bearing Qty.	1
75. Insulated Bearing	no
76. Lubrication Type	oil
77. Grease Condition	(NA) Not Applicable
78. Bearing Retainers	(Y) Yes

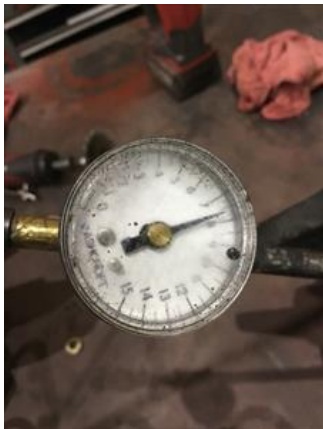
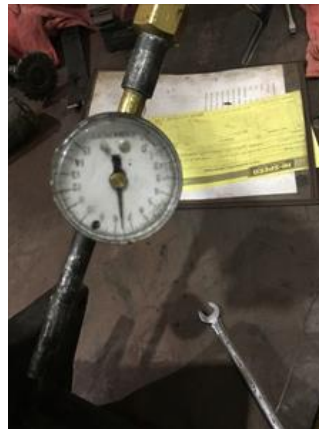
- 128. Seal Cavity Pressure Test (P) Pass P35

- 127. Stator Pressure Test (P) Pass  
 Per housing.

- 129. Time Under Pressure 15 min
- 130. Overload Continuity (P) Pass
- 131. Water Sensor Open? (Y) Yes

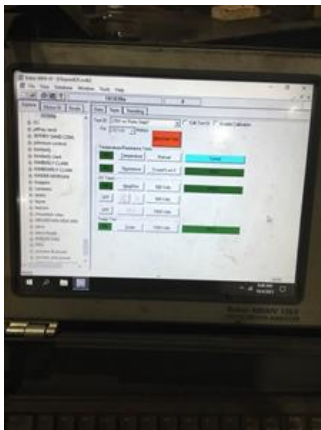
P67

## 133. Surge Test

(P) Pass

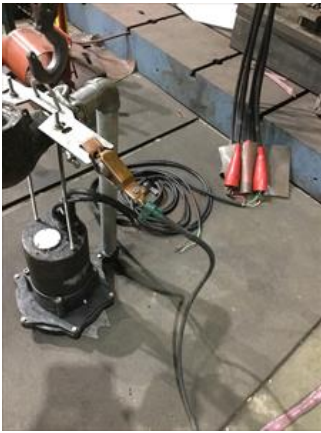
P90

## 136. Test Run

(P) Pass

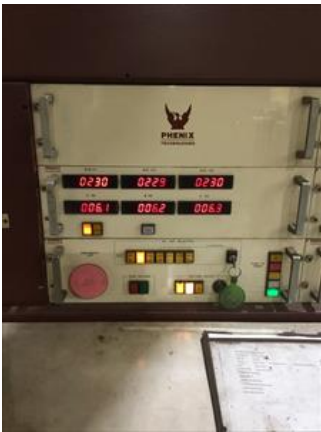
P95

### 137. Test Run Voltage

Phase A

Phase B

Phase C

230

229

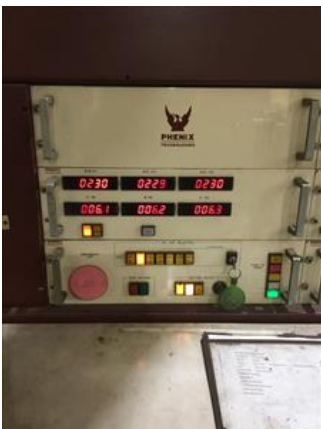
P99

### 138. Test Run Current

Phase A

Phase B

Phase C

6.1

6.2

6.3
