## AC Inspection as Found

### Custom Craft Poultry

#### AC Inspection - Rev. 2

Description: FMC FOODTECH GEARMOTOR  
121.12 RATIO

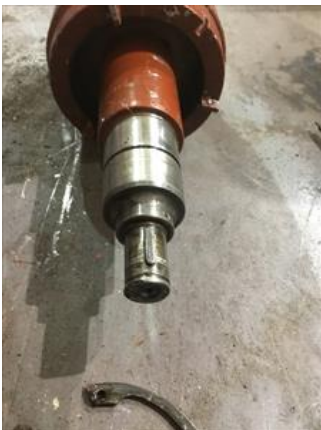
7. Does Shaft Have Visible Damage?

**(No) No**

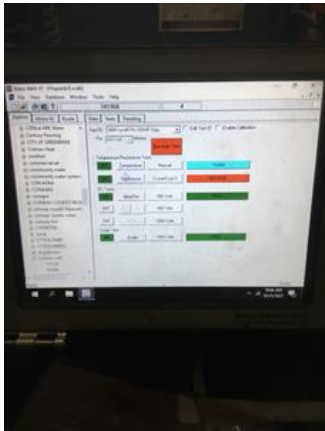
13.	Lead Numbers	1-9
14.	Frame Condition	pass
15.	Fan Condition	(N) NA
	Missing	
16.	Broken or Missing Components	
	Fan and fan cover missing.	
Initial Electrical Inspection		
17.	Insulation Resistance/Megger	Megohms
		P8

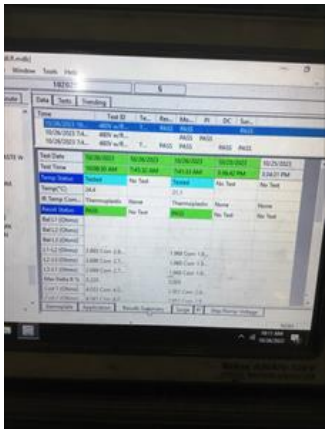
18.	Winding Resistance	P18
	1-2	1-3
	2.693	2.696
		2-3
		2.699

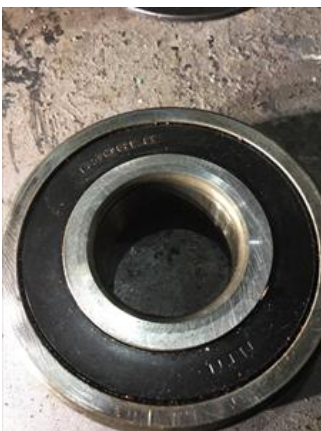
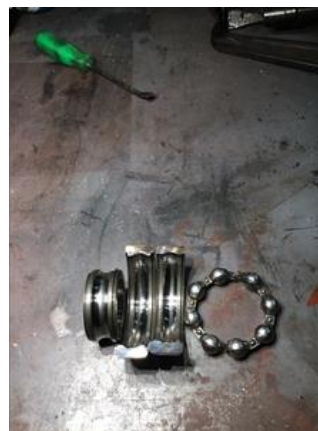
20. Number of Stator Slots	48	
21. Stator Condition	pass	
22. Stator Thermistors/Ohms	na	
23. Stator Overloads/Ohms	na	
<b>Mechanical Inspection</b>		 
24. Drive End Bearing Brand	NTN	
25. Drive End Bearing Number-	6306	P30

26. Drive End Bearing Qty.	1	
27. Drive End Bearing Type	(Ball) Ball Bearing	
28. Drive End Lubrication Type	(Grease) Grease Lubricated	
29. Drive End Bearing Insulation or Grounding Device?	none

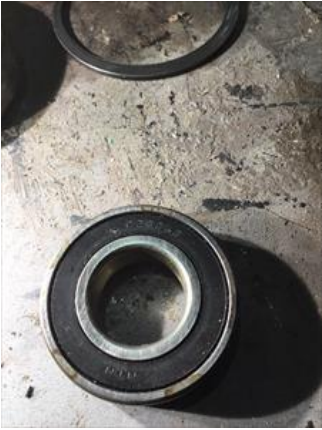
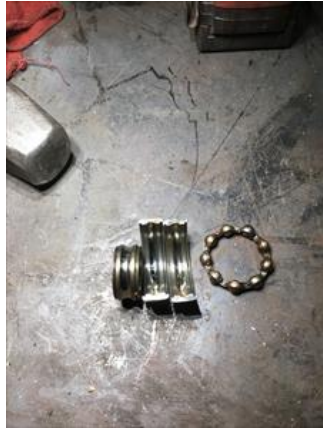
30.	Drive End Wavy Washer/Snap-Ring Other Retention Device?	snap ring	
31.	Drive End Bearing Condition	replace	
32.	Opposite Drive End Bearing Brand	NTN	
33.	Opposite Drive End Bearing Number-	6205	P90
<div>

</div>			
34.	Opposite Drive End Bearing Qty.	1	
35.	Opposite Drive End Bearing Type	(Ball) Ball Bearing	
36.	Opposite Drive End Lubrication Type	(Grease) Grease Lubricated	
37.	Opposite Drive End Bearing Insulation or Grounding Device?	none	
38.	Opposite Drive End Wavy Washer/Snap-Ring Other Retention Device?	na	
39.	Opposite Drive End Bearing Condition	replace	
40.	Drive End Seal	30*17*10 motor	P102
	65*90*10 gearbox

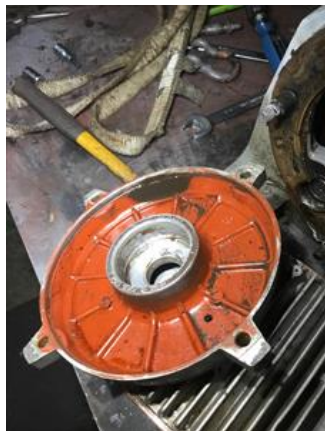
P41

60. Opposite Drive End - Endbell Bearing Fit Condition

(F) Fail

Lip worn in, and excessive wear.

*Machine ODE housing.*
