AC Inspection as Found

Arauco-Malvern MDF (10298)

AC Inspection - Rev. 2

Description: 100 HP RELIANCE

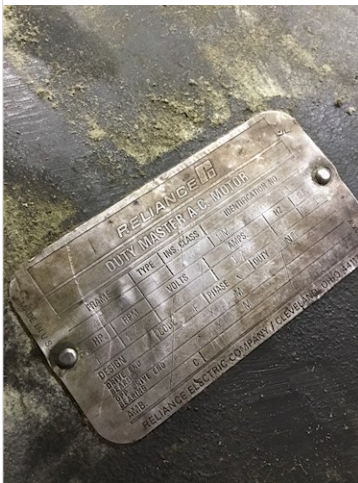
2. Nameplate Picture

Manufacturer: Reliance

Spec/ID #: 1MA460269-G1-1Y

HP/kW: 100 (HP)

RPM: 1770 (RPM)

Frame: 404TS

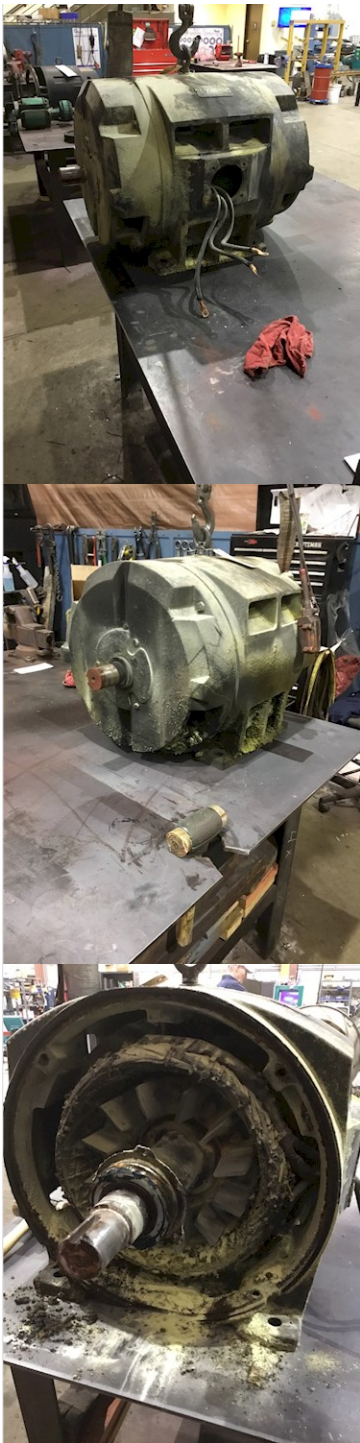
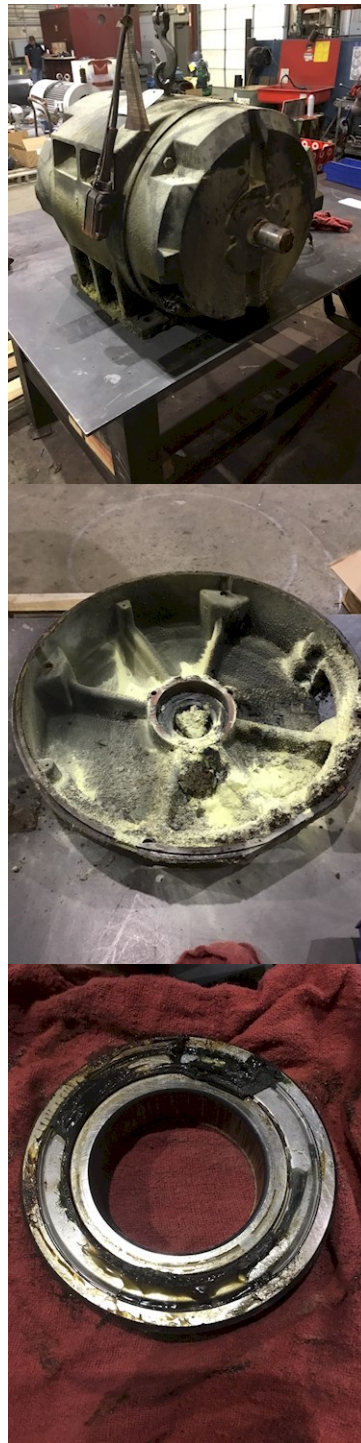
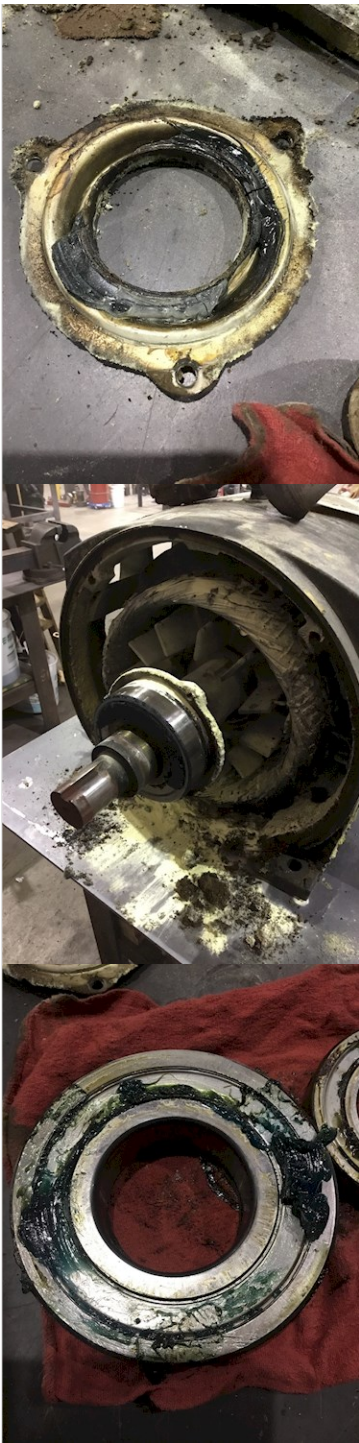
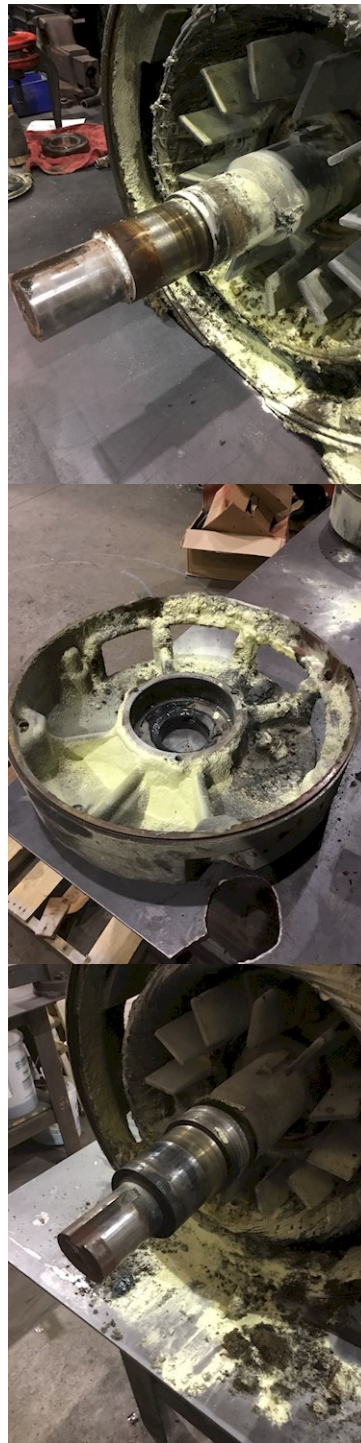
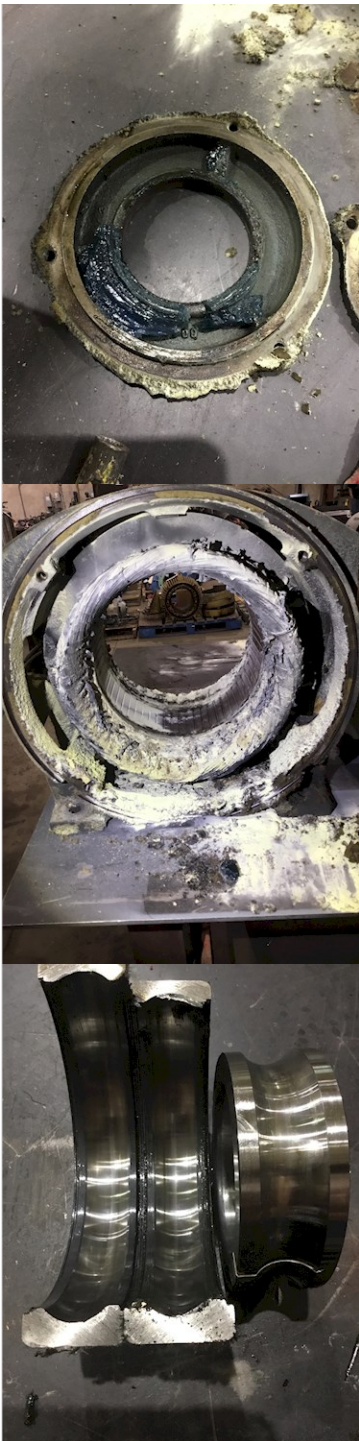
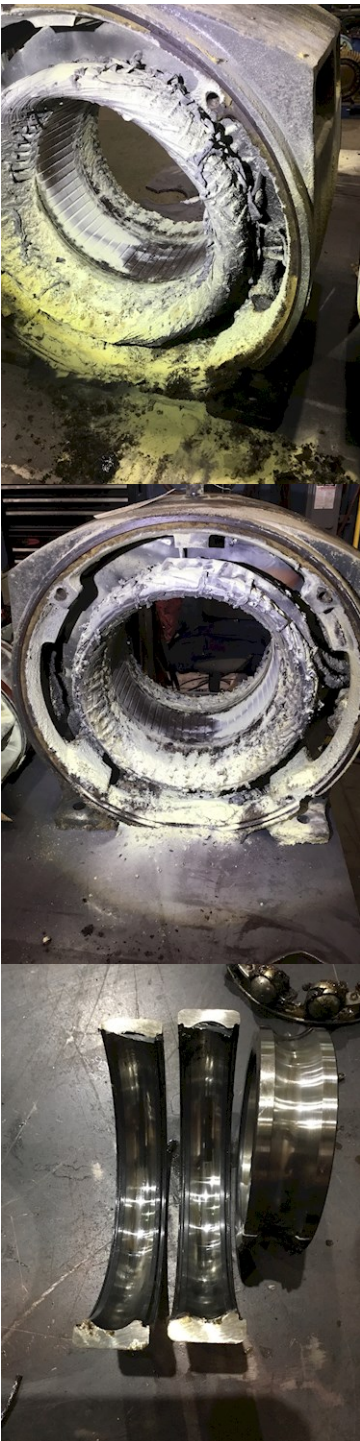
3. Photos of all six sides of the machine.

4. Describe the Overall Condition of the Equipment as Received
Covered in fire extinguisher dust

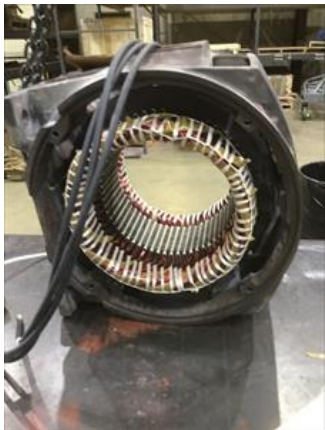
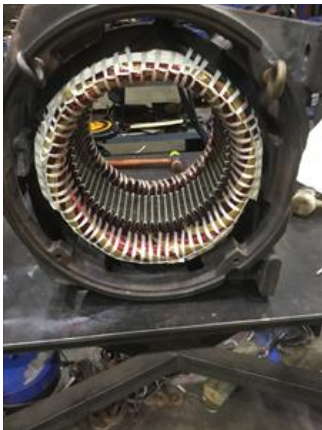
20.	Winding Resistance		
	1-2	1-3	2-3
	<i>Na</i>		
21.	Perform Surge Test	(NA) Not Applicable	
	<i>Rewind</i>		
22.	Number of Stator Slots	60	P73
<div style="display: flex; justify-content: space-around;">

23.	Stator Condition	pass	
24.	Stator Thermistors/Ohms		
	<i>Na</i>		
25.	Stator Overloads/Ohms		
	<i>Na</i>

Materials inside stator caught fire burning the windings and winding strings. Bearings have wear

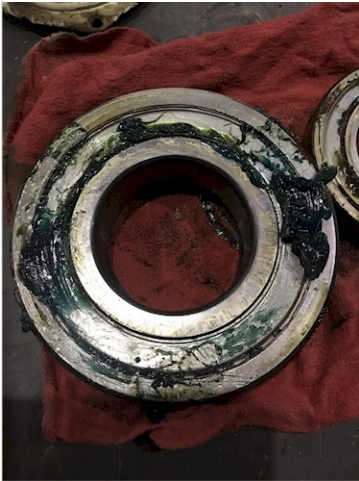
26.	Drive End Bearing Brand	na	
27.	Drive End Bearing Number-	6316	P28

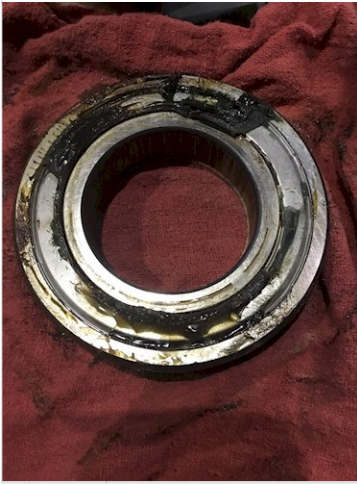
36. Opposite Drive End Bearing Qty.	1	
37. Opposite Drive End Bearing Type	(Ball) Ball Bearing	
38. Opposite Drive End Lubrication Type	(Grease) Grease Lubricated	
39. Opposite Drive End Bearing Insulation or Grounding Device?	na	
40. Opposite Drive End Wavy Washer/Snap-Ring Other Retention Device?	na	
41. Opposite Drive End Bearing Condition	signs of wear	P116

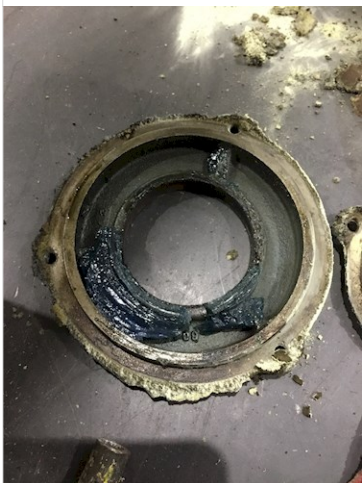
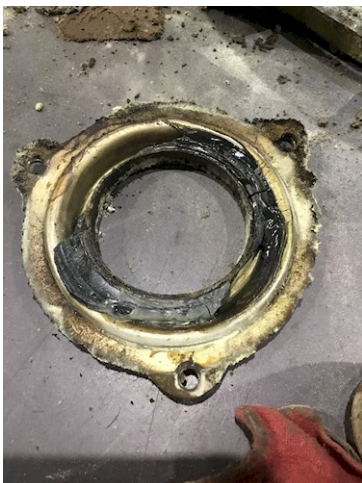
71. Bearing Cap Condition

Drive End Bearing Cap
pass

Opposite Drive End Bearing Cap
pass

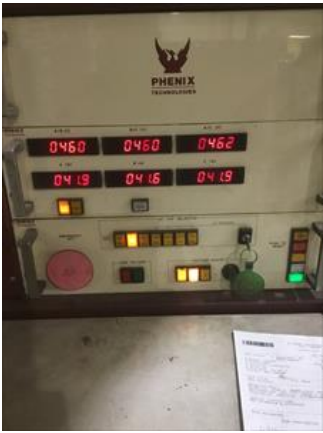
- 111. Photograph All Major Components prior to assembly
- 112. Final Insulation Resistance Test
- 113. Assembled Shaft Endplay
- 114. Assembled Shaft Runout
- 115. Test Run Voltage

Volts	Volts	Volts
460	460	462

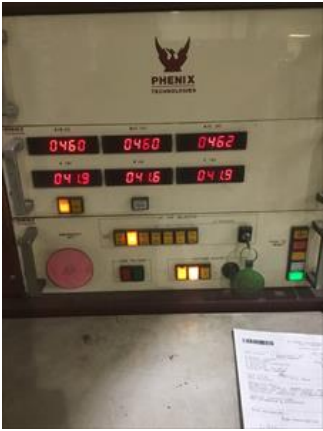
- 116. Test Run Amperage

Amps	Amps	Amps
41.9	41.6	41.9
