**AC Inspection as Found**  
**Bryce Corporation (10053-BRC)**  
450 S. Benton  
Searcy, AR 72143

**AC Inspection - Rev. 2**

Description: 15 HP SIEMENS RUSH!

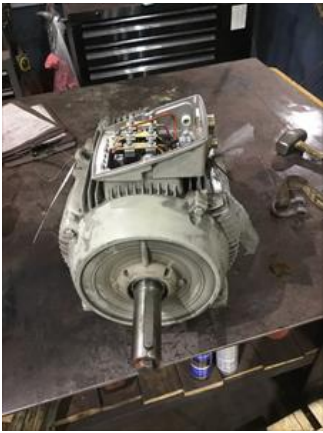
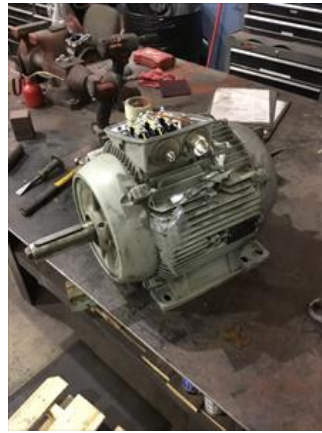
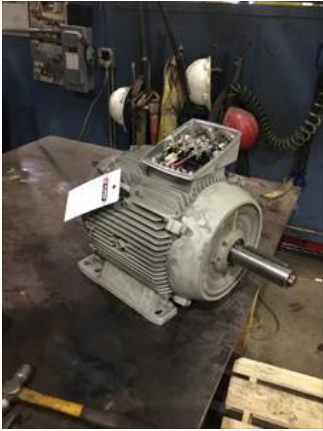
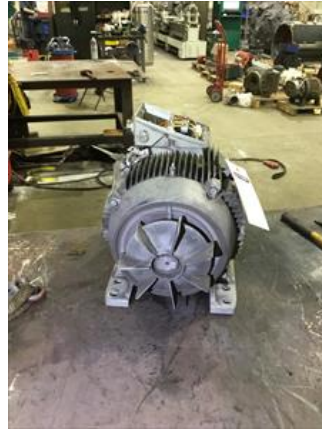
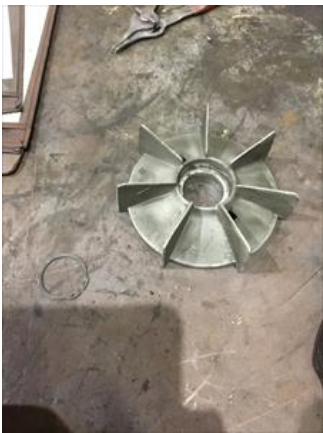
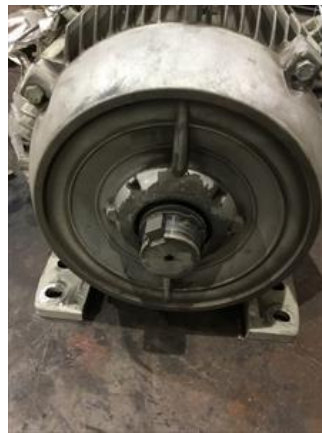
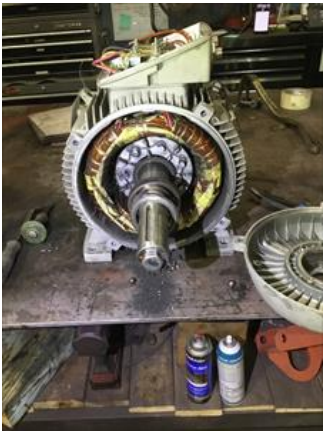
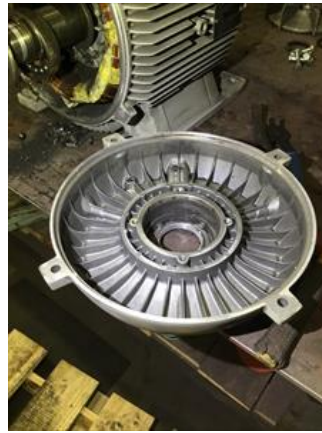
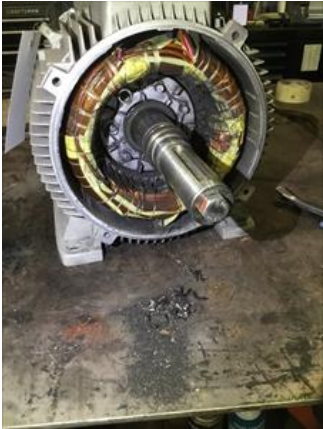
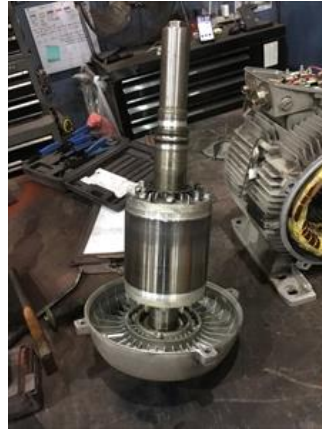
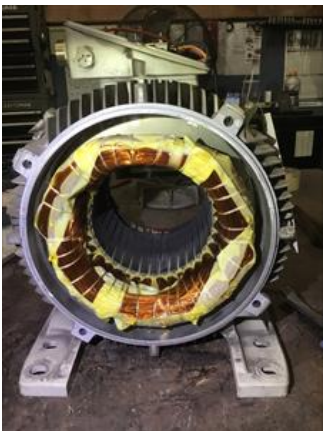
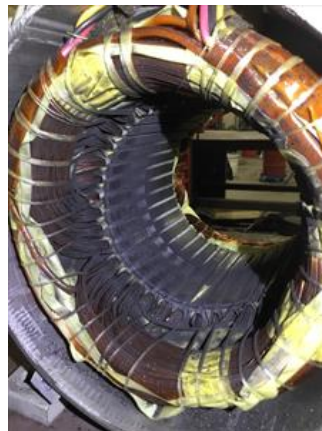
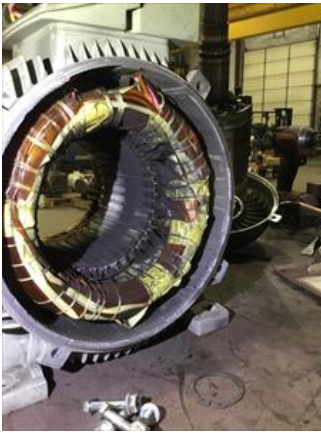
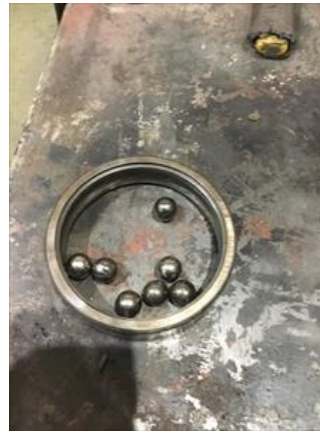
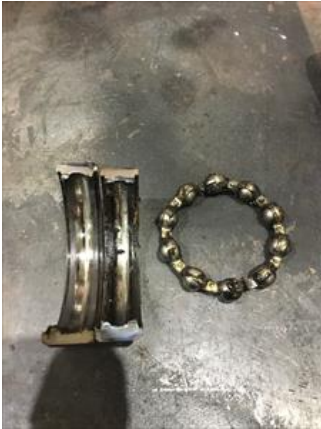
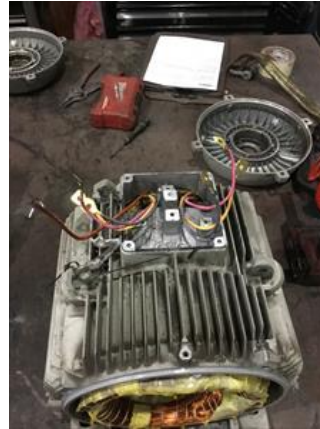
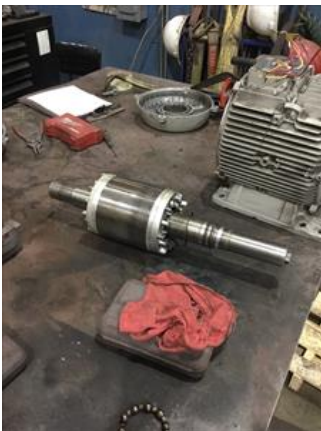
4. Describe the Overall Condition of the Equipment as Received  
*Serviceable*

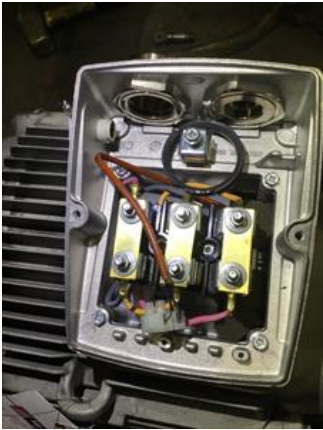
11.	Lead Length	7 Inches	
12.	Lead Numbers	1-6	
13.	Frame Condition	pass	
 	14. Fan Condition	(P) Pass	P106

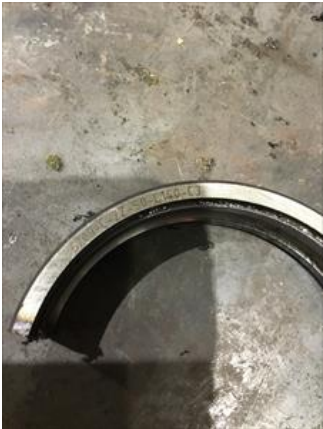
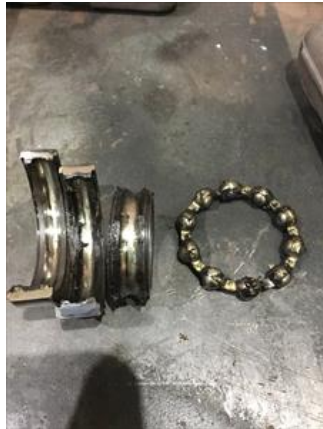
30.	Drive End Wavy Washer/Snap-Ring Other Retention Device?		wavy washer	
31.	Drive End Bearing Condition		destroyed	
32.	Opposite Drive End Bearing Brand		fag

38.	Opposite Drive End Wavy Washer/Snap-Ring Other Retention Device?		snap ring	
39.	Opposite Drive End Bearing Condition		replace	
40.	Drive End Seal		VA 045

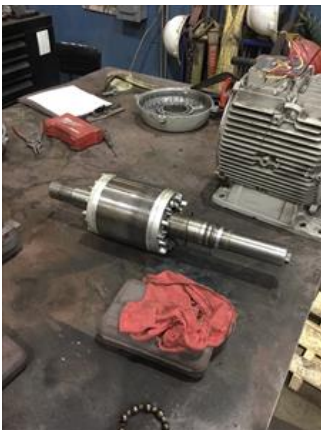
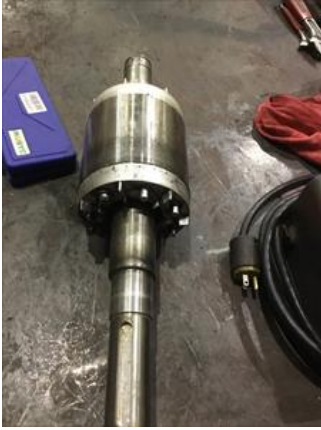
17.	Insulation Resistance/Megger			
18.	Winding Resistance			
	1-2	1-3	2-3	
19.	Perform Surge Test			
20.	Number of Stator Slots		36	
21.	Stator Condition		rewind

52. Number of Rotor Bars **28**

53. Rotor Condition **pass**

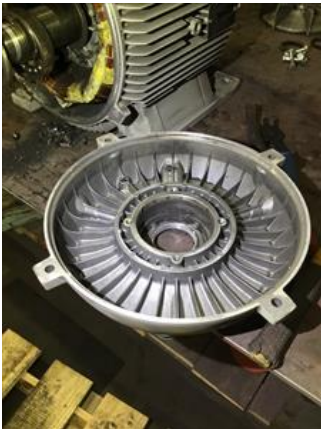
65.	Drive End - Endbell Bearing Fit				
	0 Degrees	60 Degrees	120 Degrees		
	3.3479	3.3479	3.3478		
66.	Drive End - Endbell Bearing Fit Condition			(F) Fail	P13
	Excessive wear from bearing failure.

*D.E bearing suffered total cage failure due to lack of lubricant. This caused to rotor to drop onto the stator core and short out the windings.*

69.	Bearing Cap Condition				
	Drive End Bearing Cap	Opposite Drive End Bearing Cap			
70.	End Bell Air Seal Fits				
	Drive End Air Seal	Opposite Drive End Air Seal			
71.	List Machine Work Needed Below				P67
	Sleeve both housing fits. Possibly sleeve D.E housing shaft opening.

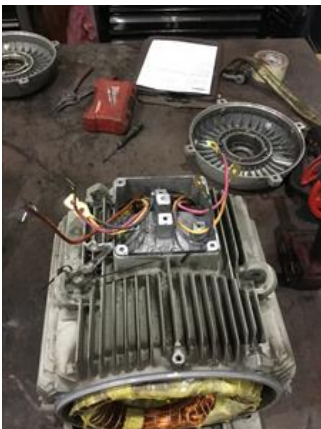
67.	Opposite Drive End - Endbell Bearing Fit				
	0 Degrees	60 Degrees	120 Degrees		
	3.3477	3.3477	3.3476		
68.	Opposite Drive End - Endbell Bearing Fit Condition			(F) Fail	P38
	Excessive wear
