**AC Inspection as Found**  
**Bryce Corporation (10053-BRC)**  
450 S. Benton  
Searcy, AR 72143

**AC Inspection - Rev. 2**

Description: 15 HP SIEMENS RUSH!

Hi-Speed Job Number:	101995
Manufacturer:	Siemens
Serial Number:	1LE10031DA234AB4-Z
HP/kW:	15 (HP)
RPM:	3560 (RPM)
Frame:	160M
Voltage:	460
Current:	17.2
Phase:	Three
Hz:	60 (Hz)
Service Factor:	1.15
Enclosure:	TEFC
# of Leads:	6
J-box Included:	Half
Coupling/Sheave:	None
Date Received:	10/16/2023
Bearing RTDs:	No
Stator RTDs:	No
Repair Stage:	Final

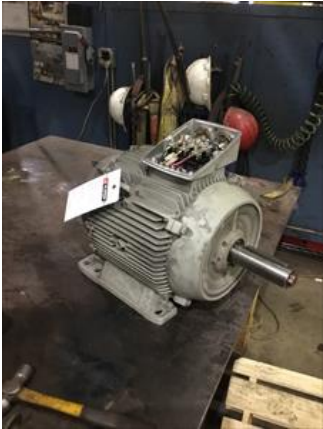
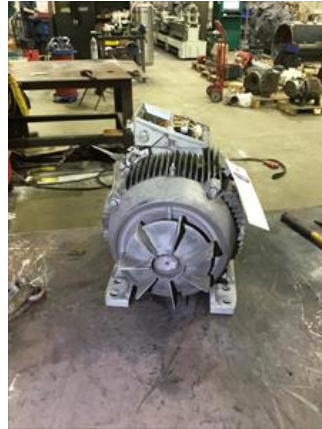
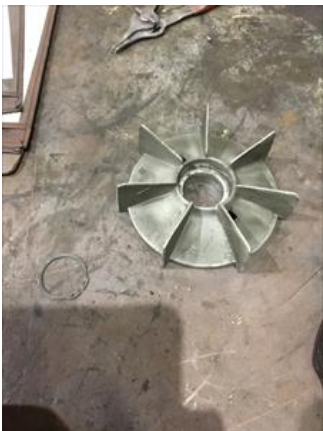
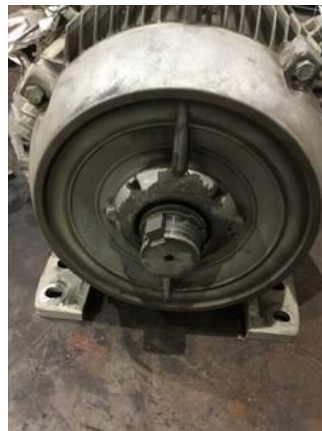
3. Photos of all six sides of the machine.

4. Describe the Overall Condition of the Equipment as Received  
*Serviceable*

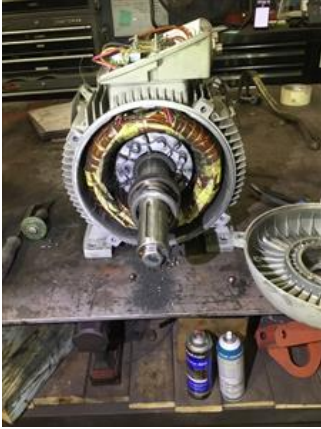
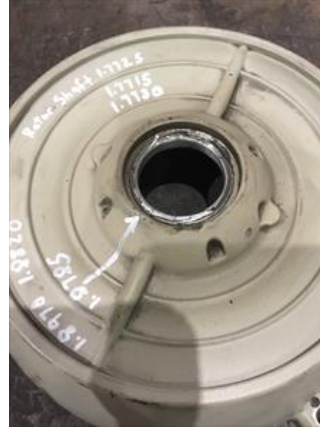
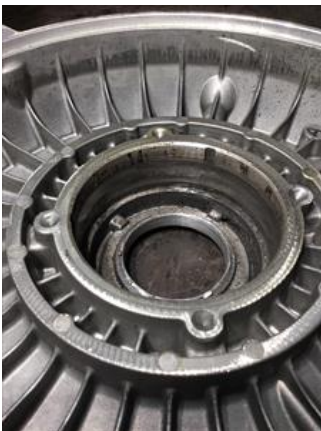
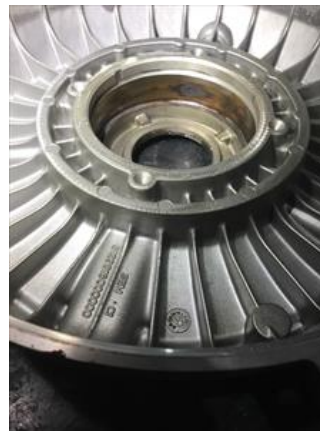
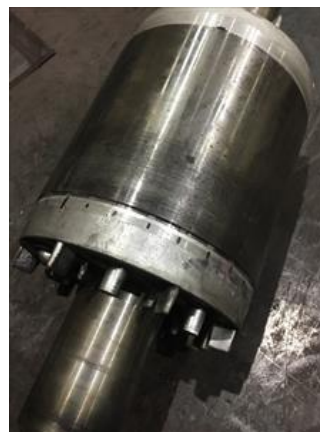
# 85. Failure locations

*D.E bearing suffered total cage failure due to lack of lubricant. This caused to rotor to drop onto the stator core and short out the windings.*

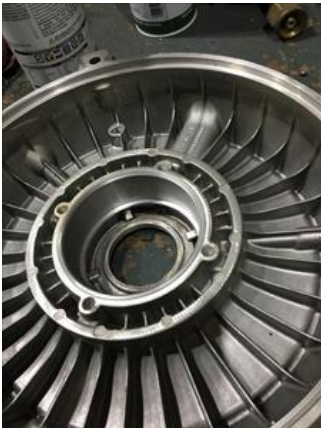
96. Opposite Drive End - Endbell Bearing Fit Post Repair

**3.347**

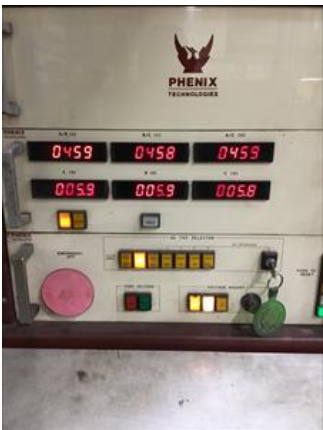
113. Test Run Voltage

459

458

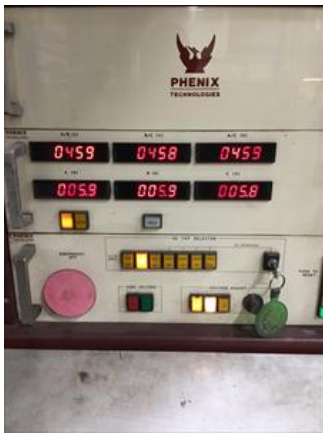
114. Test Run Amperage

5.9

5.8

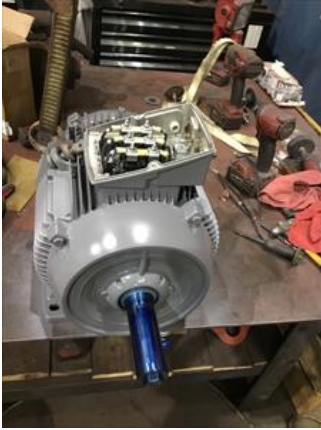
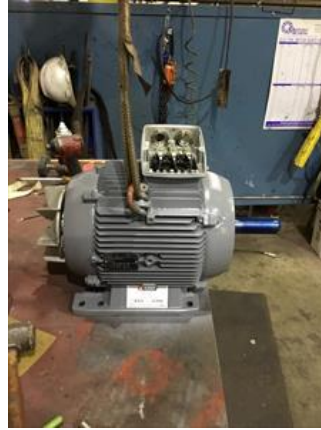
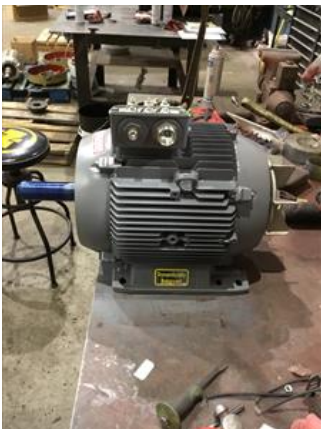
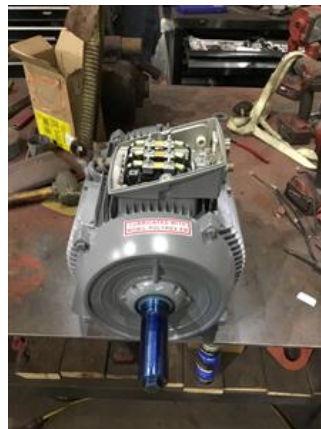
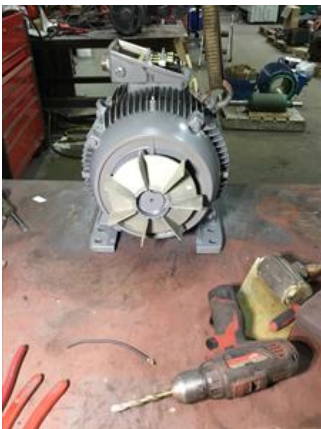
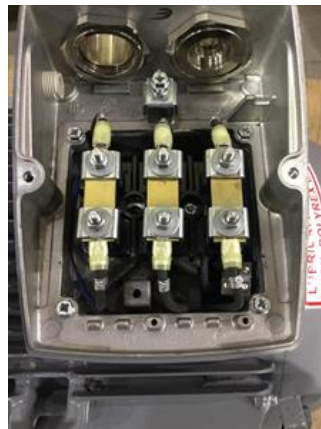
P124

130. Document Final Condition with Pictures after paint
