AC Recondition As Found
Sonoco Products Harbor Ave (001514)
2755 Harbor Ave.
Memphis, TN 38113

AC Recondition - Rev. 2

Hi-Speed Job Number:	148192
Manufacturer:	TECO Westinghouse
Product Number:	AEEANE
Serial Number:	VB E4168204013
HP/kW:	7.5 (HP)
RPM:	3500 (RPM)
Frame:	213TZ
Voltage:	208-230/460
Current:	20.2-18.2/9.1 (Amps)
Phase:	Three
Hz:	60 (Hz)
Service Factor:	1.15
Enclosure:	TEFC
# of Leads:	9
J-box Included:	Half
Coupling/Sheave:	Fan Blades
Date Received:	11/16/2022
Bearing RTDs:	No
Stator RTDs:	No
Repair Stage:	Teardown Inspection
Rewind:	Yes
Shaft Machined Fit Repairs Required:	No
Bearing Housing Machined Fit Repairs Required:	No
Heaters:	No
Winding Type :	Random Wound
Bearing Type:	Rolling Element

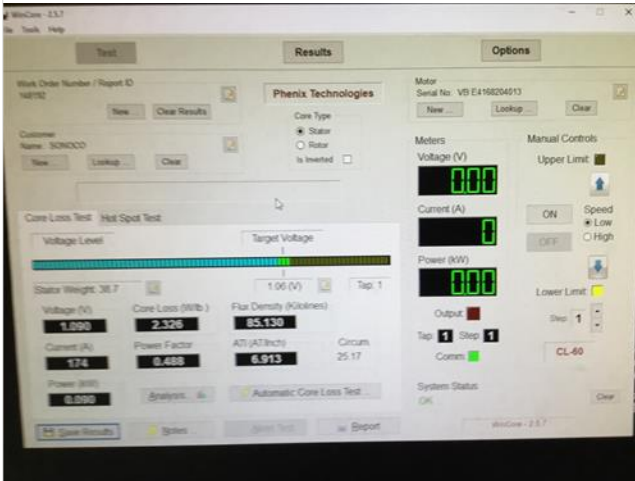
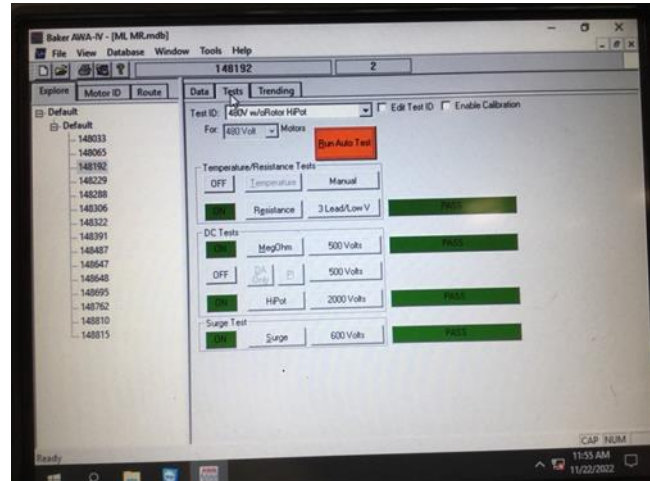
P1

1. Report Date

11/11/2022

Connected for hi volts. Wind with three leads only for the higher volts.
Ext OLE 2.0"
Ext LE 2.0"
Spacer behind DE Bearing.
After rewind 3.1 amps @ 460 volts
Megged greater than 1000 mohms @ 1000 volts

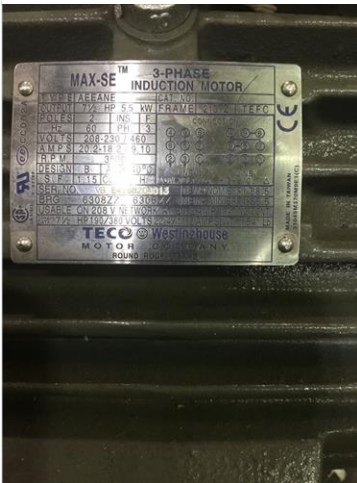
P2

2. Nameplate Picture

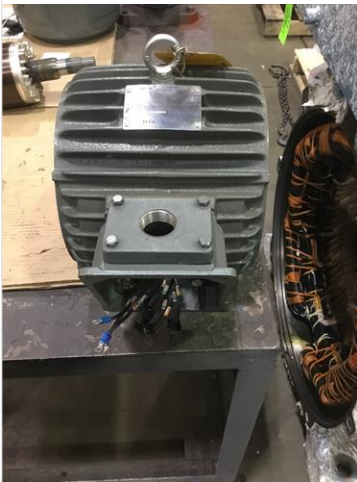
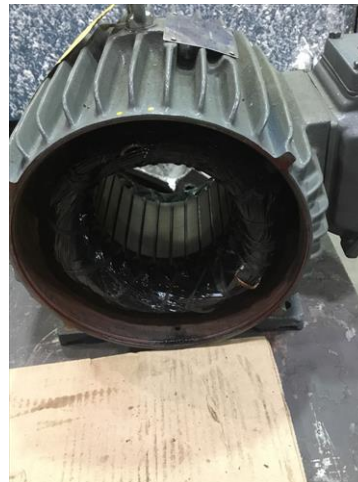
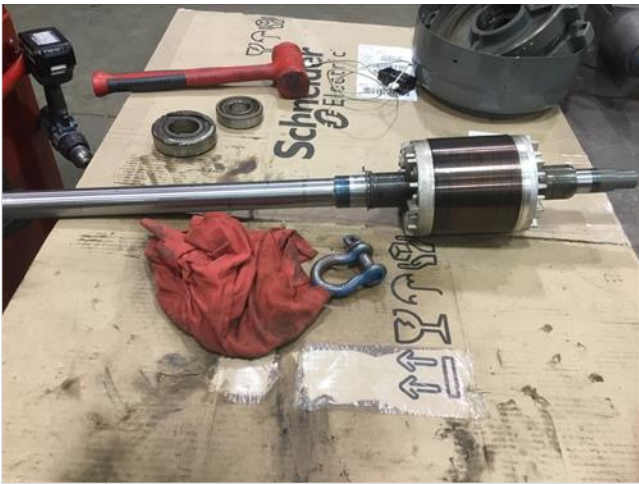
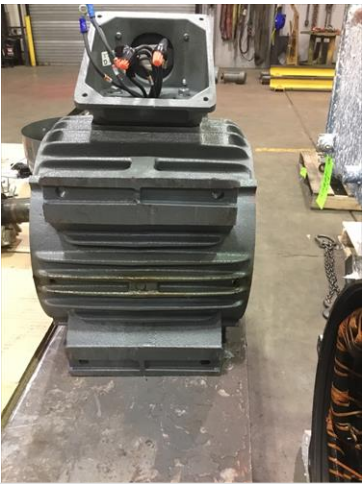
P3

3. Photos of all six sides of the machine.

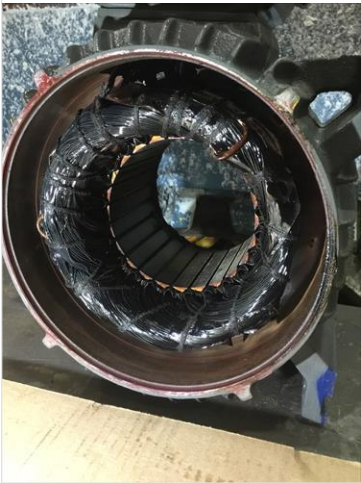
P4

4. Describe the Overall Condition of the Equipment as Received
Burned up stator

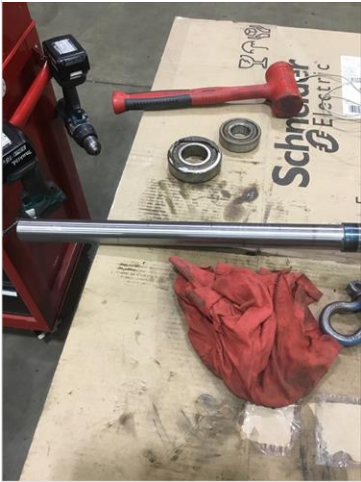
P5

5. Distance from the end of the shaft to the Coupling/Sheave

18 inches

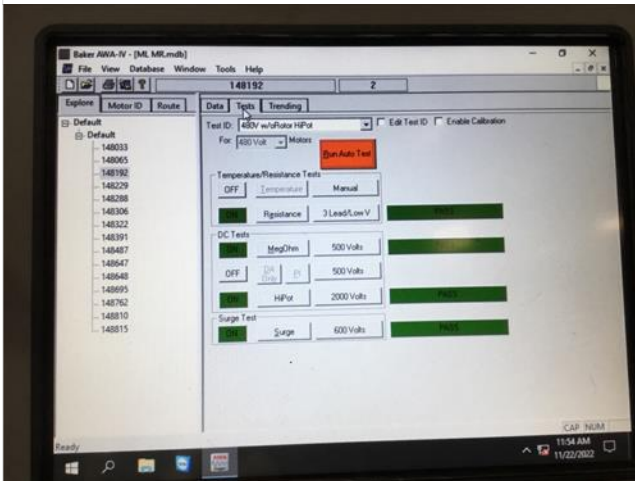
P18

14. Perform Surge Test

(P) Pass

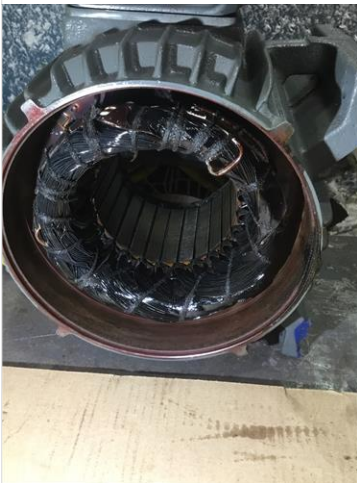
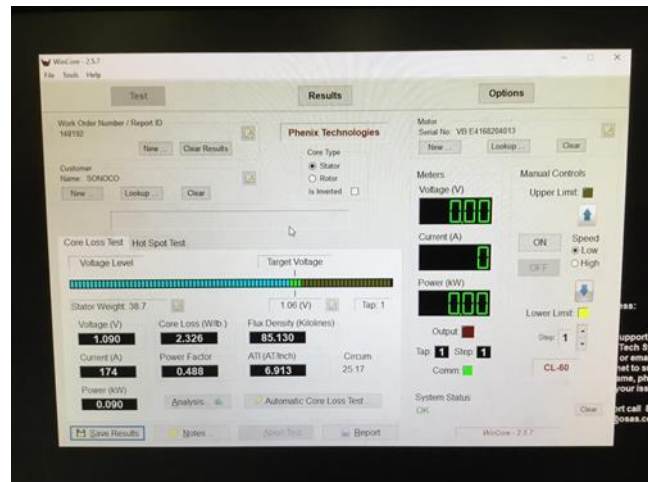
P19

15. Stator Condition

burned
