Submersible Pump Repair Report

Submersible Pump Repair Report
Location: LR MOTORSHOP
Serial Number: G00117651
Description: 3HP MYERS SUBMERSIBLE PUMP
3600RPM

Make:	MYERS
HP:	3 (HP)
Model:	WG30-43
Serial:	G00117651
V:	460 (V)
A:	8.9 (A)
RPM:	3450 (RPM)
Hz:	60 (Hz)
Phase:	3
Impeller Diameter:	3.75 (in)

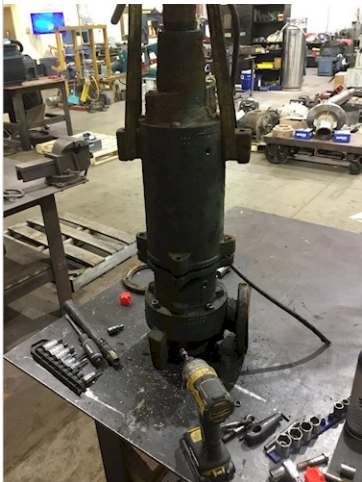
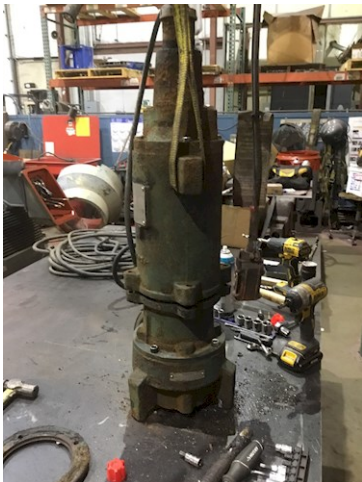
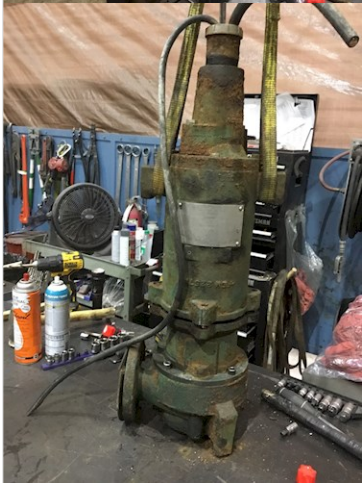
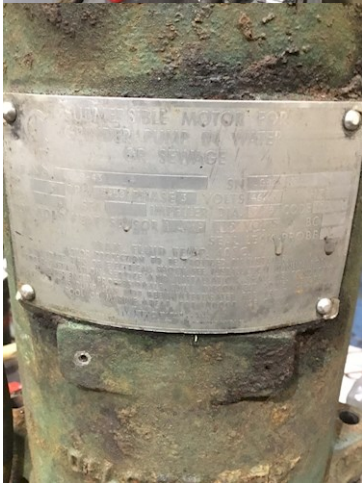
P17

3.	Customer	CoorsTec
Initial Pump Inspection		
4.	Power Cord Wire Size	10 AWG
5.	Power Cord # of Conductors	4
6.	Power Cord Length	36 ft
7.	Power Cord Condition	(F) Fail

8.	Sensor Cord Wire Size	16 AWG
9.	Sensor Cord # of Conductors	5
10.	Sensor Cord Length	38 ft
11.	Sensor Cord Condition	(F) Fail
12.	Sensor Cord for Thermal Protection?	(NA) Not Applicable

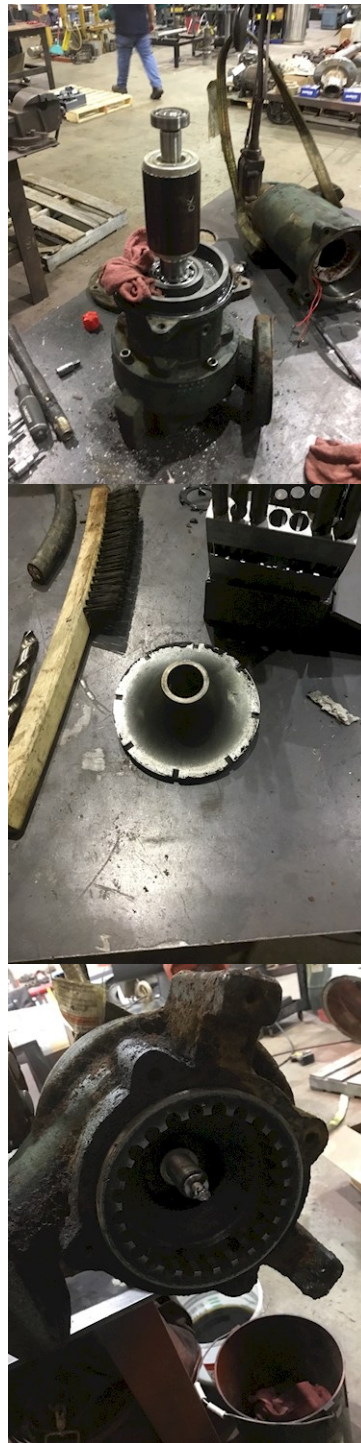
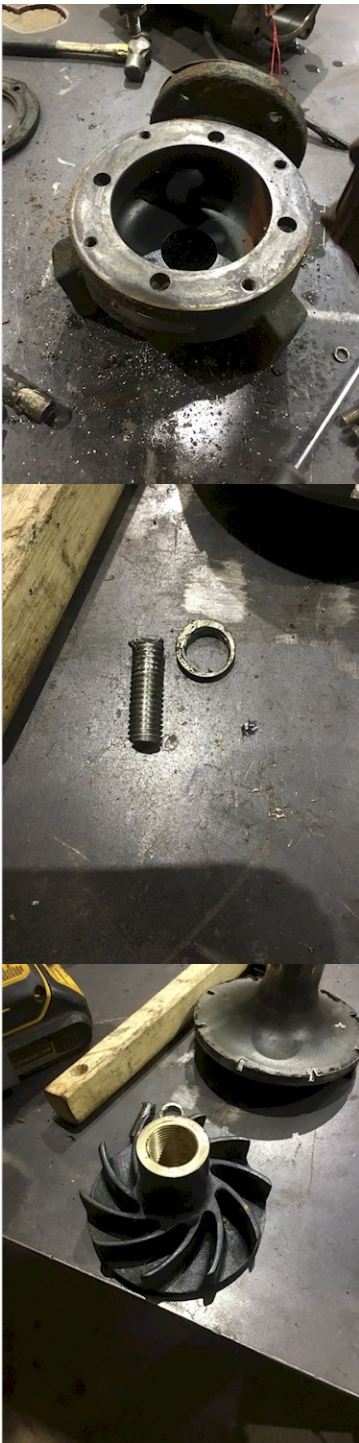
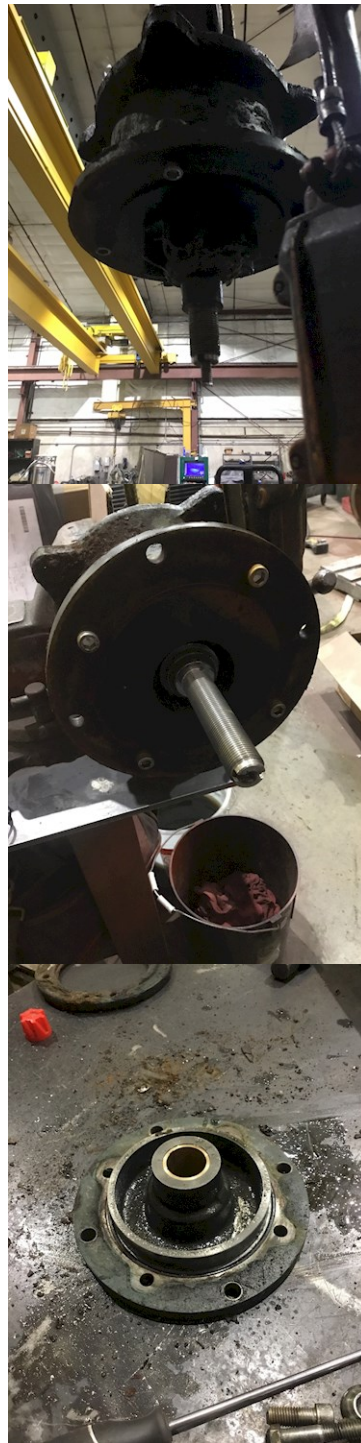
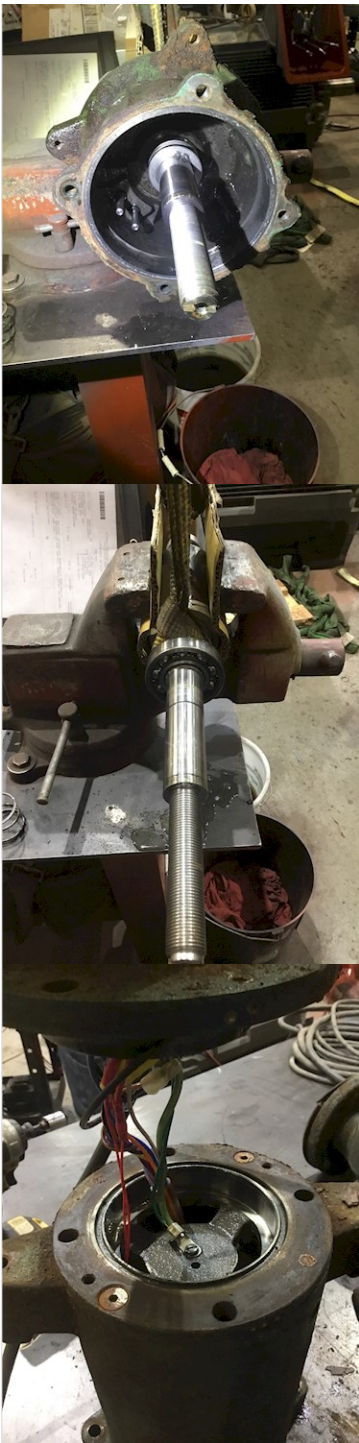
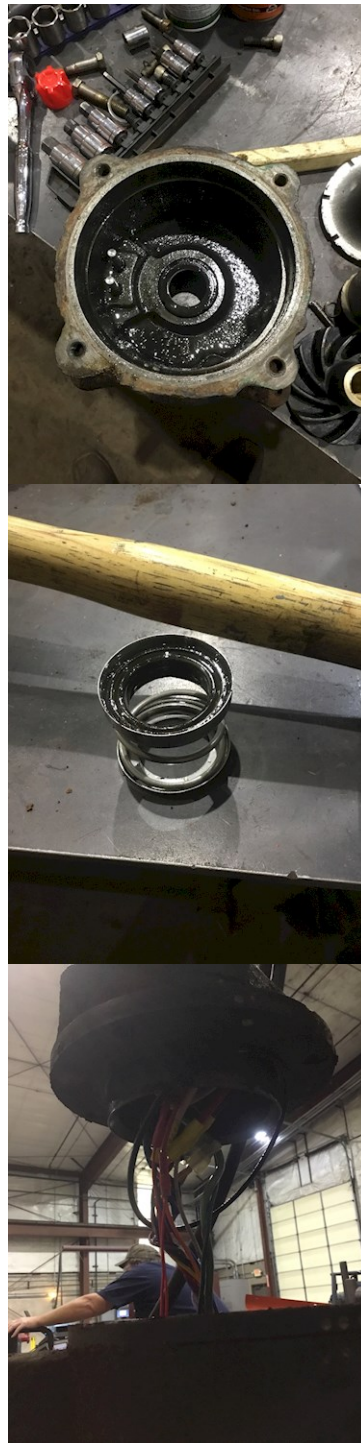
Test Date	10/26/2023	10/26/2023	10/26/2023
Test Time	12:06:07 PM	12:02:50 PM	11:56:43 AM
L1-L2 (Ohms)		3.017 Corr: 3.0...	
L2-L3 (Ohms)		3.017 Corr: 3.0...	
L3-L1 (Ohms)		3.009 Corr: 3.0...	
Max Delta R %		0.293	
Coil 1 (Ohms)		4.528 Corr: 4.5...	
Coil 2 (Ohms)		4.528 Corr: 4.5...	
Coil 3 (Ohms)		4.502 Corr: 4.5...	
Megohm Stat...	No Test	PASS	No Test
Volts (V)		508	
I(μA)		0.0798	
Resist		6366	
At 40°C		1778	
Pol Charting	No Test	No Test	No Test
Nameplate	Application	Results Summary	Surge PI

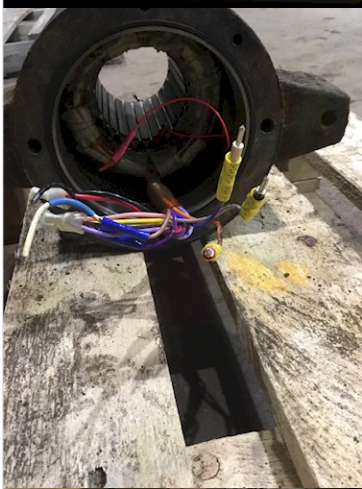
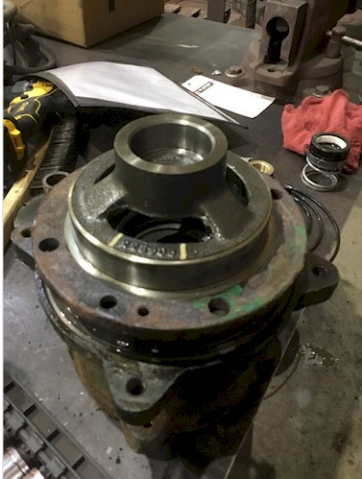
P56

59. Surge Test

(F) Fail

Test Type			
Volts (V)			
I(μA)			
Resist			
At 40°C			
Surge Status	L-L EAR	L-L EAR	No Test
Peak Volt(V) L1	1590	1580	
Peak Volt(V) L2	1500	1560	
Peak Volt(V) L3	1580	1560	
Max P-P EAR(...	1.6/1.5/1.5	1.6/1.4/1.5	
EAR 1-2/2-3/...	10/38/47	10/38/48	
Nameplate	Application	Results Summary	Surge PI

61. Failure Location

weak insulation

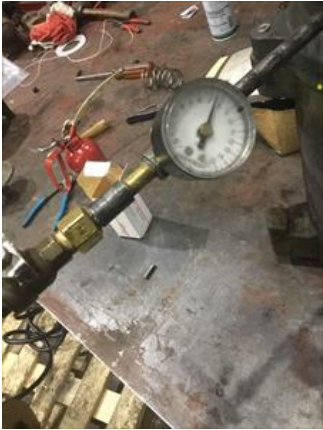
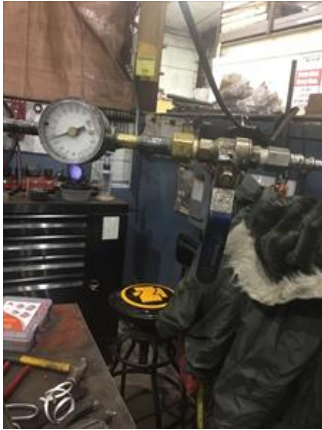
125. Rotor and Impeller Balanced			
126. Stator Housing Refilled with Oil (if required)			
● 127. Stator Pressure Test		(P) Pass	P29
