## AC Inspection as Found

### AC Inspection - Rev. 2

Location: MOTOR SHOP LR

Manufacturer:	Toshiba
Product Number:	B1504FLF4USH01
Serial Number:	98303977
HP/kW:	150 (HP)
RPM:	1785 (RPM)
Frame:	445T
Voltage:	230 / 460
Current:	354/177
Phase:	Three
Hz:	60 (Hz)
Service Factor:	1.15
Enclosure:	TEFC
# of Leads:	6
J-box Included:	None
Coupling/Sheave:	None
Date Received:	12/13/2023
Bearing RTDs:	No
Stator RTDs:	No
Repair Stage:	Final
Rewind:	No
Shaft Machined Fit Repairs Required:	No
Bearing Housing Machined Fit Repairs Required:	Yes
Heaters:	No
Bearing Type:	Rolling Element

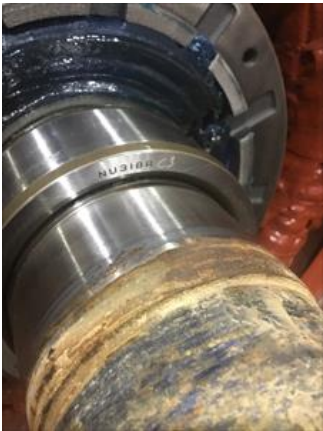
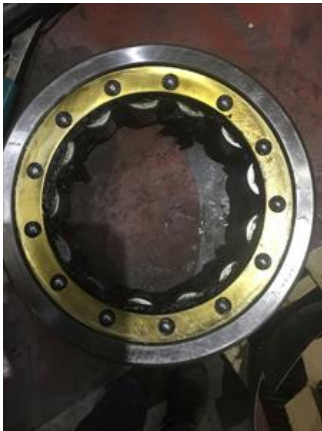
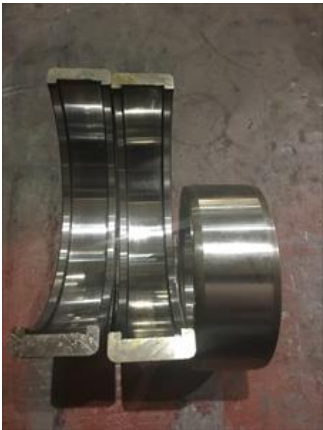
23.	Drive End Bearing Brand	Koyo
24.	Drive End Bearing Number-	NU 318R C3

25.	Drive End Bearing Qty.	1
26.	Drive End Bearing Type	(Roller) Roller Bearing
27.	Drive End Lubrication Type	(Grease) Grease Lubricated

28.	Drive End Bearing Insulation or Grounding Device?	none	
29.	Drive End Wavy Washer/Snap-Ring Other Retention Device?	none	
30.	Drive End Bearing Condition	replace	
31.	Opposite Drive End Bearing Brand	Koyo	P92

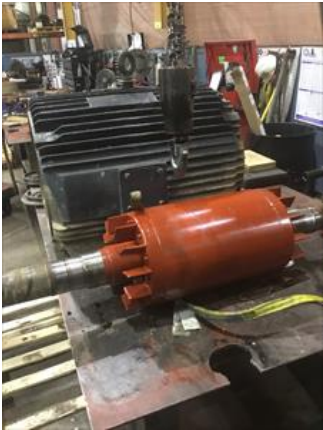
41.	Rotor Type/Material	(Squirrel Aluminum) Squirrel Cage Aluminum Die Cast	P3
-----	---------------------	--------------------------------------------------------	----

42.	Growler Test	(Pass) Pass
43.	Number of Rotor Bars	50
44.	Rotor Condition	pass
45.	List the Parts needed for the Repair Below

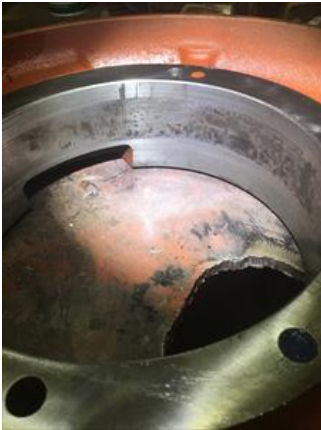
P38

59. Opposite Drive End - Endbell Bearing Fit Condition

(F) Fail

Excessive pitting and wear.

Sleeve ODE housing fit.

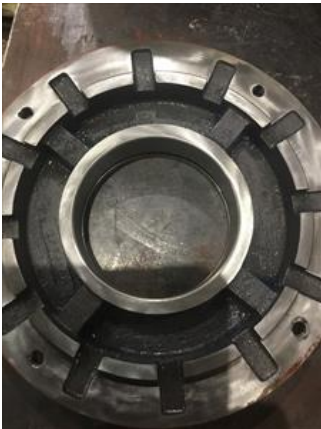
P52

60. Bearing Cap Condition

Drive End Bearing Cap

Opposite Drive End Bearing Cap

pass

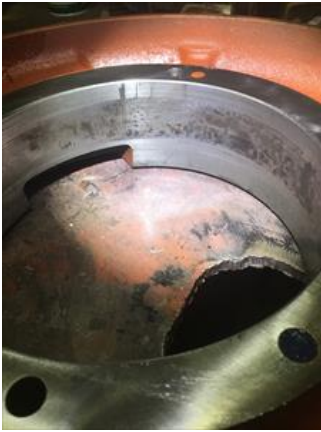
P18

64. Failure locations

ODE housing fit.

65. Root cause of failure  
*ODE housing fit bad.*
