DC Repair Report

Arkansas Box

DC Repair Report Rev. 2

Description: 30HP ELECTROSTAT DC 2500RPM
327AT

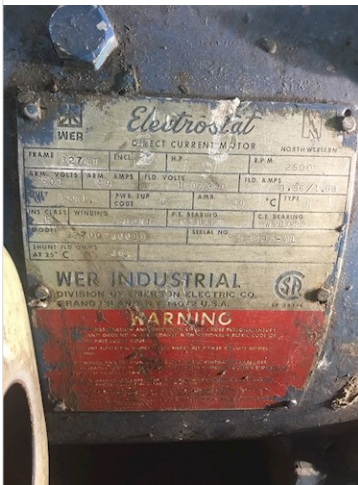
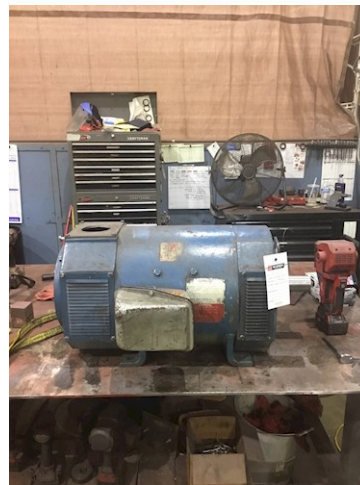
P17

2. Nameplate Picture

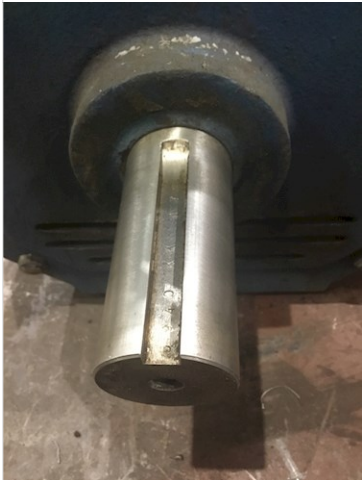
5.	Does Shaft Have Visible Damage?	(No) No	P22

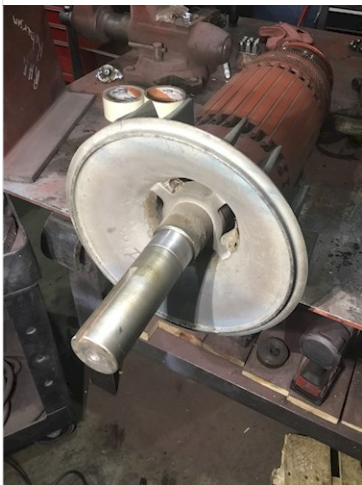
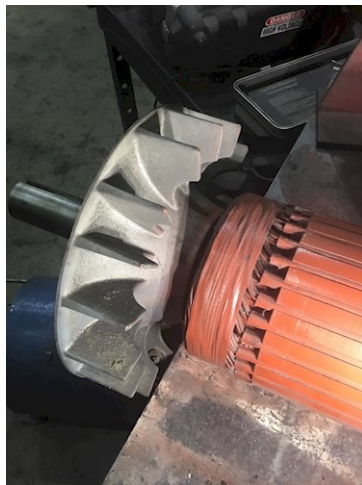
10.	Lead Length	Inches	
11.	Frame Condition	(P) Pass	
12.	Fan Condition	(P) Pass	P81
	Front fan.

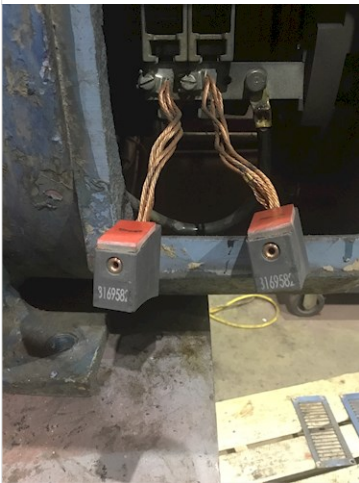
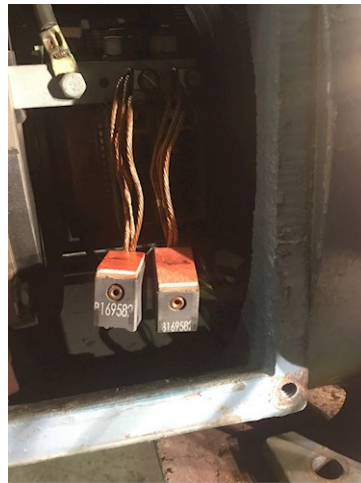
P87

13. Brush Information

replace

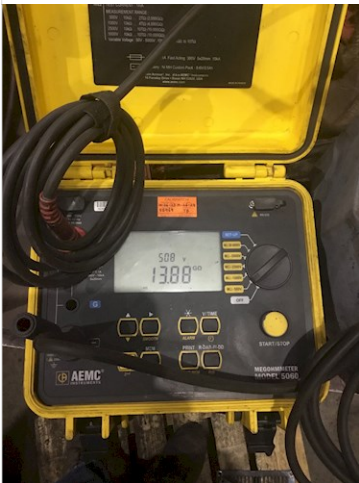
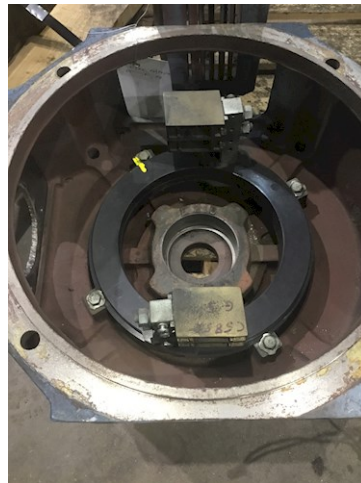
P92

14. Brush Holder Condition - Verify proper gap to Commutator

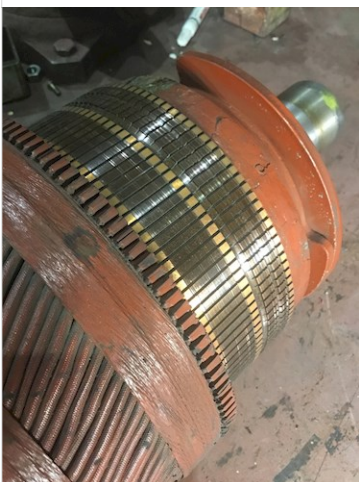
P6

15. General Condition of the Armature/Commutator

worn un-evenly

Both bearings worn from grease contamination. D.E housing fit pitted possibly from minute electrical discharge. Comm is unevenly worn and needs undercut and turned.

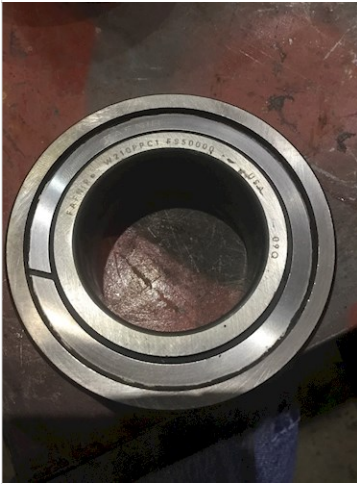
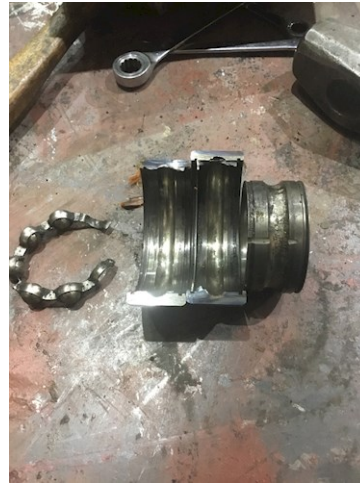
40.	Drive End Wavy Washer/Snap-Ring Other Retention Device?		none
41.	Drive End Bearing Condition		replace

Caused by grease contamination.

50. List Parts Needed Prior to Reassembly
Bearings, sleeve D.E housing fit.

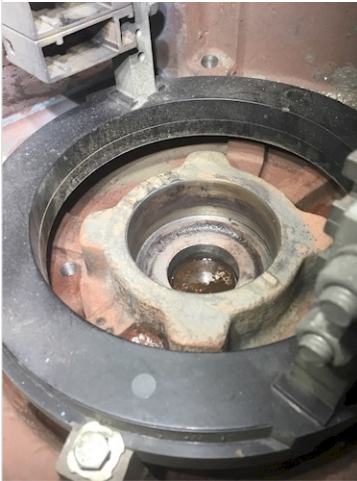
P9

58. Drive End - End Bell Bearing Fit

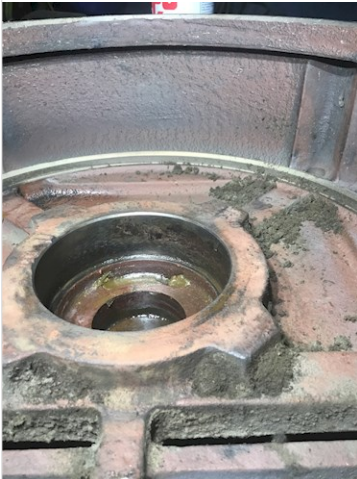
P18

59. Drive End - Endbell Bearing Fit Condition

(F) Fail

Excessive pitting and wear.

Housing fit pitted from electrical discharges and bearing has frosting. Recommend Aegis ring combined with insulation of end bell housing or insulated bearing.

D.E housing fit bad

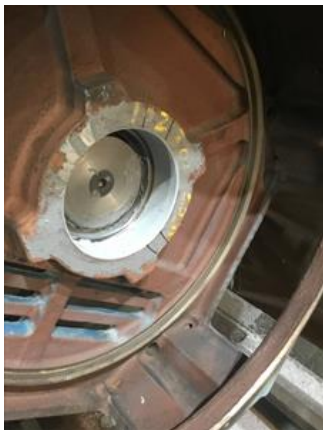
103.	Post Repair Opposite Drive End - Endbell Bearing Fit Condition		(P) Pass
	3.9373 3.9373 3.9373		P84

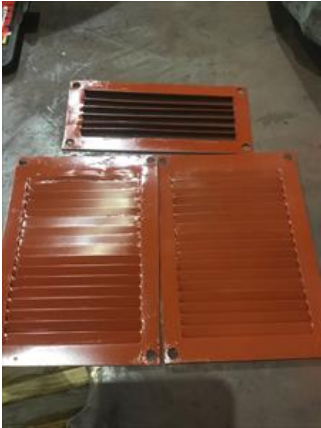
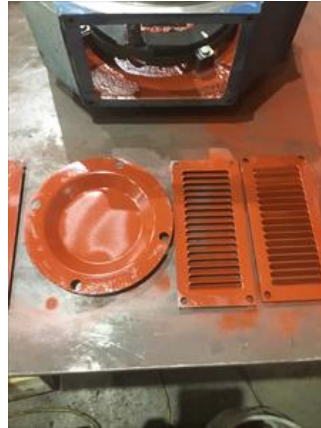
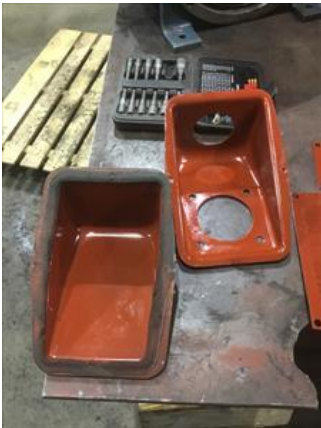
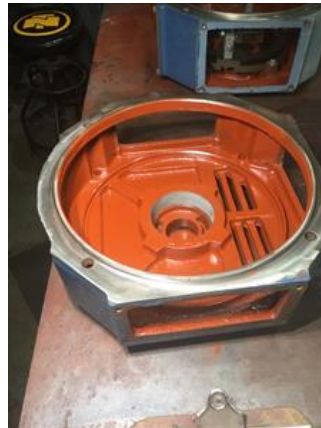
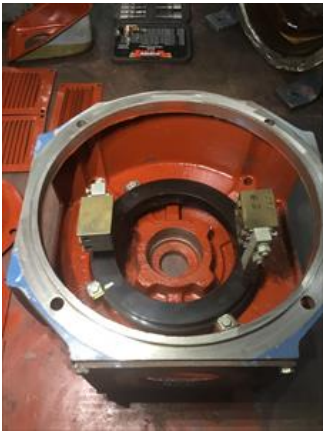
P7

107. Take Pictures of all Major Components Prior to Reassembly

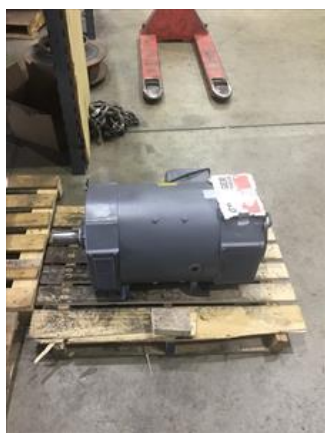
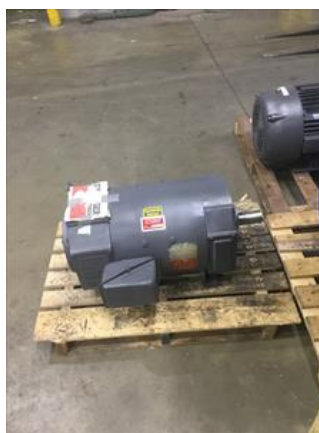
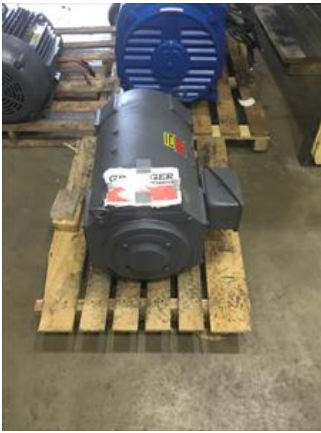
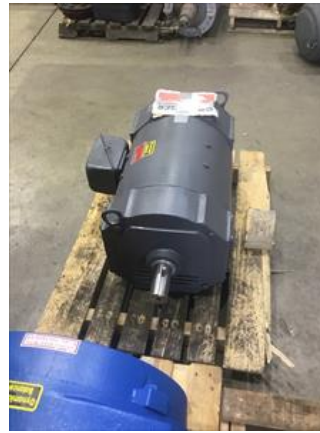
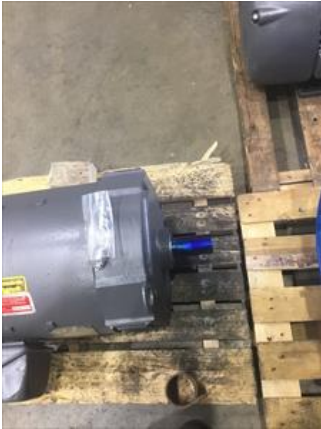
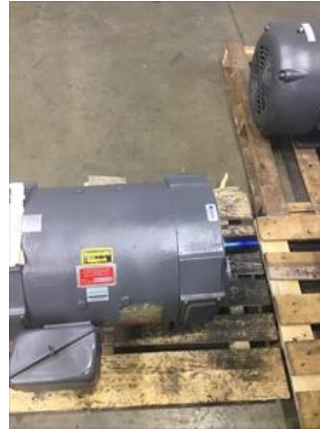
P116

122. Document Final Condition With Pictures
