AC Inspection as Found
Almatis Inc/RCP Bauxite (10014)
4701 Alcoa Road
Bauxite, AR 72011

AC Inspection - Rev. 2

Description: 1.5HP RELIANCE 1800RPM
182TDZ SHAKER

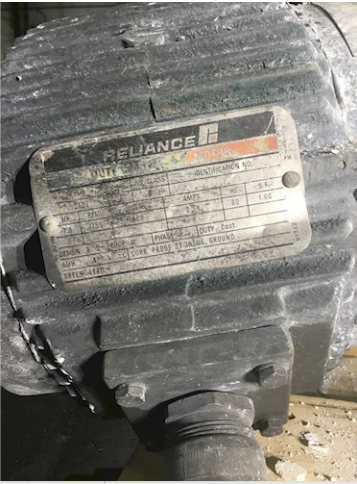
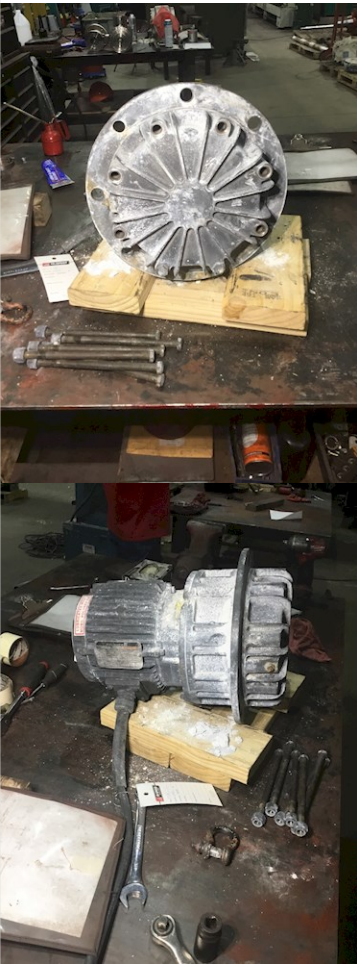
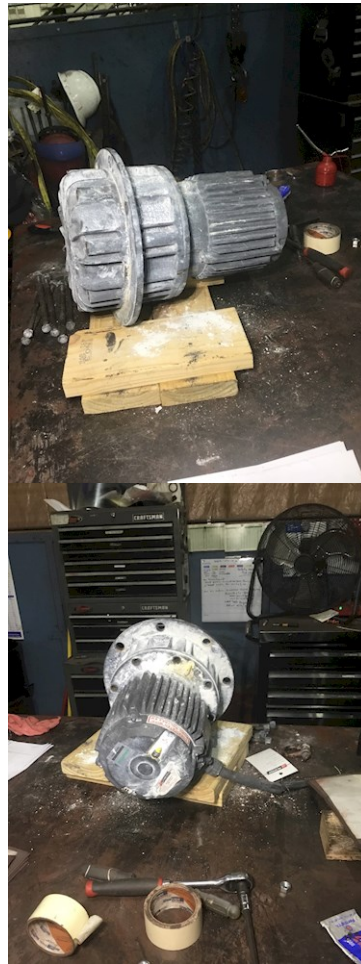
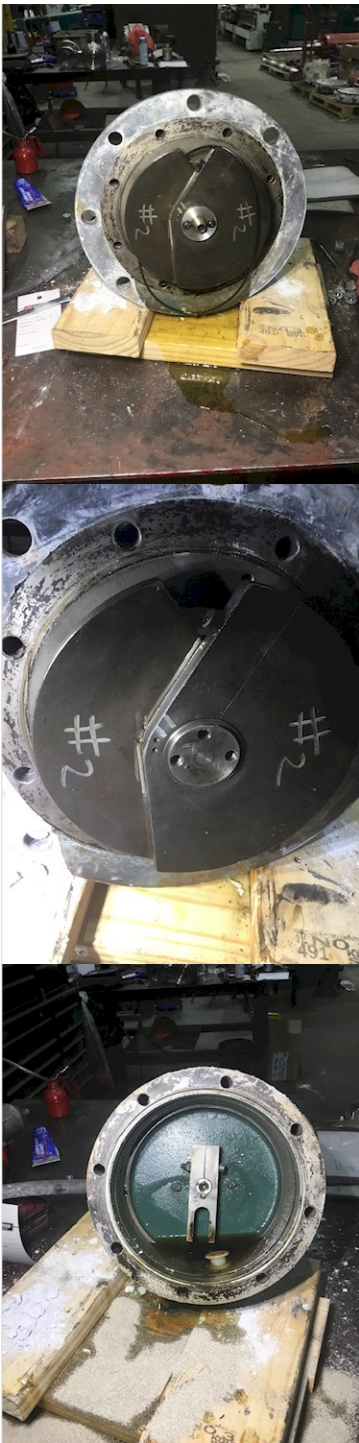
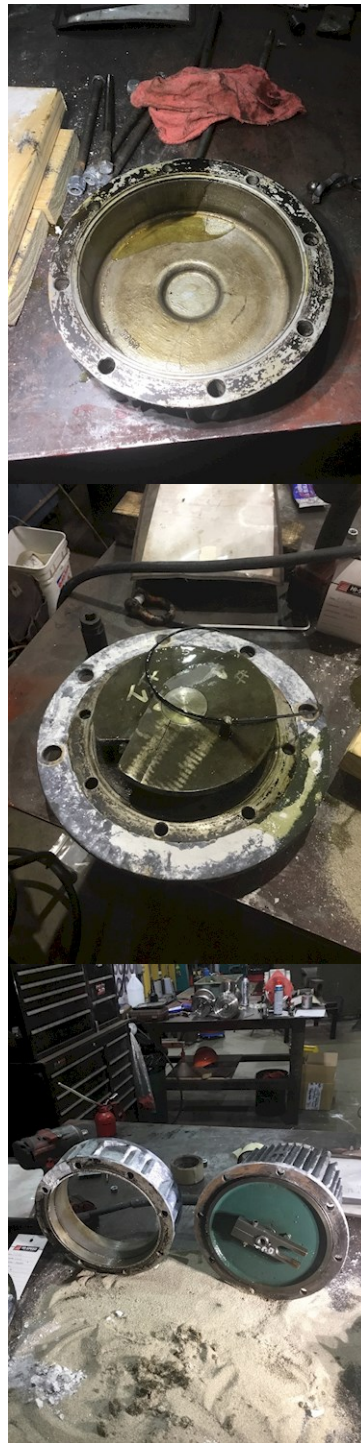
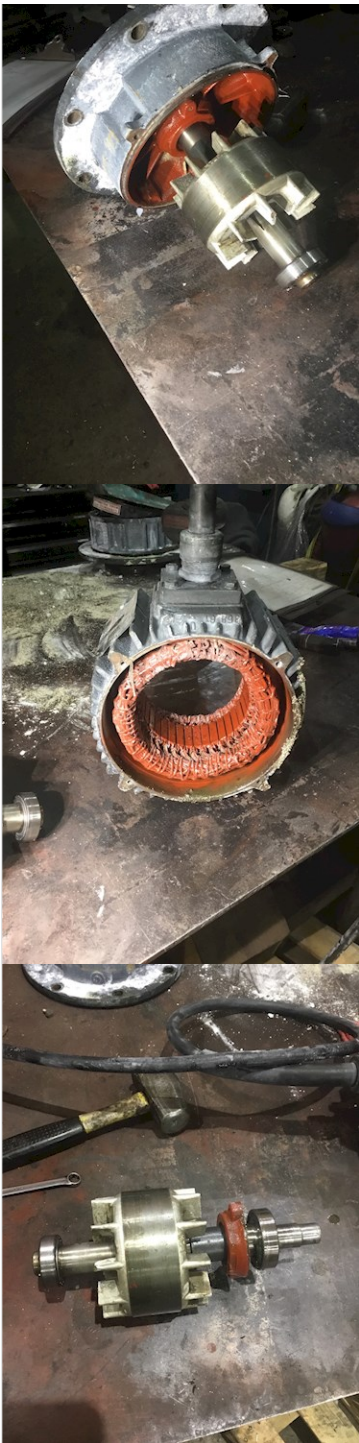
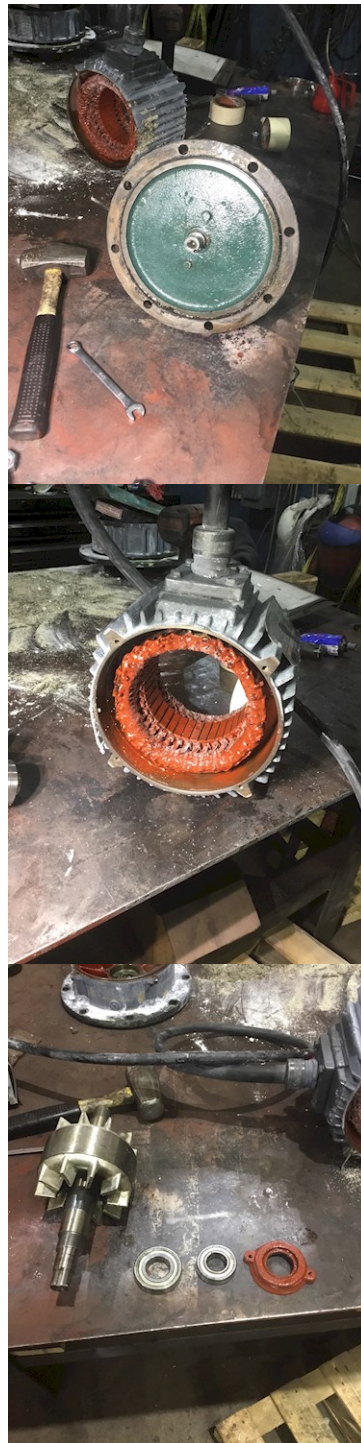
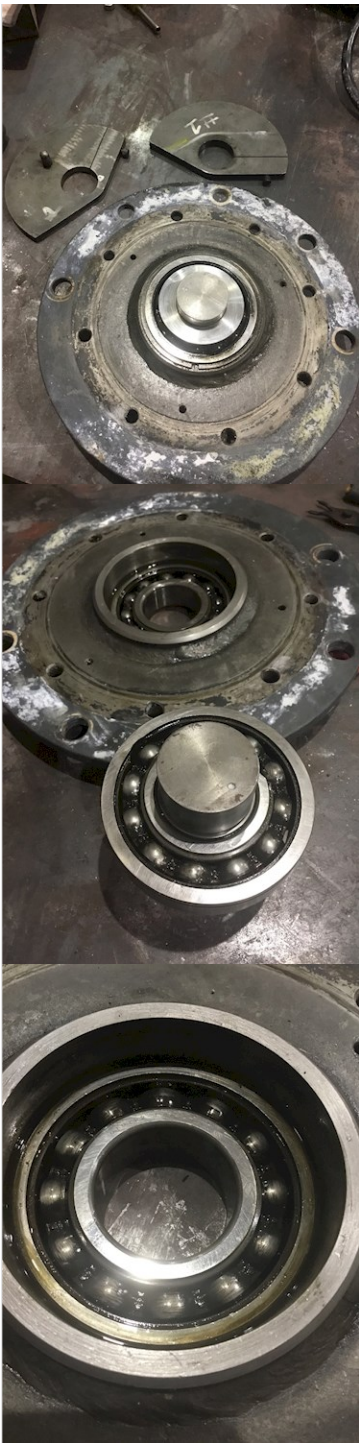
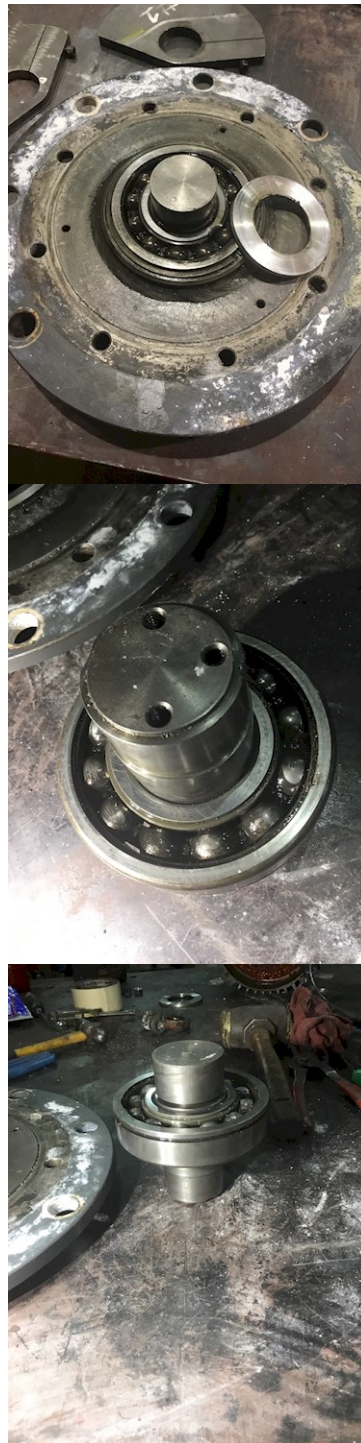
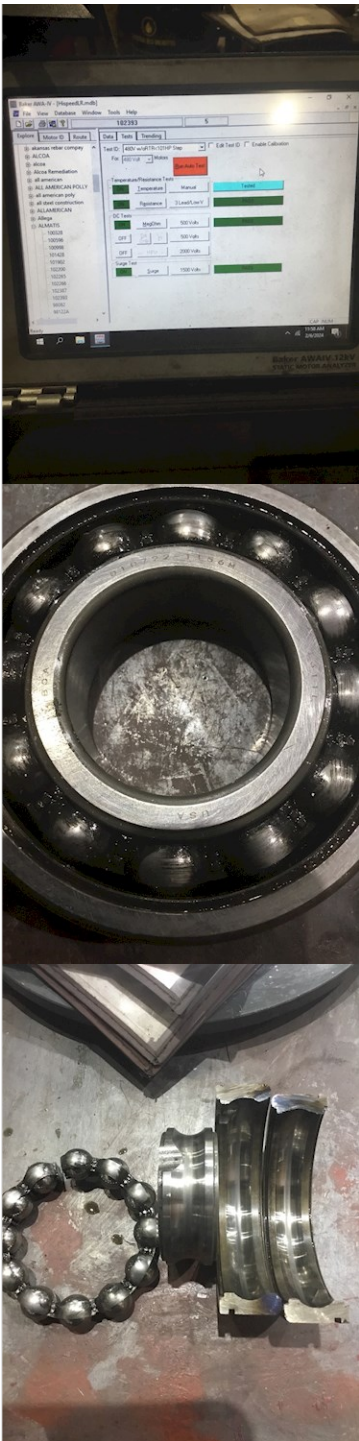
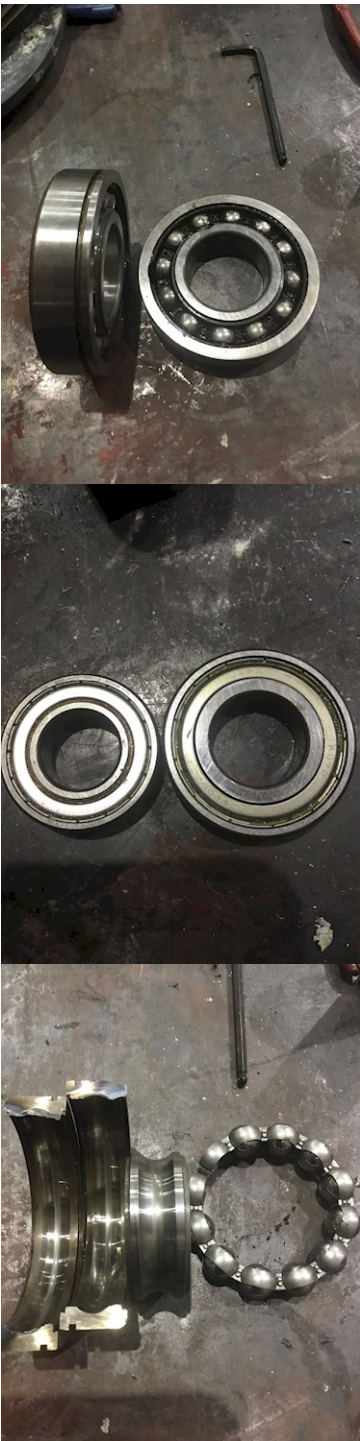
4. Describe the Overall Condition of the Equipment as Received
Serviceable

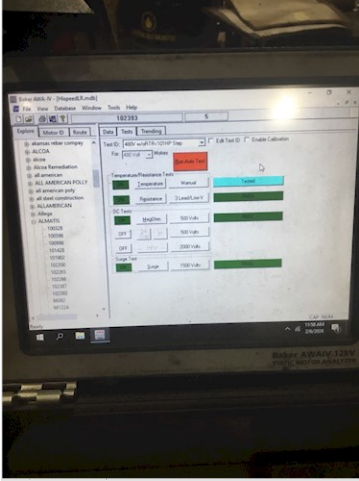
12.	Lead Length	Inches	
	5' 4"		
13.	Does it have Lugs?, If so what is the Stud Size?		
14.	Lead Numbers	1-3	
15.	Frame Condition	pass	
16.	Fan Condition	(N) NA	
17.	Broken or Missing Components	none	
Initial Electrical Inspection			
18.	Insulation Resistance/Megger	Megohms	P8

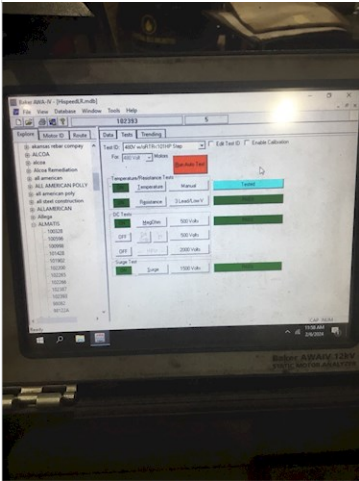
19.	Winding Resistance		
	1-2	1-3	2-3
20.	Perform Surge Test	(P) Pass	P57

21.	Number of Stator Slots	36	
22.	Stator Condition		
	Oil saturation on windings but passed surge test.		
23.	Stator Thermistors/Ohms		
24.	Stator Overloads/Ohms		
Mechanical Inspection			
25.	Drive End Bearing Brand	Koyo

66. Failure locations		
<i>O ring Seals allowed oil to leak into the stator.</i>		
67. Root cause of failure		
<i>O ring Seals allowed oil to leak into the stator.</i>		
Dynamic Balance Report

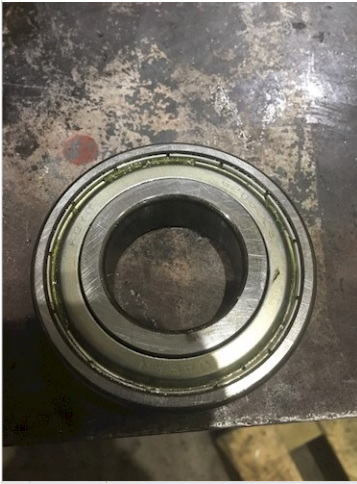
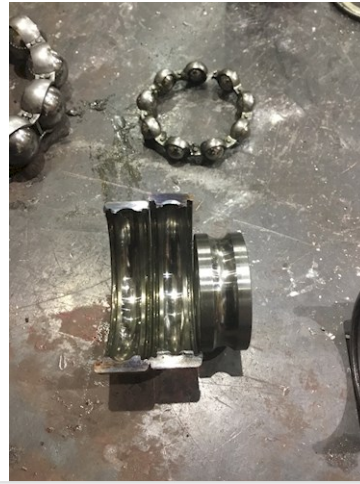
P33

26. Drive End Bearing Number-

6206 Z C3

32. Drive End Bearing Condition

replace

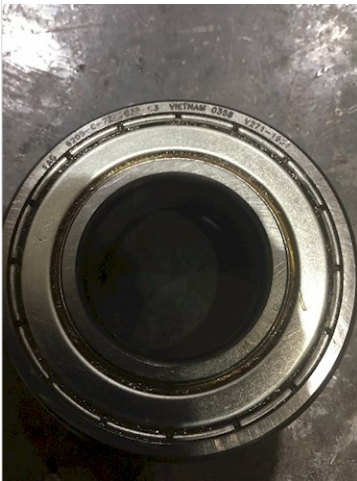
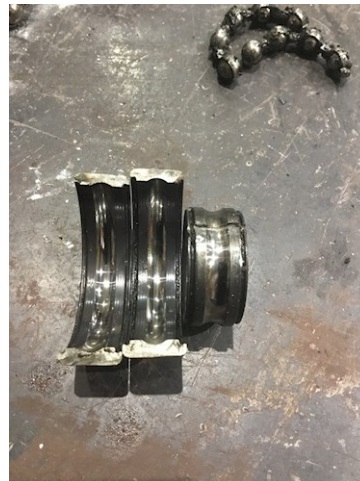
P86

33. Opposite Drive End Bearing Brand

Fag

34. Opposite Drive End Bearing Number-

6205

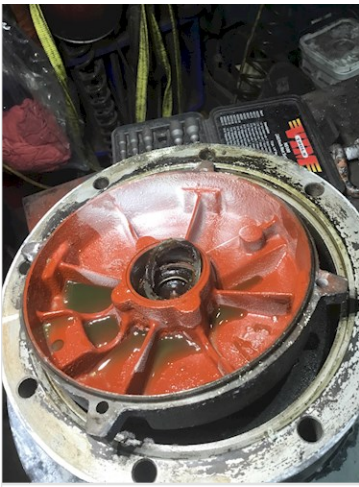
P99

40.	Opposite Drive End Bearing Condition	replace
41.	Drive End Seal	
42.	Opposite Drive End Seal	
Rotor Inspection		
43.	Rotor Type/Material	(Squirrel Aluminum) Squirrel Cage Aluminum Die Cast

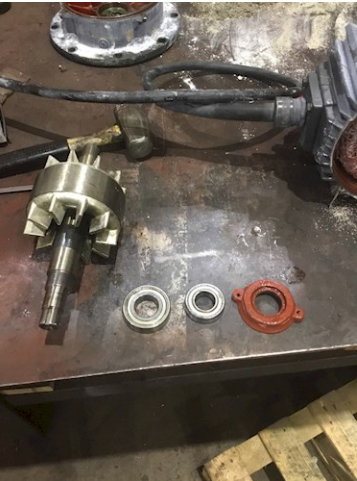
2.0477	2.0476
		2.0476
●	61. Opposite Drive End - Endbell Bearing Fit Condition	(P) Pass
62. Bearing Cap Condition P51		
	Drive End Bearing Cap	Opposite Drive End Bearing Cap
pass

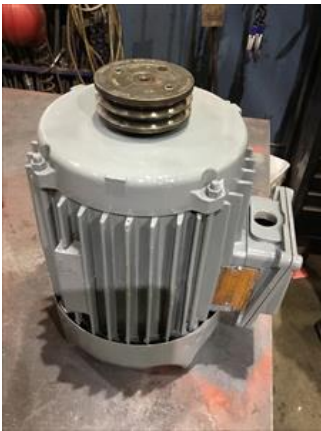
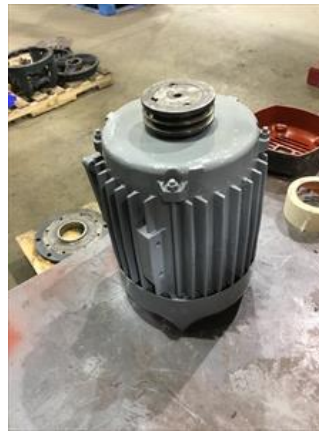
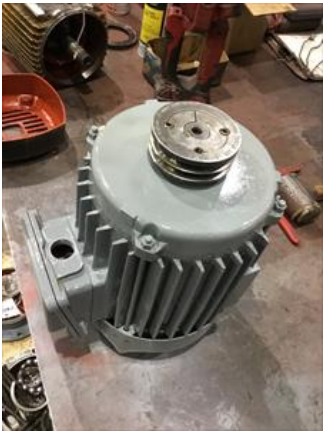
P105

84. Document Final Condition with Pictures after paint
