## AC Inspection as Found

Kimberly Clark (10176-KCM)

### AC Inspection - Rev. 2

Location: MOTOR SHOP LR  
Serial Number: RKG173045  
Description: 150HP GE 1800RPM 449T

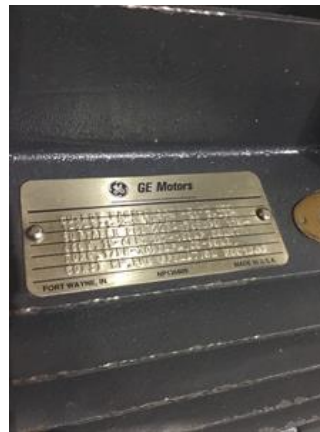
1. Report Date
2. Nameplate Picture

Hi-Speed Job Number:	102456
Manufacturer:	GE
Product Number:	5KAF44933229AP
Serial Number:	RKG173045
HP/kW:	150 (HP)
RPM:	1790 (RPM)
Frame:	449T
Voltage:	460
Current:	161
Phase:	Three
Hz:	60 (Hz)
Service Factor:	1.15
Enclosure:	TEFC
J-box Included:	Complete
Coupling/Sheave:	None
Bearing RTDs:	No
Stator RTDs:	No
Repair Stage:	Final
Heaters:	No
Winding Type :	Random Wound
Bearing Type:	Rolling Element

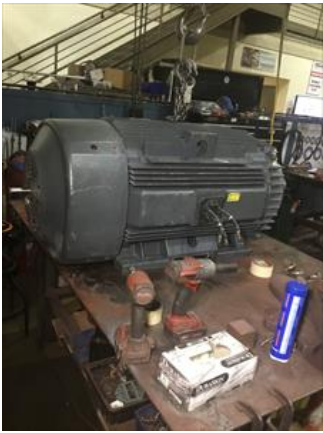
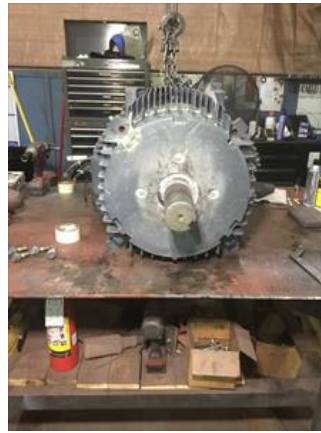
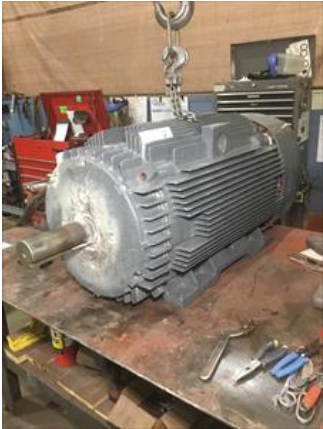
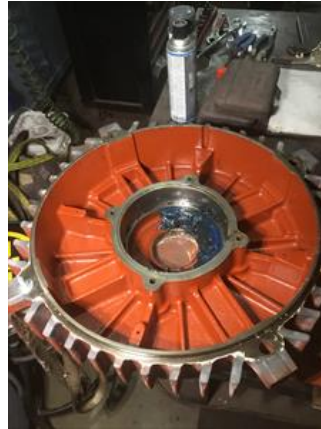
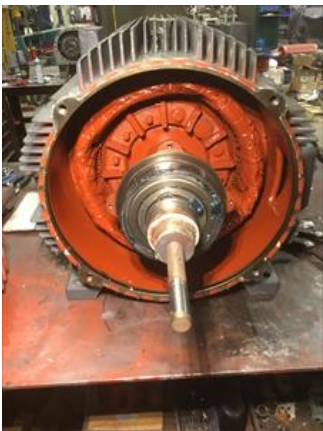
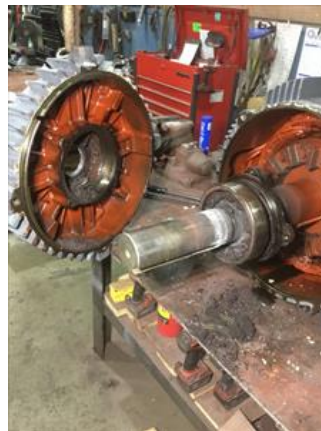
3. Photos of all six sides of the machine.

4. Describe the Overall Condition of the Equipment as Received  
*Serviceable*

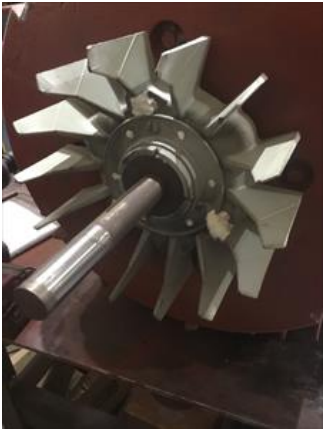
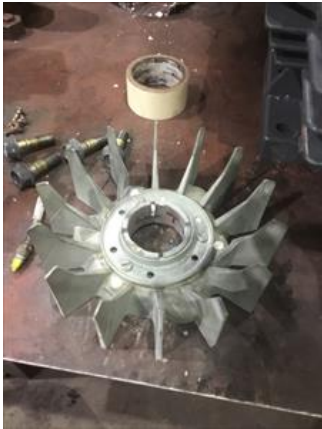
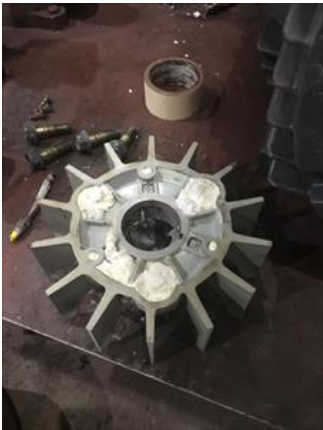
12.	Lead Length	7 Inches	
13.	Does it have Lugs?, If so what is the Stud Size?		
14.	Lead Numbers	1-3	
15.	Frame Condition	pas	
16.	Fan Condition	(P) Pass	P100

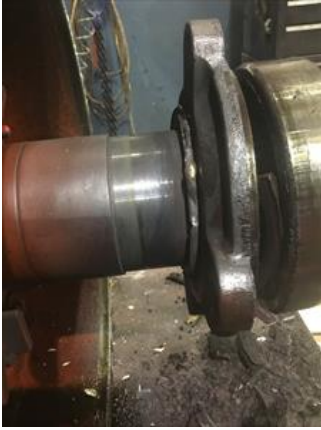
30. Drive End Bearing Insulation or Grounding Device?

**aegis ring**

*New shaft, and new DE bearing cap. Sleeve DE housing and shaft opening. Replace plastic fan with metal one. Replace aegis ring, shaft diameter 4.1875. Drill and tap ODE fan cover mount bolt hole. Motor needs to be converted from using a 318 NU to a 318 ball bearing.*

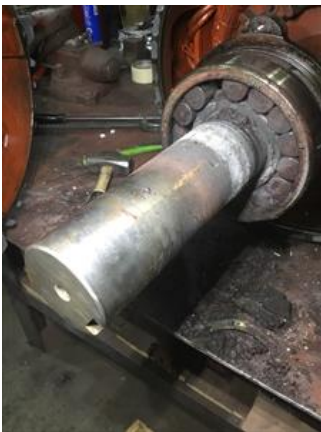
32. Drive End Bearing Condition

**destroyed**

<b>Root Cause of Failure</b>			
66.	Failure locations		
	D.E housing and shaft-fits.		
67.	Root cause of failure		
	Wrong bearing for application and contaminated lubrication.		
<b>Dynamic Balance Report</b>

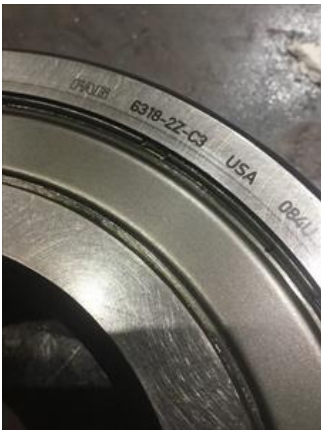
33. Opposite Drive End Bearing Brand

**FAG**

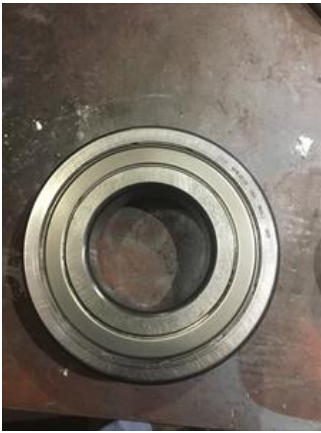
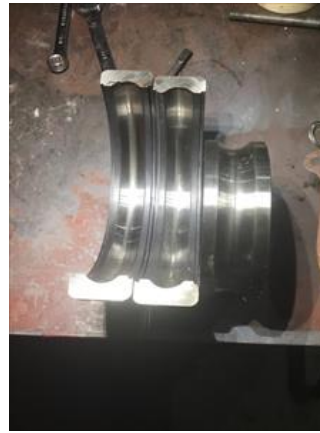
34. Opposite Drive End Bearing Number-

35. Opposite Drive End Bearing Qty.	1
36. Opposite Drive End Bearing Type	(Ball) Ball Bearing
37. Opposite Drive End Lubrication Type	(Grease) Grease Lubricated
38. Opposite Drive End Bearing Insulation or Grounding Device?	none
39. Opposite Drive End Wavy Washer/Snap-Ring Other Retention Device?	snap ring
40. Opposite Drive End Bearing Condition	replace
41. Drive End Seal	
42. Opposite Drive End Seal

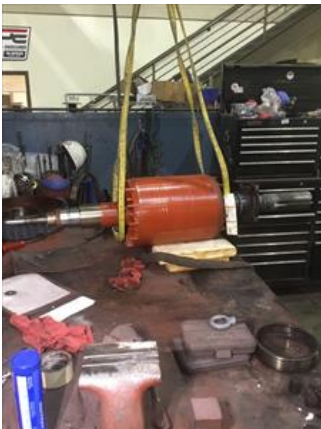
43. Rotor Type/Material	(Squirrel Aluminum) Squirrel Cage Aluminum Die Cast	P3
-------------------------	--	----

44. Growler Test	(Pass) Pass
45. Number of Rotor Bars	58
46. Rotor Condition

Good, needs new shaft.

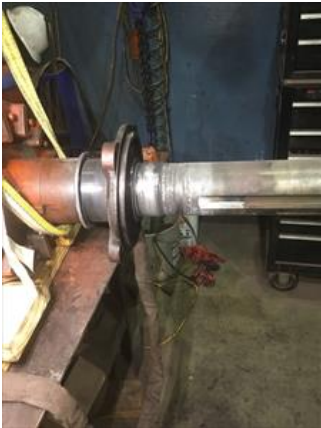
53. Drive End Bearing Shaft Fit

54. Drive End Bearing Shaft Fit Condition (F) Fail

63.	End Bell Air Seal Fits		
	Drive End Air Seal	Opposite Drive End Air Seal	
64.	List Machine Work Needed Below		
	Recommend new shaft. Sleeve D.E housing, shaft opening. Repair D.E bearing cap. Remove, drill and tap ODE housing fan cover mount bolt.
