DC Repair Report
FUTURE FUEL CHEMICAL
 2800 GAP RD HWY 394 SO
 BATESVILLE, AR 72501

DC Repair Report Rev. 2

Location: MOTOR SHOP LR
Job Number: 102566
Serial Number: WP-8-139-WP
Status: Quarantine for review
Description: 25HP 1150 RPM GE

Hi-Speed Job Number: 102566
Manufacturer: GE
Product Number : 5CD184ZA877B800
Serial Number: WP-8-139-WP
HP/KW: 75 (HP)
RPM: 1150
Armature Voltage: 92 (Volts)
Field Voltage: 160 (Volts)
J-Box Included: Yes

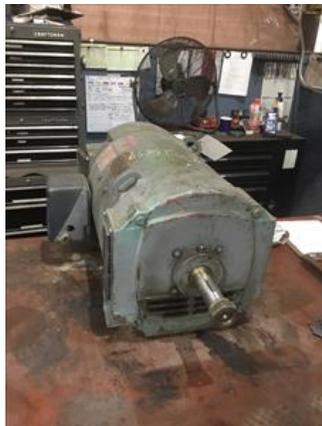
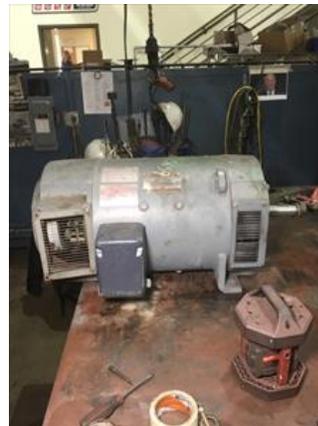
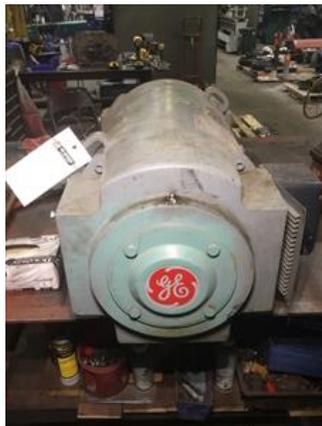
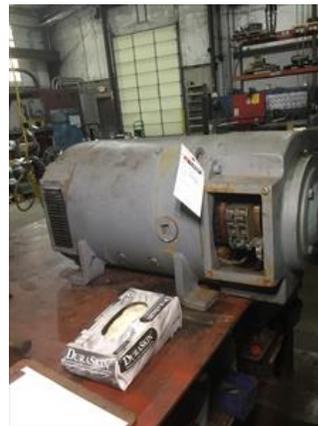
1. Describe the Overall Condition of the Equipment as Received

Serviceable

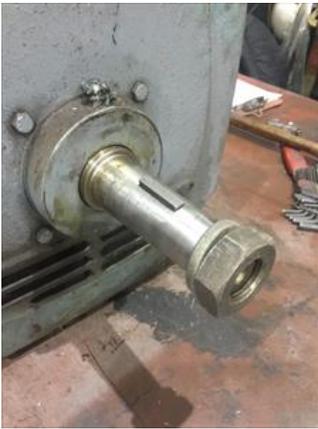
- 4. Does the Shaft Turn Freely? **(Y) Yes**
- 5. Does Shaft Have Visible Damage? **(No) No** P22

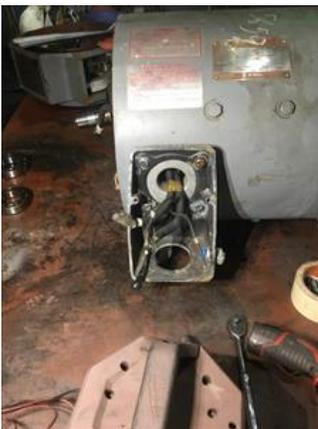
- 9. Lead Condition **(P) Pass** P55

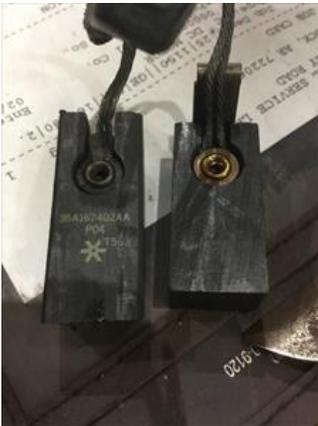
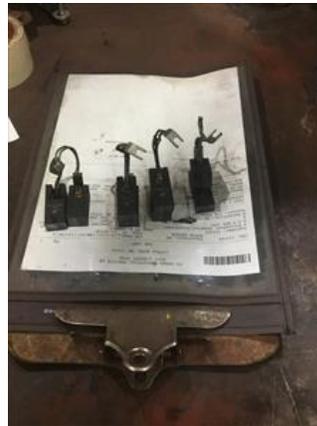
13. Brush Information

Brush Number	Quantity	Condition
36A167402AA	4	replace

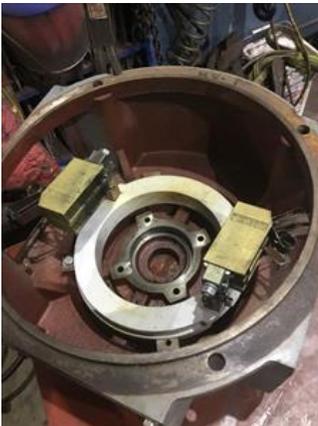
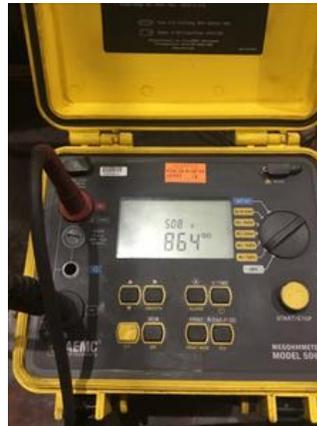
14. Brush Holder Condition - Verify proper gap to Commutator

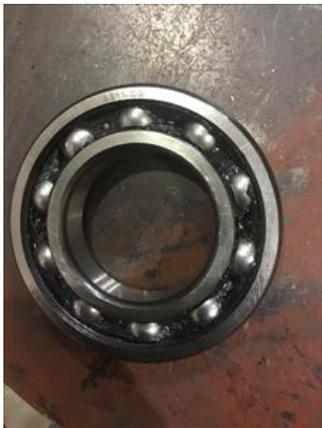
33.	Shaft Runout Drive End		0.002 inches
34.	Shaft Runout Armature		
	Drive End Bearing Journal	Armature Core	ODE Bearing Journal
35.	Drive End Bearing Number		6211
36.	Drive End Bearing Quantity		1
37.	Drive End Bearing Type		(Ball) Ball Bearing P47

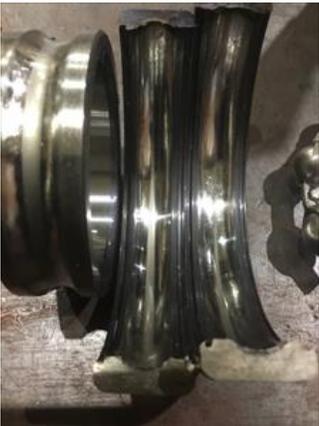
38.	Drive End Lubrication Type	(Grease) Grease Lubricated	
39.	Drive End Bearing Insulation or Grounding Device?		
	<input type="checkbox"/> <i>None</i>		
40.	Drive End Wavy Washer/Snap-Ring Other Retention Device?	none	
41.	Drive End Bearing Condition	replace/frosting	P79

Motor has no shaft current protection i.e. aegis shaft grounding ring or insulated housing fit or bearing. Both bearings show evidence of electrical discharge machining in the form of frosting.

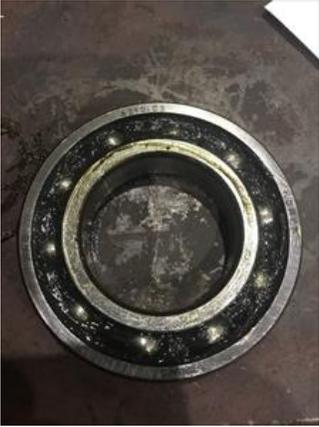
42.	Opposite Drive End Bearing Number	6210	
43.	Opposite Drive End Bearing Quantity	1	
44.	Opposite Drive End Bearing Type	(Ball) Ball Bearing	P100

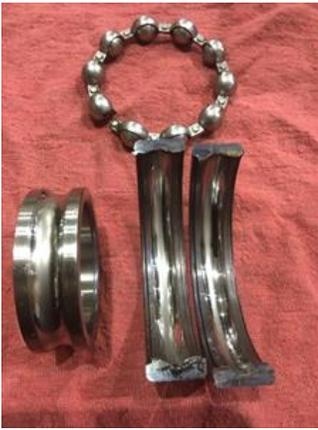
45.	Opposite Drive End Lubrication Type	(Grease) Grease Lubricated	
46.	Opposite Drive End Bearing Insulation or Grounding Device?		
	<input type="checkbox"/> <i>None</i>		
47.	Opposite Drive End Wavy Washer/Snap-Ring Other Retention Device?	none	
48.	Opposite Drive End Bearing Condition	replace/frosted	P114

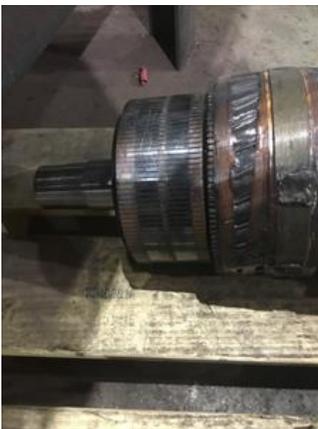
66. Failure Locations

D.e and ode bearings, and comm requires polishing.

D.E & ODE housing fits bad

ODE housing fit requires insulated fit.
