AC Inspection as Found

Rogers Group (01189502)

AC Inspection - Rev. 2

Description: 200HP 1175RPM TOSHIBA

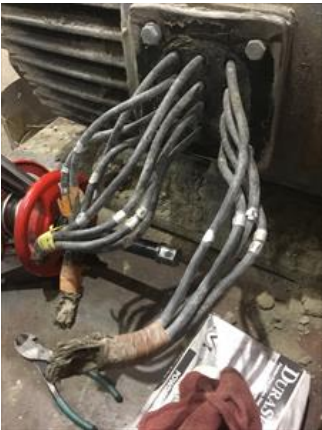
8.	Assembled Shaft Runout	0.002 Inches	
9.	Assembled Shaft End Play	0 inches	
10.	Air Gap Variation <10%		
	Na		
11.	Lead Condition	(P) Pass	
12.	Lead Length	13.5 Inches	P87

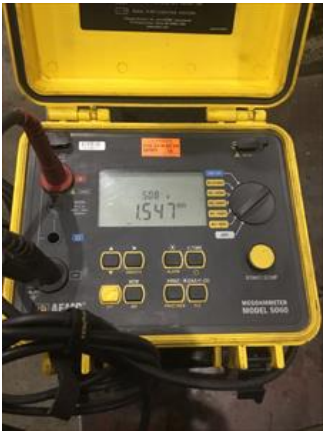
20. Insulation Resistance/Megger

182570		3	
Data		Tests	Trending
Time	Test ID	Test	Result
1/5/2024 10:40	400V w/o...	T...	PASS
8/22/2023 8:35...	400V w/o...	T...	PASS
8/22/2023 8:23...	400V w/o...	T...	PASS
Test Date: 1/5/2024 8/22/2023 8/22/2023			
Test Time: 10:40:26 AM 8:35:40 AM 8:23:28 AM			
Temp Status: Tested Tested No Test			
Temp (°C): 32.8 21.1			
IR Temp Com.: Thermoplastic Thermoplastic None			
Test Status: PASS PASS No Test			
Bal L1 (Ohms)			
Bal L2 (Ohms)			
Bal L3 (Ohms)			
L1-L2 (Ohms): 0.0298 Core B... 0.0348 Core B...			
L2-L3 (Ohms): 0.0255 Core B... 0.0348 Core B...			
L3-L1 (Ohms): 0.0250 Core B... 0.0348 Core B...			
Max Delta R %: 2.985 0.193			
Cable 1 (Ohms): 0.0081 Core B... 0.0022 Core B...			
Cable 2 (Ohms): 0.0081 Core B... 0.0022 Core B...			
Template Application Results Summary Surge PI Step-Ramp Voltage

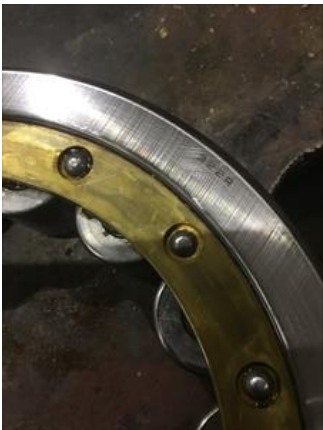
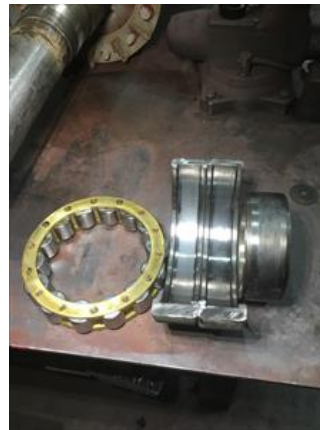
27.	Drive End Bearing Brand	Koyo	
28.	Drive End Bearing Number-	NU 322R	P32

replace

49.	List the Parts needed for the Repair Below	
	<i>New fan cover bearings and recondition.</i>	
50.	Signature of Technician that Disassembled Motor	Terrence Holland

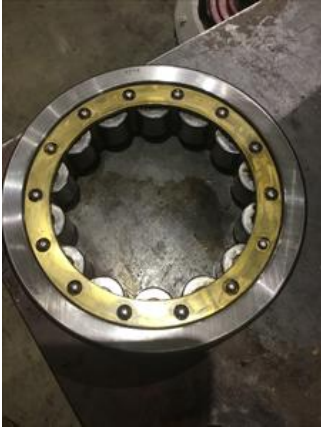
31. Drive End Lubrication Type

(Grease) Grease Lubricated

34. Drive End Bearing Condition

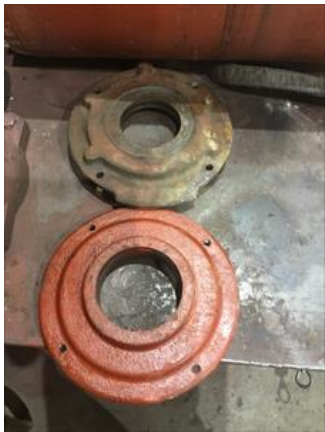
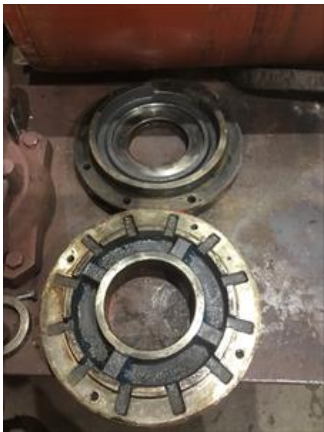
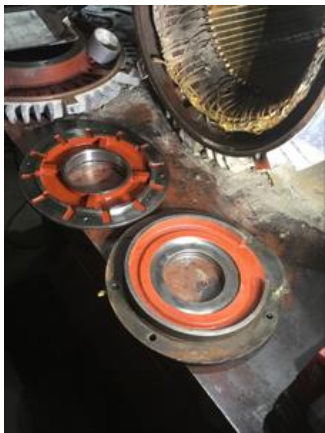
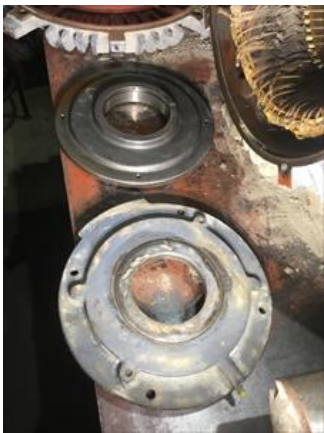
62.	Opposite Drive End - Endbell Bearing Fit		
		0 Degrees	60 Degrees	120 Degrees
	<div>Bad due to groove worn in fit.</div>			
<div></div>	63.	Opposite Drive End - Endbell Bearing Fit Condition		(F) Fail

Fan cover mount bolts need to be drilled and tapped from broken off bolts.

66. List Machine Work Needed Below

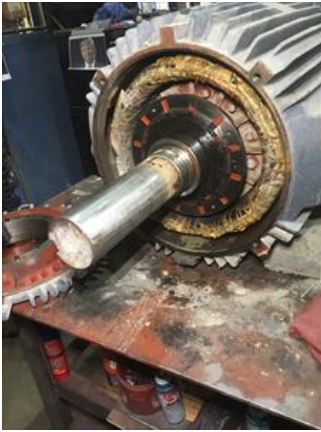
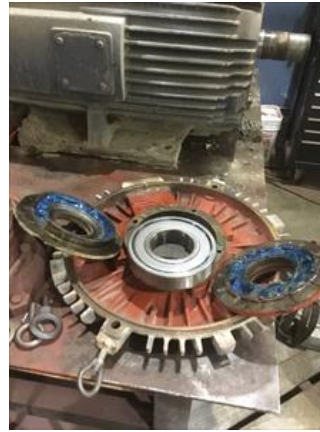
68. Failure locations

Stator housing had water inside and ODE housing fit.

Excessive amounts of water inside the stator and contaminated grease on both ends

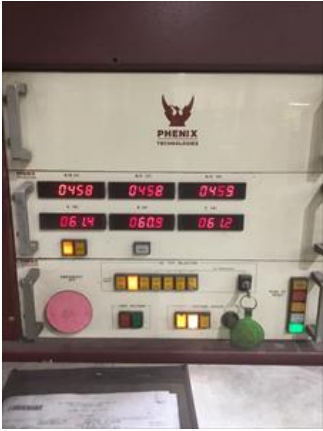
100. Test Run Voltage P56

Volts	Volts	Volts
458	458	459
