## AC Inspection as Found Novus Arkansas, LLC (11612)

Description:150HP 1780RPM WEG

Hi-Speed Job Number:	102593
Manufacturer:	WEG
Product Number:	15018EP3GBB445T
Spec/ID #:	ET
HP/kW:	150 (HP)
RPM:	1780 (RPM)
Frame:	444/5T
Voltage:	460
Current:	168 (Amps)
Phase:	Three
Hz:	60 (Hz)
Service Factor:	1.15
Enclosure:	TEFC
# of Leads:	12
J-box Included:	Complete
Coupling/Sheave:	None
Bearing RTDs:	No
Stator RTDs:	No
Repair Stage:	Final
Rewind:	No
Shaft Machined Fit Repairs Required:	Yes
Bearing Housing Machined Fit Repairs Required:	No
Heaters:	No
Winding Type :	Random Wound
Bearing Type:	Rolling Element

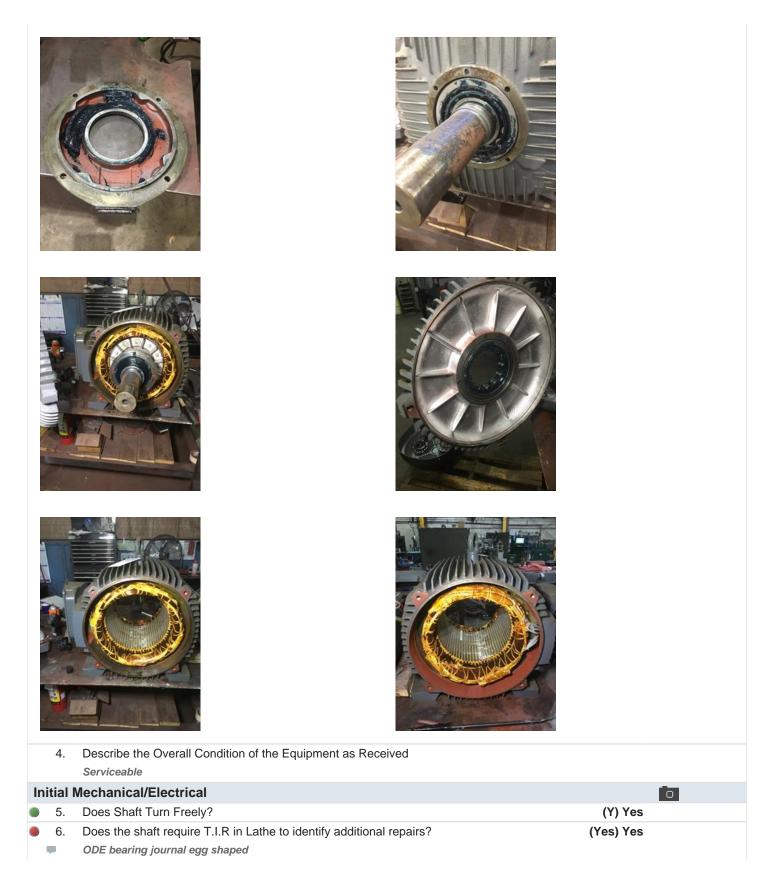
P45

7.	Does Shaft Have Visible Damage?	(No) No	P26
	Some minor rust		
8.	Assembled Shaft Runout	0.001 Inches	
9.	Assembled Shaft End Play	0 inches	
10.	Air Gap Variation <10%	pass	
• 11.	Lead Condition	(P) Pass	P69
12.	Lead Length Does it have Lugs?, If so what is the Stud Size?	12 Inches (No) No	
14.	Lead Numbers		P97
•	2,4,8,10 5,9,3,11 1,6,7,12

1	5.	Frame Condition			pass	
	5. 6.	Frame Condition Fan Condition			pass (P) Pass	P115
17	7.	Broken or Missing Components			none	
		lectrical Inspection				0
Deta Ten Time Internet Interne	Trend           422200           42200           42200           8           1025           8           1020	Test B         Data         Data <thdata< th="">         Data         Data         <t< td=""><td></td><td>Image: Control of the first fir</td><td>Megohms</td><td>P8</td></t<></thdata<>		Image: Control of the first fir	Megohms	P8
edel entre Transit	Al Page 18553 Test International	1-2	1-3	2-3		P20

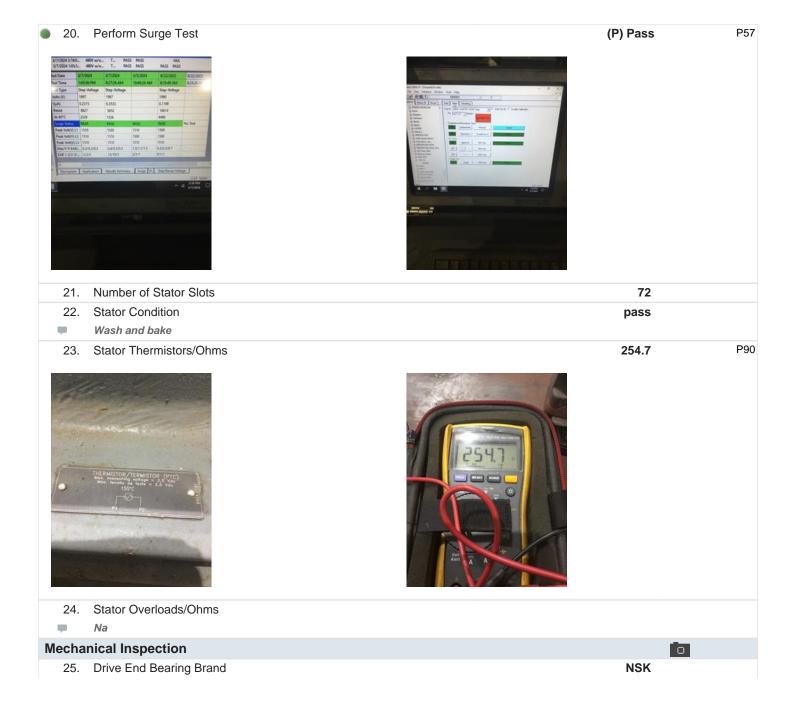
27.	Drive End Bearing Qty.	1	
28.	Drive End Bearing Type	(Roller) Roller Bearing	
29.	Drive End Lubrication Type	(Grease) Grease Lubricated	
30.	Drive End Bearing Insulation or Grounding Device?	none	
31.	Drive End Wavy Washer/Snap-Ring Other Retention Device?	snap ring	
32.	Drive End Bearing Condition	replace	P82
33.	Opposite Drive End Bearing Brand	SKF	
34.	Opposite Drive End Bearing Number-	6316 2Z/C3	P99

NU 319 C3

35.	Opposite Drive End Bearing Qty.	1	
36.	Opposite Drive End Bearing Type	(Ball) Ball Bearing	
37.	Opposite Drive End Lubrication Type	(Grease) Grease Lubricated	
38.	Opposite Drive End Bearing Insulation or Grounding Device?	none	
39.	Opposite Drive End Wavy Washer/Snap-Ring Other Retention Device?	snap ring	
40.	Opposite Drive End Bearing Condition	replace	P118

55.	Opposite Drive End Bearing Shat	t Fit		
		0 Degrees	60 Degrees	120 Degrees	
		3.1496	3.1492	3.149	
	•	Egg shaped.			
	56.	Opposite Drive End Bearing Shat	t Fit Condition	(F) Fail

66.	Failure locations		P9
	Opposite drive end shaft bearing jo Bearing grease dirty/contaminated.	ournal out of tolerance. Egg shaped.	
	Image: Control of the second secon		
67.	Root cause of failure Both bearings had contaminated gatolerance.	rease inside them and the ODE shaft bea	aring journal was out of allowable
Dynam	nic Balance Report		
68.	Rotor Weight and Balance Grade		
	Rotor Weight	Balance Grade	
-	Na		
69.	Initial Balance Readings		
	Drive End	Opposite Drive End	
_	Na		
70.	Final Balance Readings		
70.	Drive End	Opposite Drive End	
		Opposite Drive Litu	
	Na		
71.	Technician		
-	Na		
	nical Fits- Rotor - Post Repair	r	
72.	Shaft Runout Post Repair		inches

44.	Growler Test		(Pass) Pass	
	45.	Number of Rotor Bars		58	
	46.	Rotor Condition		pass	
	-	List the Parts needed for the Rep	air Below	puss	
	<i>чг</i> .	NU 319 roller bearing. 6316 2Z / C3 ball bearing

62.	Bearing Cap Condition		P52
	Drive End Bearing Cap	Opposite Drive End Bearing Cap	
		pass	
63.	End Bell Air Seal Fits		
	Drive End Air Seal	Opposite Drive End Air Seal	
	pass	pass	
64.			
	Repair ODE shaft bearing journal.		
65.	Technician	Terrence Holland	
_	Co witness RRW		
Poot C		-	
ROOT	Cause of Failure
