DC Repair Report

Location: MOTOR SHOP LR

Description: 50 HP DC

Manufacturer: Reliance

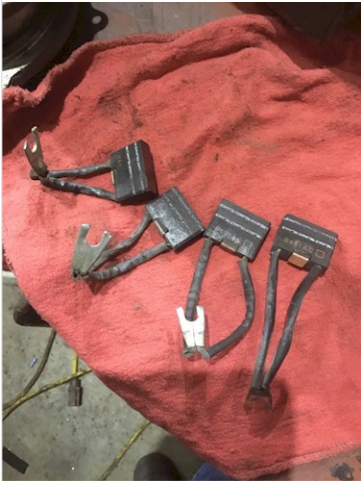
13. Brush Information

Brush Number	Quantity	Condition
0451AC	4	replace

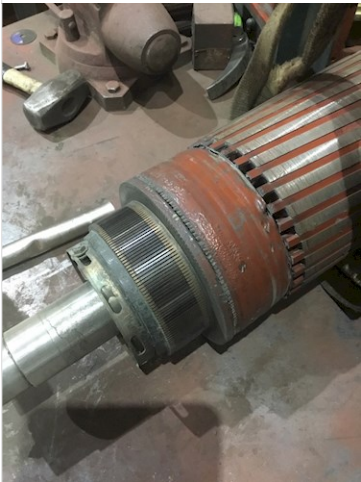
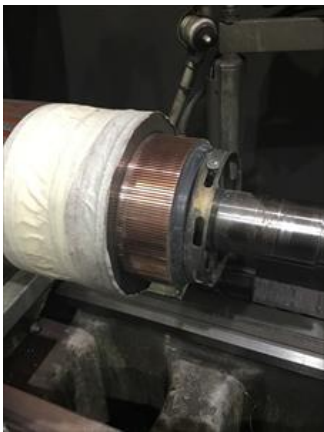
15. General Condition of the Armature/Commutator

Polish

Polished commutator
Gary

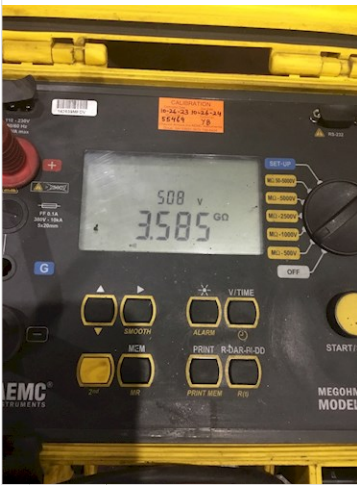
16. Armature Insulation Resistance to Ground

3.585 Gigohms

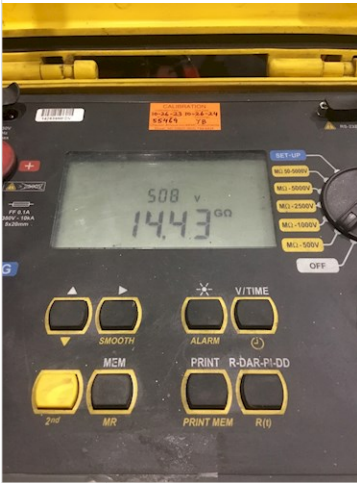
17. Field Circuit Insulation Resistance to Ground

14.43 Gigohms

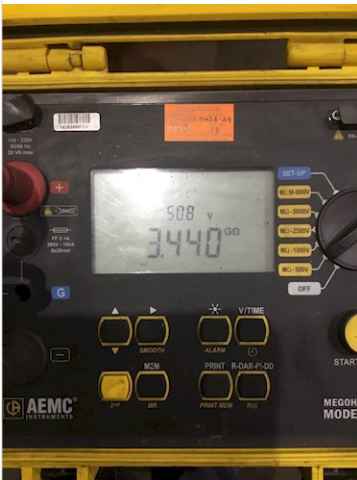
18. Interpole Circuit Insulation Resistance to Ground

3.44 Gigohms

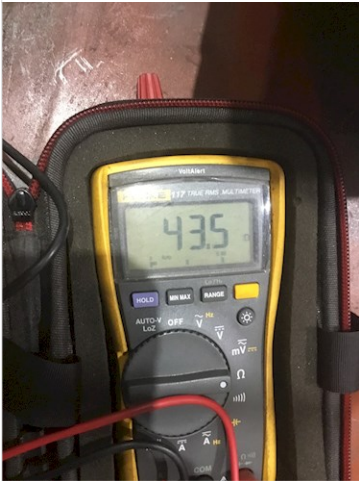
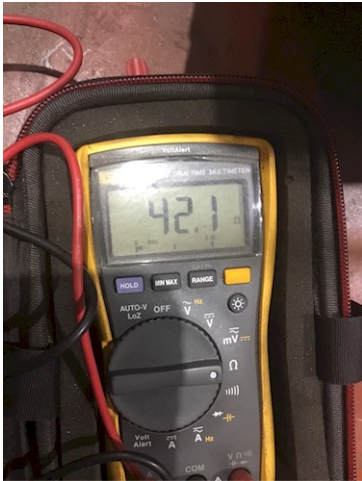
20. Field Ohms

Between F1/F2

Between F3/F4

44

42.1

67.	Root Cause of Failure		
	Fields checked bad. Ohm readings out of balance.		
Commutator Data			
68.	Total Copper Segment Length		
69.	Number of Bars		
70.	Number of Wires Per Copper Bar and Size		
	Number of Wires per Bar	Wire Size

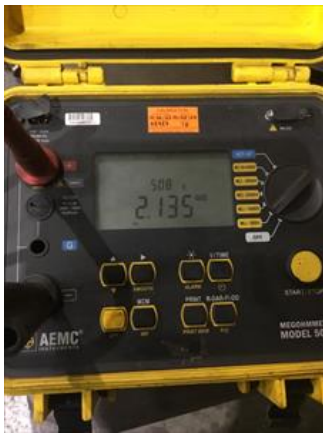
85. Post Rewind Interpole Circuit Insulation Resistance to Ground

2.135 Gigohms
