AC Inspection as Found
JA Riggs Tractor Company (10438)
9125 Interstate 30
Little Rock, AR 72209

AC Inspection - Rev. 2

Description:15KW FUJI

Hi-Speed Job Number: 102921

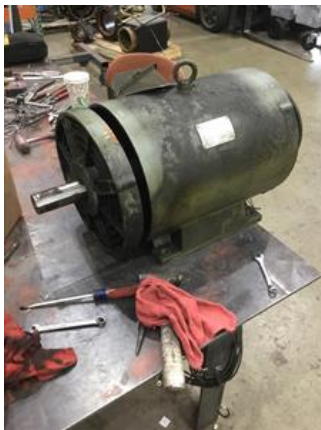
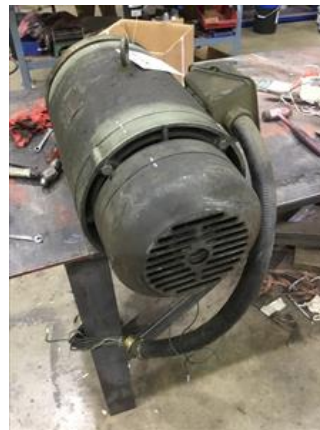
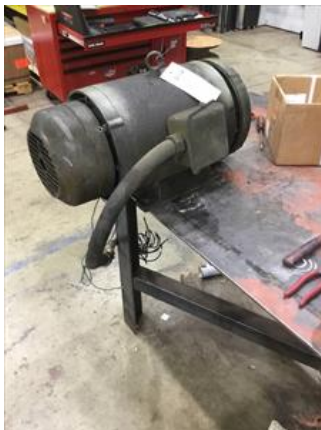
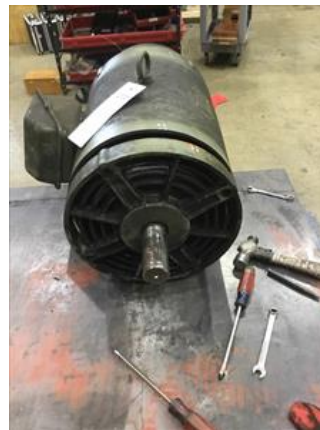
3. Photos of all six sides of the machine.

4.	Describe the Overall Condition of the Equipment as Received	
	<i>Serviceable</i>	
5.	Distance from the end of the shaft to the Coupling/Sheave	inches
Initial Mechanical/Electrical		
6.	Does Shaft Turn Freely?	(Y) Yes
7.	Does the shaft require T.I.R in Lathe to identify additional repairs?	(No) No
8.	Does Shaft Have Visible Damage?	(No) No
9.	Assembled Shaft Runout	0.001 Inches
10.	Assembled Shaft End Play	0 inches
11.	Air Gap Variation <10%	
	Na

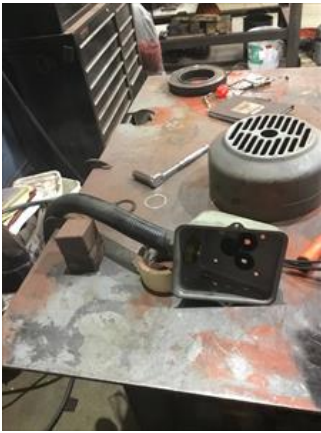
83.	Final Insulation Resistance Test		1.2 Gigohms
84.	Assembled Shaft Endplay		0 inches
85.	Assembled Shaft Runout		0.001 inches
86.	Test Run Voltage		P56
	Volts	Volts	Volts
	458	458	460
	<div><div></div>Witness: C. Wiley</div>		
<div>

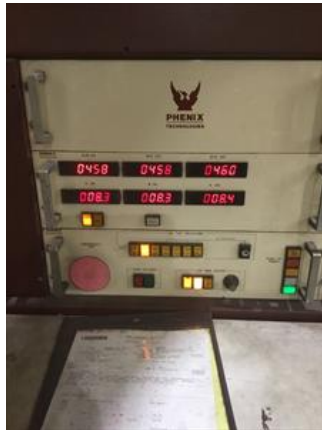
</div>			
87.	Test Run Amperage		
	Amps	Amps	Amps
	8.3000000000000001	8.3000000000000001	8.4
88.	Drive End Vibration Readings - Inches Per Second		
	Horizontal	Vertical	Axial
	0.03	0.01	0.03
89.	Opposite Drive End Vibration Readings - Inches Per Second		
	Horizontal	Vertical	Axial
	0.01	0.04	0.03
90.	Ambient Temperature - Fahrenheit		
91.	Drive End Bearing Temps - Fahrenheit		
	5 Minutes	10 Minutes	15 Minutes
92.	Opposite Drive End Bearing Temps - Fahrenheit		
	5 Minutes	10 Minutes	15 Minutes
