AC Inspection as Found
Weaver-Bailey Contractors
1601 Mayor Lane
Conway, AR 72032

AC Inspection - Rev. 2

Location: MOTOR SHOP LR

Description: 100HP 404T BALDOR

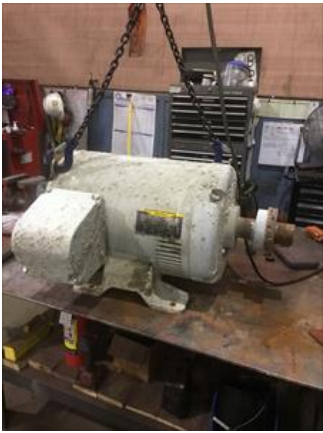
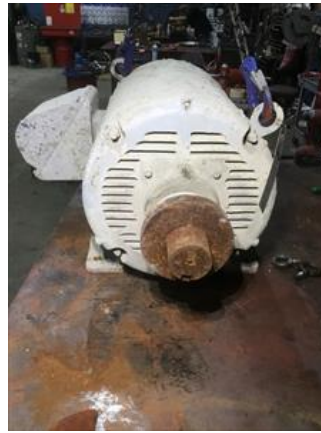
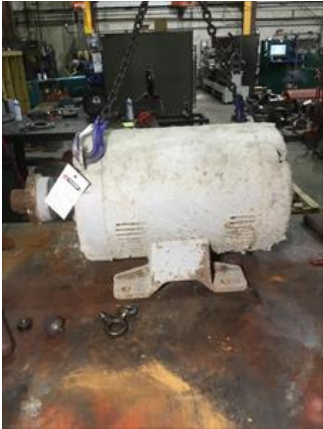
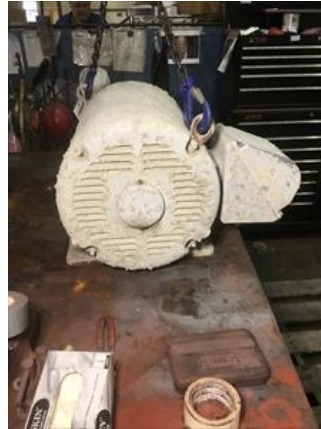
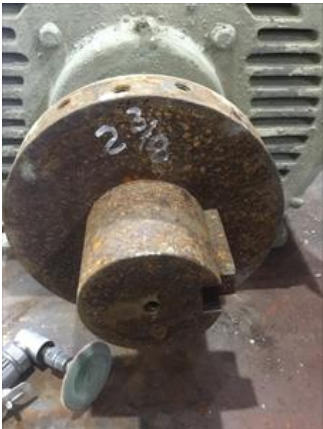
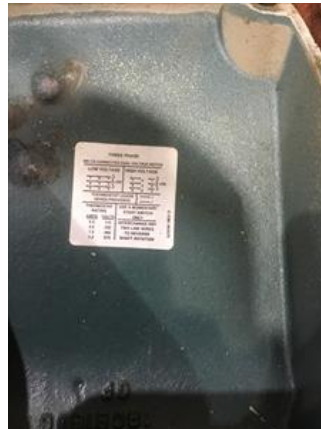
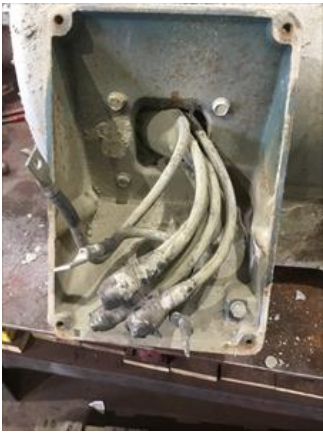
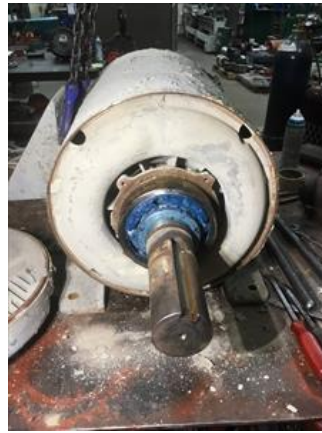
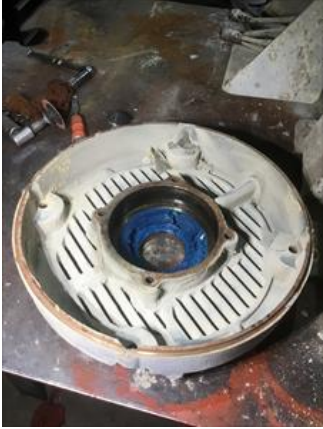
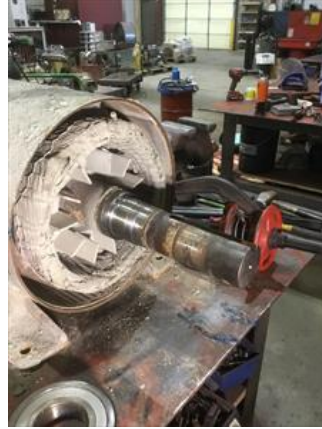
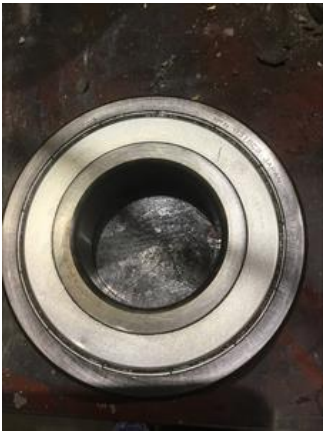
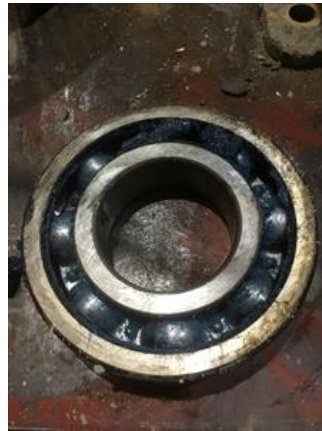
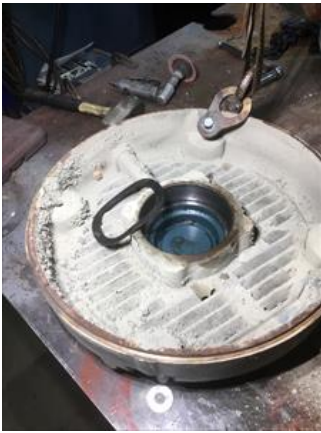
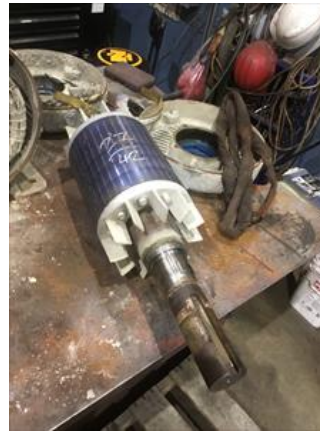
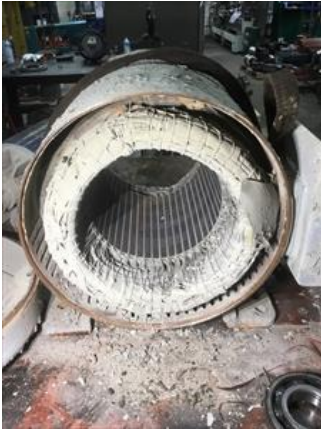
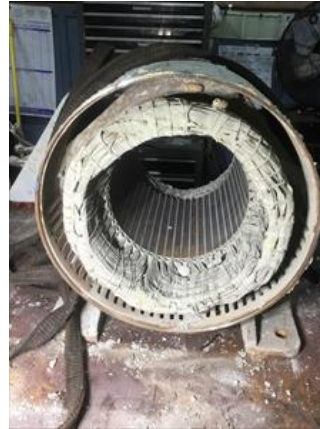
- Photos of all six sides of the machine. **P45**

4. Describe the Overall Condition of the Equipment as Received
Covered with concrete.

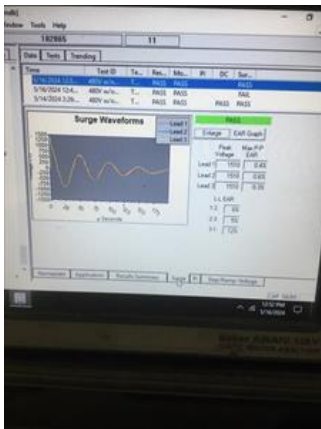
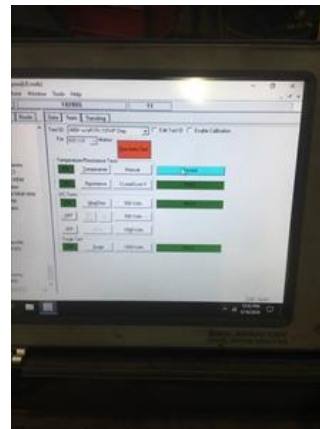
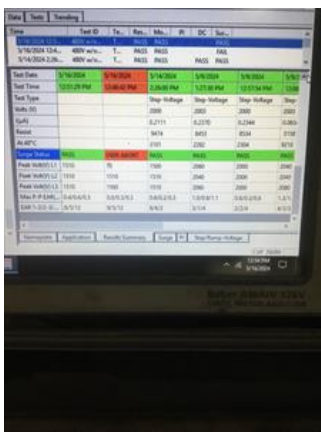
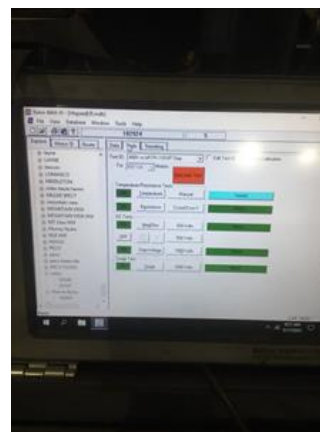
P57

22. Perform Surge Test

(P) Pass

After wash and bake.

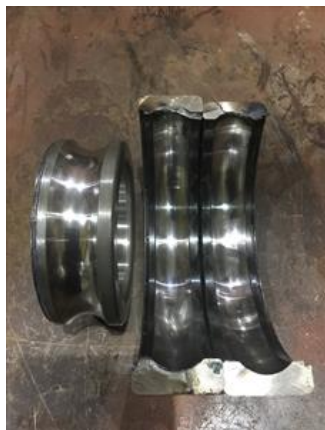
27. Drive End Bearing Brand	NTN	
28. Drive End Bearing Number-	6316	P32

29. Drive End Bearing Qty.	1	
30. Drive End Bearing Type	(Ball) Ball Bearing	
31. Drive End Lubrication Type	(Grease) Grease Lubricated	
32. Drive End Bearing Insulation or Grounding Device?		
33. Drive End Wavy Washer/Snap-Ring Other Retention Device?		
Na		
34. Drive End Bearing Condition	replace	
35. Opposite Drive End Bearing Brand	SKF	
36. Opposite Drive End Bearing Number-	6312	P99

Bearing failure due to contaminated grease and excessive amounts of concrete on motor.

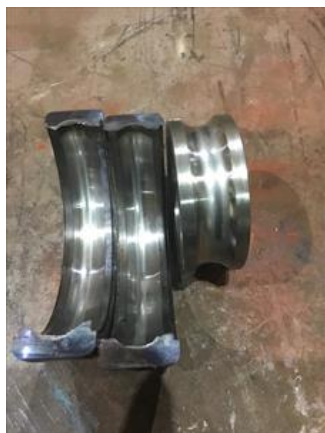
37. Opposite Drive End Bearing Qty.	1	
38. Opposite Drive End Bearing Type	(Ball) Ball Bearing	
39. Opposite Drive End Lubrication Type	(Grease) Grease Lubricated	
40. Opposite Drive End Bearing Insulation or Grounding Device?	na	
41. Opposite Drive End Wavy Washer/Snap-Ring Other Retention Device?	wavy washer	
42. Opposite Drive End Bearing Condition	replace	
43. Drive End Seal	na	
44. Opposite Drive End Seal	na	
45. DE Sleeve Bearing Inside Diameter		
0 degrees	120 degrees	240 degrees

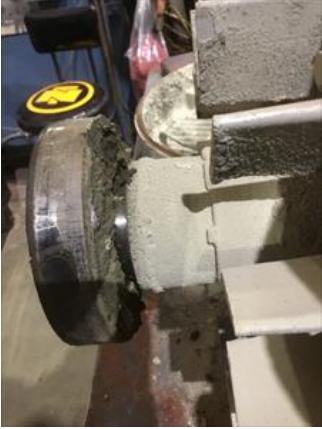
68.	Drive End - Endbell Bearing Fit		
	0 Degrees	60 Degrees	120 Degrees
	6.6942	6.695	6.6947
69.	Drive End - Endbell Bearing Fit Condition (F) Fail		
70.	Opposite Drive End - Endbell Bearing Fit		
	0 Degrees	60 Degrees	120 Degrees

73.	End Bell Air Seal Fits		
	Drive End Air Seal	Opposite Drive End Air Seal	
	Na		
74.	List Machine Work Needed Below D.E housing fit bad		
75.	Technician Terrence Holland

D.E housing

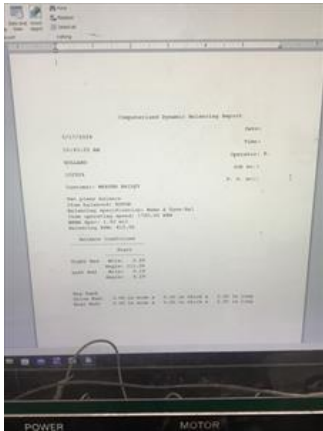
P11

79. Initial Balance Readings

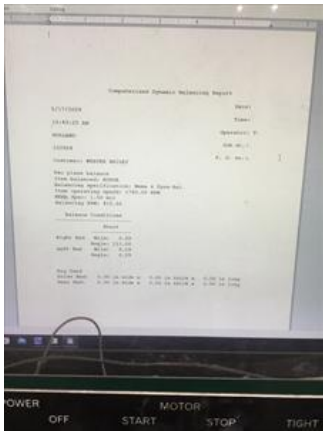
P27

80. Final Balance Readings

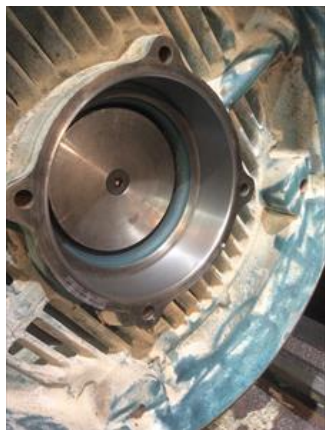
98. Drive End - Endbell Bearing Fit Post Repair

6.6934

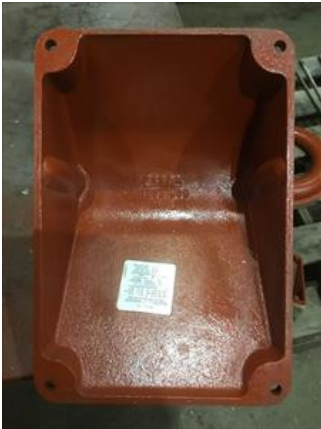
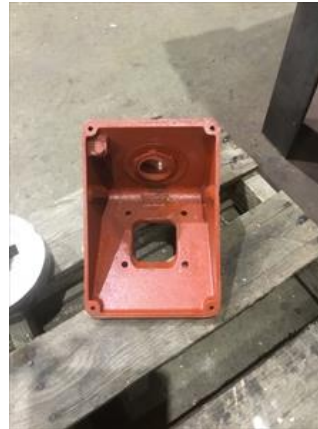
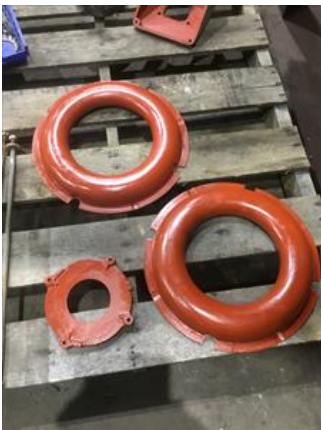
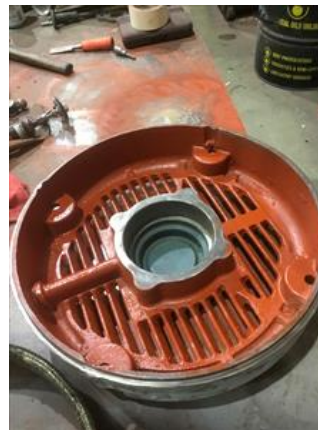
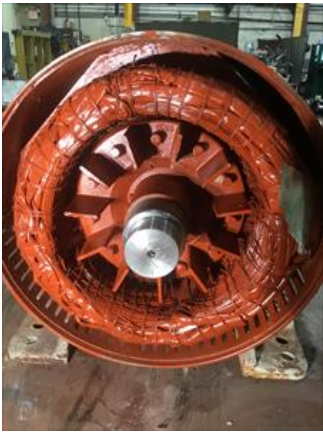
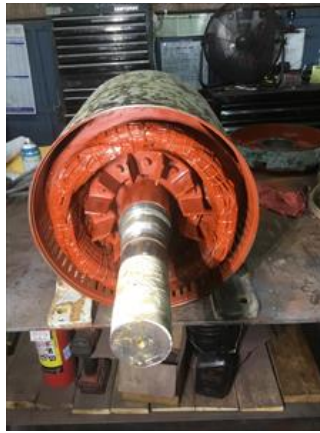
P17

112. Photograph All Major Components prior to assembly

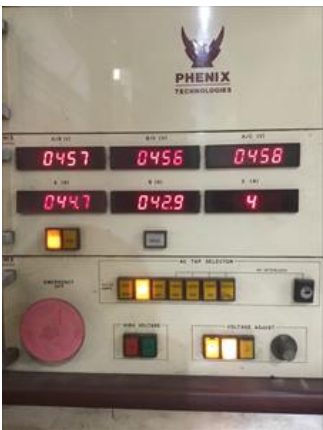
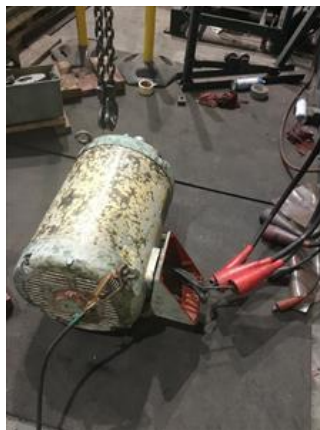
P56

116. Test Run Voltage

457

456

458

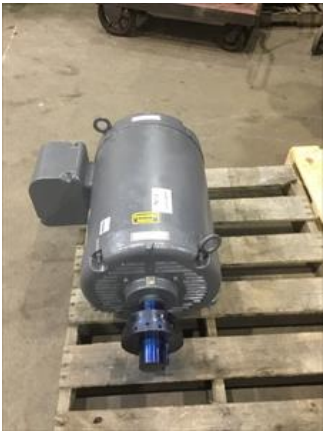
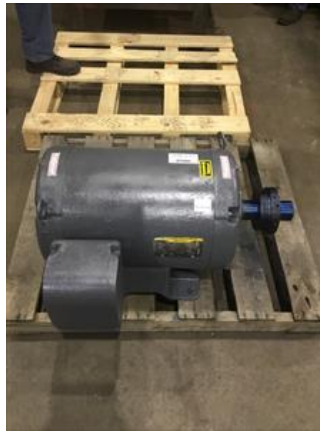
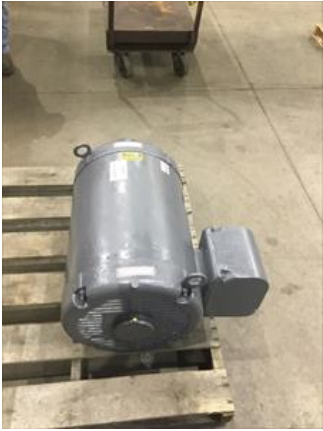
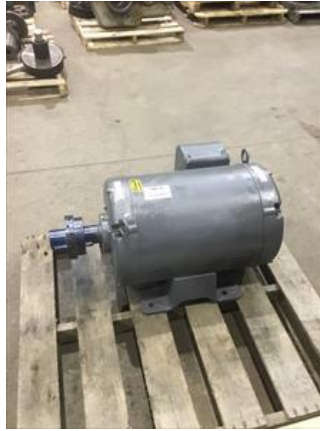
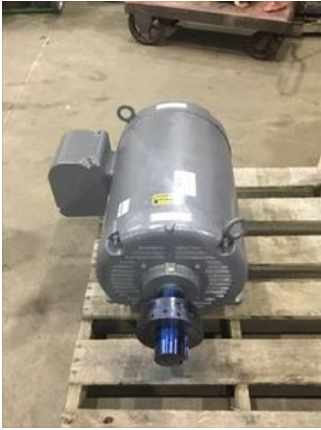
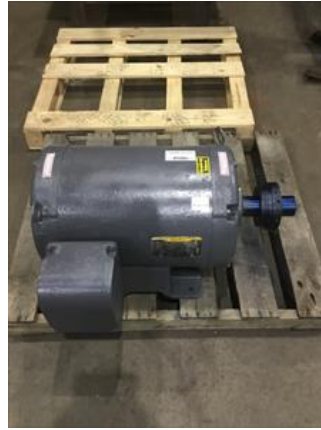
128.	Opposite Drive End Bearing Temps - Fahrenheit 50-60 Minutes		
	50 Minutes	55 Minutes	60 Minutes
	<div> <div></div> <div>Na</div> </div>		
129.	Document Final Condition with Pictures after paint		P129
