AC Inspection as Found

FUTURE FUEL CHEMICAL

AC Inspection - Rev. 2

Location: MOTOR SHOP LR
Serial Number: C0709280042
Description: 25HP BALDOR UL LISTED

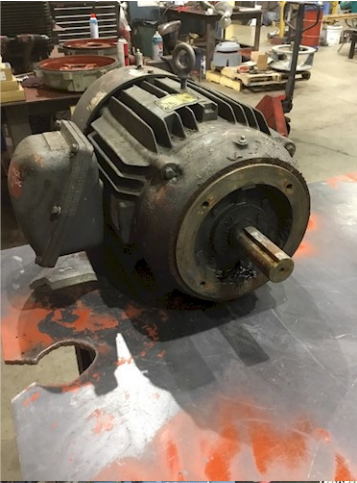
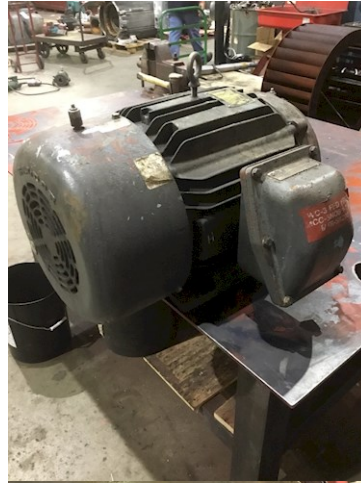
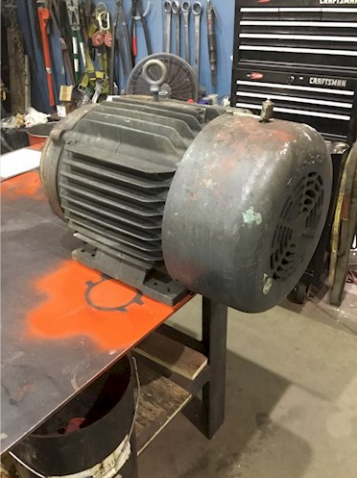
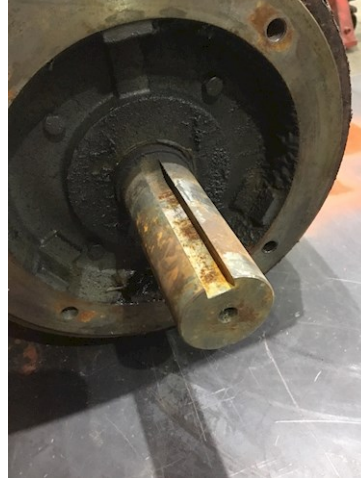
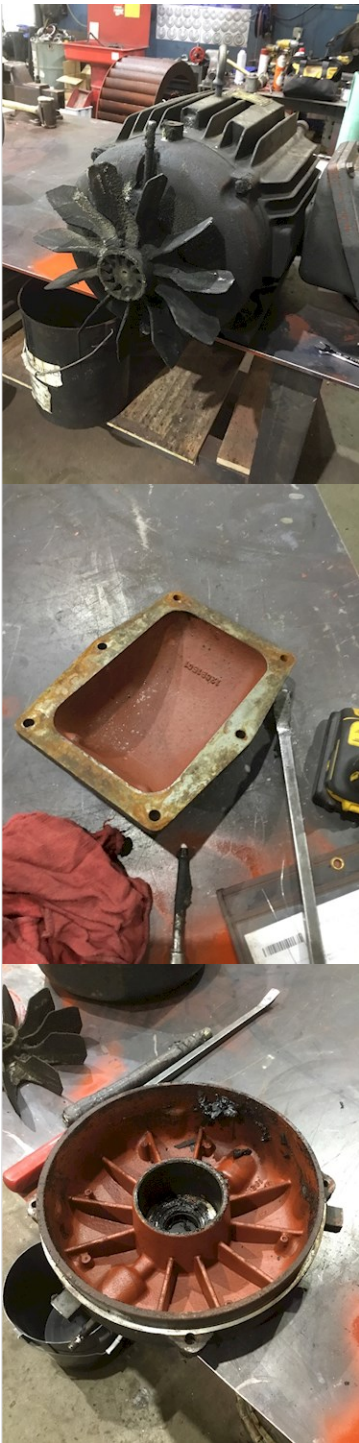
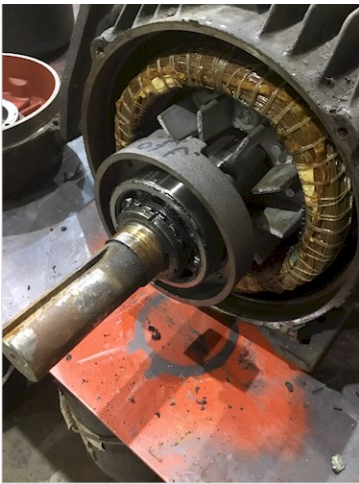
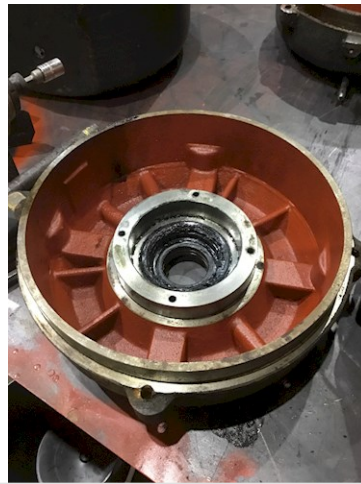
3. Photos of all six sides of the machine.

4.	Describe the Overall Condition of the Equipment as Received	
	<i>Dirty</i>	
5.	Report Date [COPY]	05/24/2024
Initial Mechanical/Electrical		
6.	Does Shaft Turn Freely?	(Y) Yes
7.	Does the shaft require T.I.R in Lathe to identify additional repairs?	(No) No
8.	Does Shaft Have Visible Damage?	(No) No
9.	Assembled Shaft Runout	Inches
	Na	
10.	Assembled Shaft End Play	inches
	Na	
11.	Air Gap Variation <10%	
	Na	
12.	Lead Condition	(P) Pass
13.	Lead Length	18 Inches
14.	Does it have Lugs?, If so what is the Stud Size?	P93
	Yes	
15.	Lead Numbers	1-9
16.	Frame Condition	pass
17.	Fan Condition	(P) Pass
18.	Broken or Missing Components	fan cover bolt
Initial Electrical Inspection

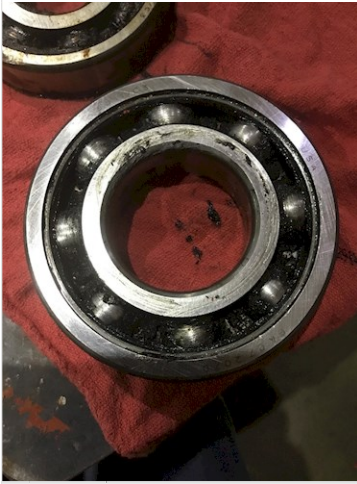
26. Drive End Bearing Brand

na

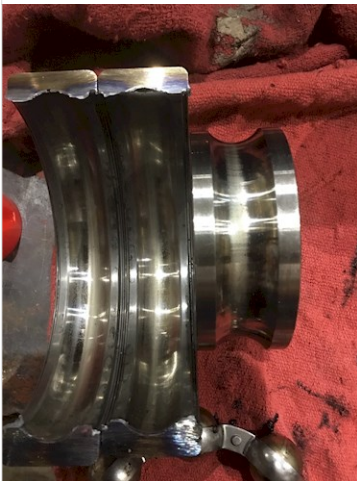
33. Drive End Bearing Condition

67.	Failure locations Bearings		
68.	Root cause of failure Contamination and fluting		
Dynamic Balance Report			
69.	Rotor Weight and Balance Grade		
	Rotor Weight	Balance Grade

6311

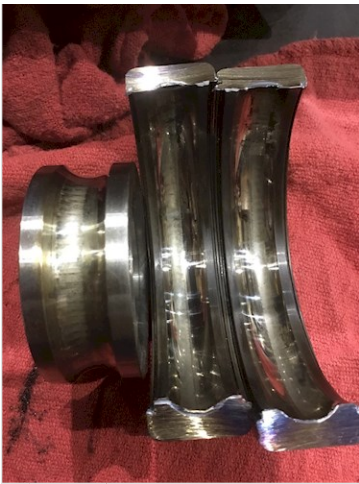
41. Opposite Drive End Bearing Condition

59.	Drive End - Endbell Bearing Fit		
	0 Degrees	60 Degrees	120 Degrees
	4.7253	4.7252	4.7252
60.	Drive End - Endbell Bearing Fit Condition		(P) Pass
61.	Opposite Drive End - Endbell Bearing Fit		
	0 Degrees	60 Degrees	120 Degrees
	Unable to provide proper measurements due to excessive wear

62.	Opposite Drive End - Endbell Bearing Fit Condition		(F) Fail
63.	Bearing Cap Condition		
	Drive End Bearing Cap	Opposite Drive End Bearing Cap	
	Pass

6309

Need 4.5 inch OD and 6inch length brass for sleeving

64.	End Bell Air Seal Fits		
	Drive End Air Seal	Opposite Drive End Air Seal	
	Na		
65.	List Machine Work Needed Below ODE end bell bearing fit		
66.	Technician		Cw

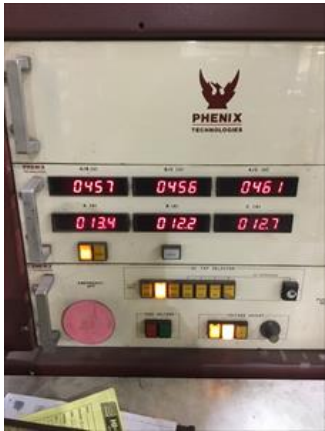
76.	Assembled Shaft Endplay	0 inches	
77.	Assembled Shaft Runout	0.002 inches	
78.	Test Run Voltage		P56
	Volts	Volts	Volts

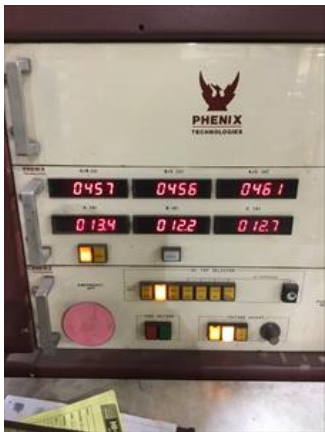
79.	Test Run Amperage		P65
	Amps	Amps	Amps
