## AC Inspection as Found

Novus Arkansas, LLC (11612)

### AC Inspection - Rev. 2

Description: 1.5HP CARMAN MOTOR REPAIR

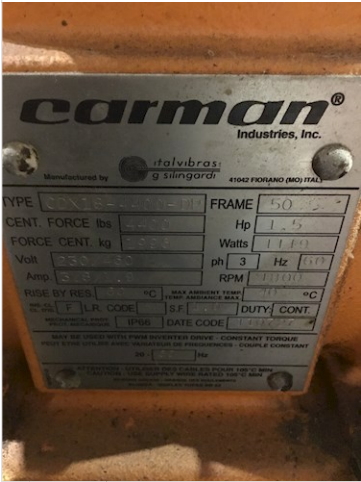
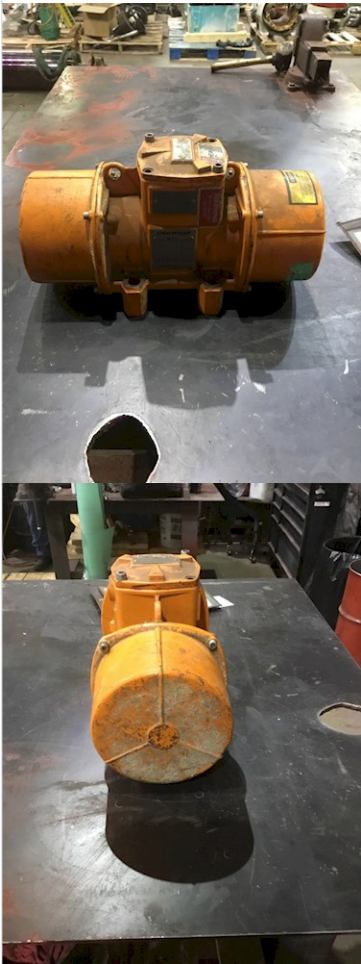
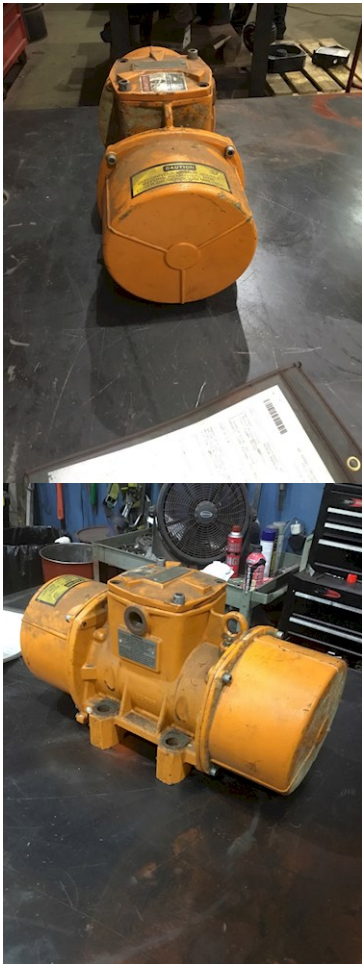
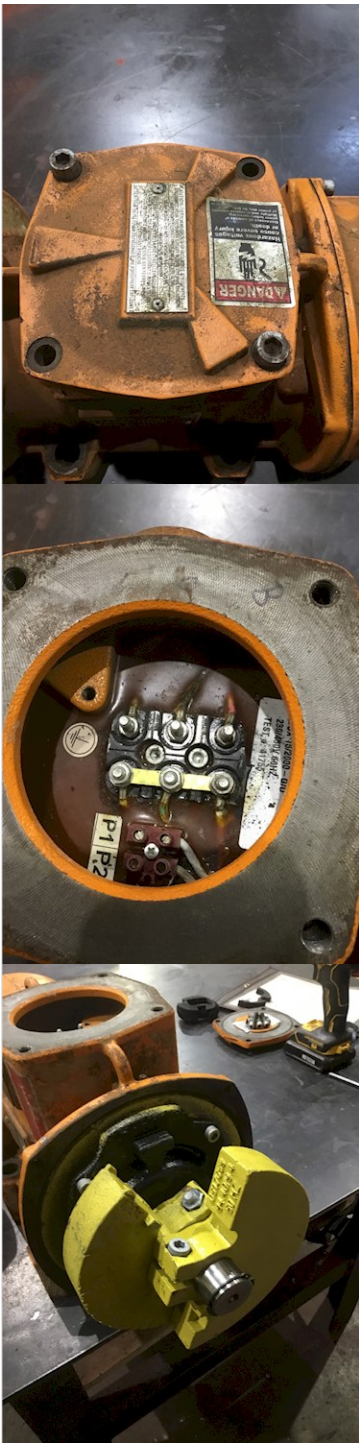
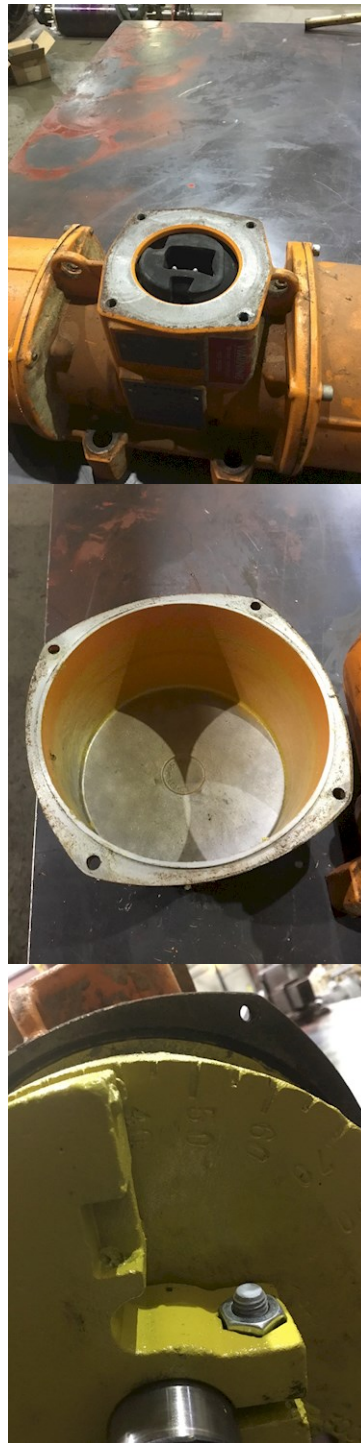
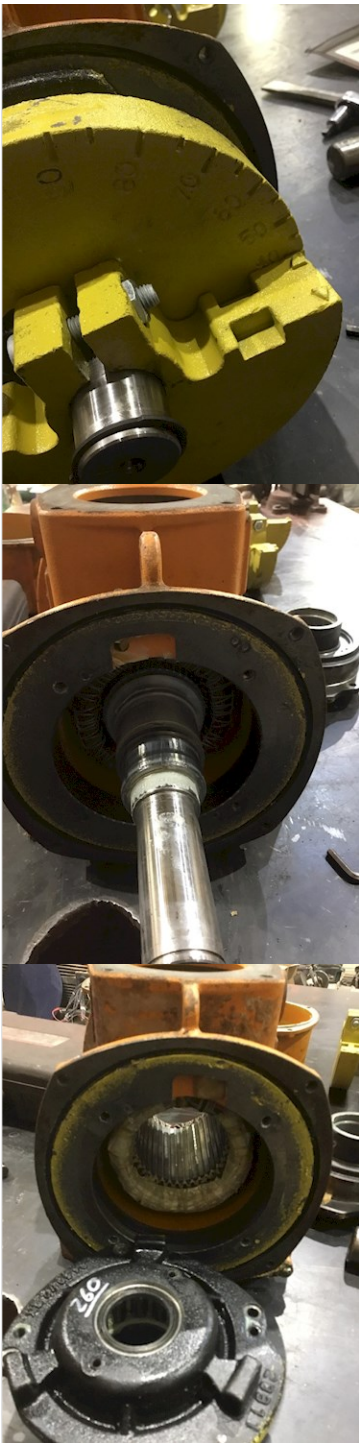
4. Describe the Overall Condition of the Equipment as Received

*Dirty*

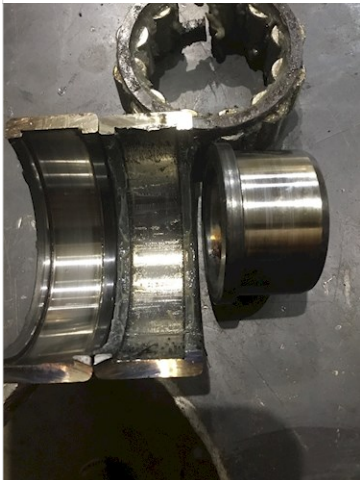
26.	Drive End Bearing Number-	NJ2308 EC/C4	
27.	Drive End Bearing Qty.	1	
28.	Drive End Bearing Type	(Roller) Roller Bearing	
29.	Drive End Lubrication Type	(Grease) Grease Lubricated

30.	Drive End Bearing Insulation or Grounding Device?		
	Na		
31.	Drive End Wavy Washer/Snap-Ring Other Retention Device?	na	
32.	Drive End Bearing Condition		P82
	Replace

<div> <div></div> <div>Co sign: RRW</div> </div>	
<b>Root Cause of Failure</b>		
66.	Failure locations	
	Bearings

67.	Root cause of failure	
	Contamination	
<b>Dynamic Balance Report</b>		
68.	Rotor Weight and Balance Grade	
	Rotor Weight	Balance Grade
69.	Initial Balance Readings	
	Drive End	Opposite Drive End

45.	Number of Rotor Bars			46
46.	Rotor Condition			pass
47.	List the Parts needed for the Repair Below NJ2308EC/C4 X2 Shaker grease			
48.	Signature of Technician that Disassembled Motor			Cw

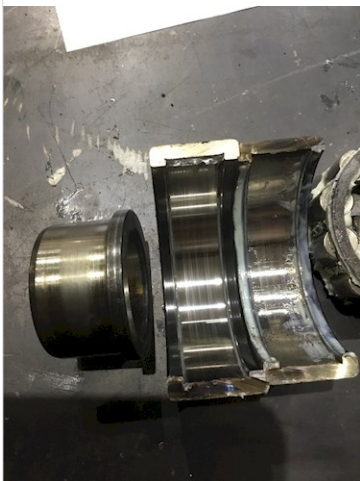
33.	Opposite Drive End Bearing Brand	skf	
34.	Opposite Drive End Bearing Number-	NJ2308EC/C4	
35.	Opposite Drive End Bearing Qty.	1	
36.	Opposite Drive End Bearing Type	(Roller) Roller Bearing

37.	Opposite Drive End Lubrication Type	(Grease) Grease Lubricated	
38.	Opposite Drive End Bearing Insulation or Grounding Device?	na	
39.	Opposite Drive End Wavy Washer/Snap-Ring Other Retention Device?	na

40.	Opposite Drive End Bearing Condition		P118
	Replace
